# **POMPEII SUSTAINABLE PRESERVATION PROJECT**

**Documentation of the funerary monuments  
14\_EN and 07\_ES**

**Christina Elsässer**

Munioch, February 25<sup>th</sup>, 2015

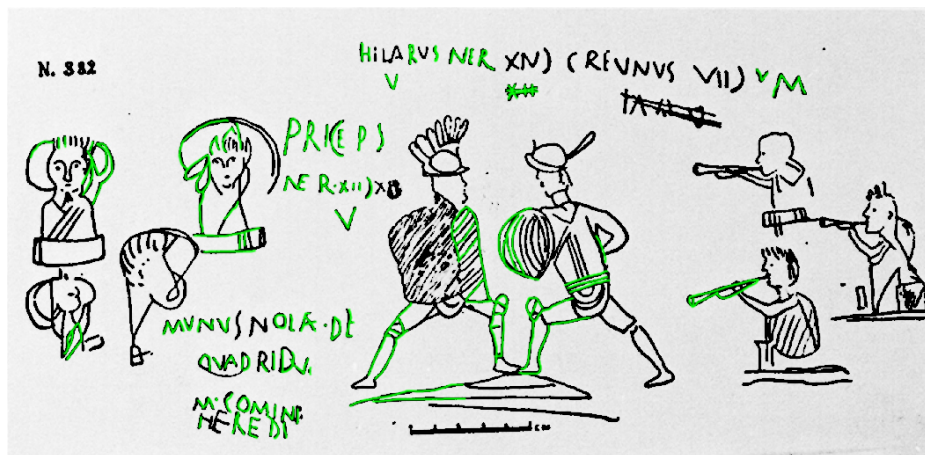
The funerary monument 14\_EN has been described by D'AMBROSIO<sup>3</sup>. The documentation of D'AMBROSIO is the starting point of this documentation. Only observed addition should be named here. One of the additions are the ancient graffiti, which are mainly along the base of the south wall. They have been described by DELLA CORTE<sup>4</sup>, but so far only one drawing (Figure 2) of one graffito exists. It shows a fight of two gladiators at position 2 (Figure 112). With the drawing of DELLA CORTE, it is possible to compare the situation of graffiti from 1958 with its present state (November 2014). As Figure 2 and Figure 3 shows only 40% of the incisions are still visible.

Figure 2: Drawing of the graffito at position 2 of DELLA CORTE, 1958, p.152 No. 382. Incisions which are still visible are green marked.

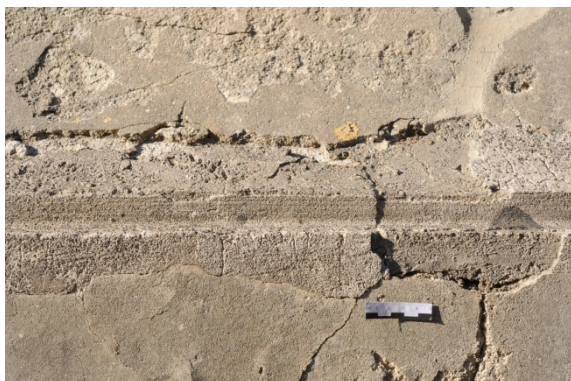
Two possible different filling materials could be observed at the walls. One, which seemed to be very hard but having a rather good connection to the original surfaces, and the other, which has a very smooth surface, a rather dark gray color and a bad connection to the original surface. The first described filling material is a hard mortar maybe containing cement (Figure 120 – Figure 121). The other described filling mortar could presumably contain plasticizer (Figure 120 – Figure 121). The filling mortar presumably containing plasticizer is very tense and the filling material itself has a lot of fine cracks. The connection to the original material is badly bonded and the filling material scales off. Therefore, most of these fillings have to be renewed.

Figure 5: filling with hard mortar (cement?).

Cracks and edges have been protected in former conservation interventions and maintenance work. But new cracks have appeared and some of the fillings and protection of the edges has to be renewed (see conservation master plan).

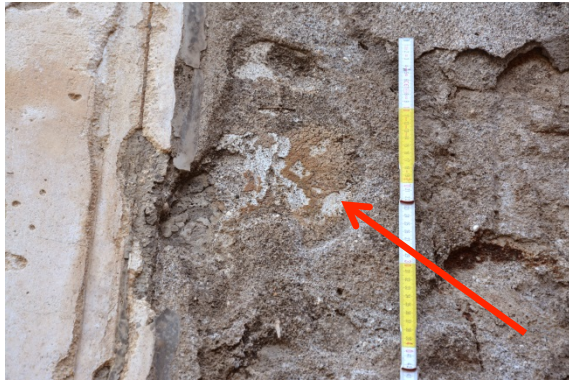
There are some brown and black discolored areas, unequally diversified over the walls of 14\_EN, which could result of former consolidation materials residues.

The brown discoloration was found in missing parts of preparatory layers (Figure 7) and the black discoloration in missing parts of Intonaco (Figure 8).

Figure 7: brown discoloration in missing parts of preparatory layers (red arrow).

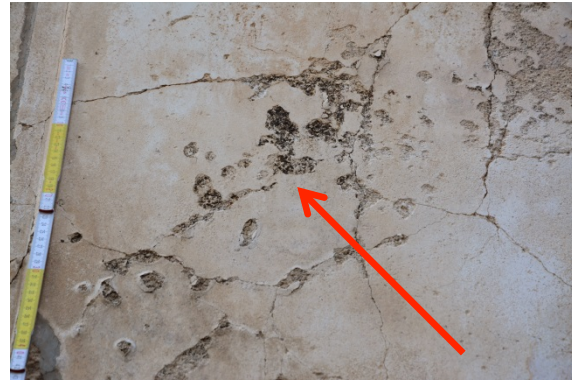
Figure 8: black discoloration in missing parts of Intonaco (red arrow).

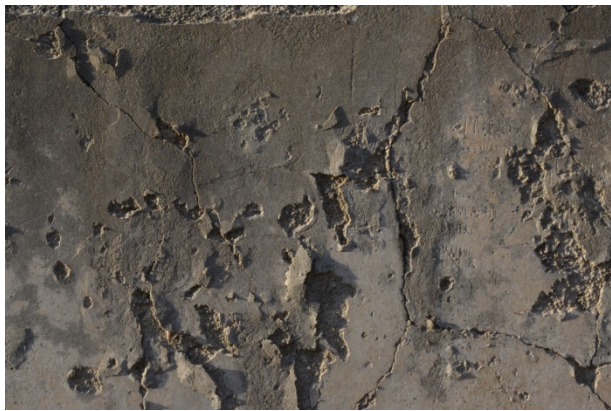
At the base of the south wall, the intonaco is affected by scaling. Especially the graffiti bear losses from scaling intonaco (Figure 9).

Figure 9: Scaling intonaco close to one graffito at position 2.

The documentation of damages shows no cracks which could cause static problems at the masonry of 14\_EN. The plaster layers are in a rather bad condition. The plaster shows a wide spread amount of different kind of damages (scaling, flaking, detachment etc.). The detachment of the whole plaster layers from structure is one of the server problems. Many of these plaster pieces seem just to be kept in place by the previous edge protection. As maps (Figure 150 – Figure 151) show, there are plaster areas, which have rather no attachment to their substrate and could fall off any time (Figure 10). To conserve these parts emergency intervention has to be done.

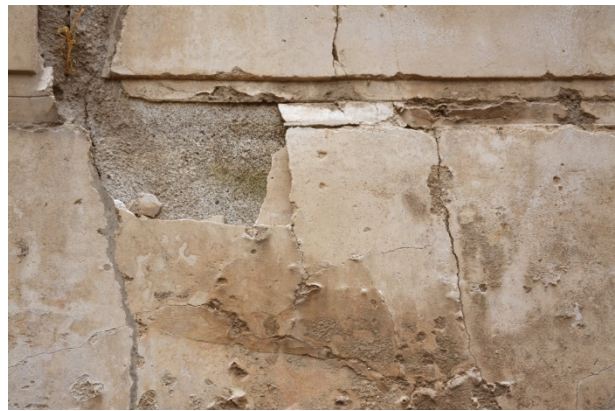
Figure 10: collapsing lacunae at 14\_EN\_S.

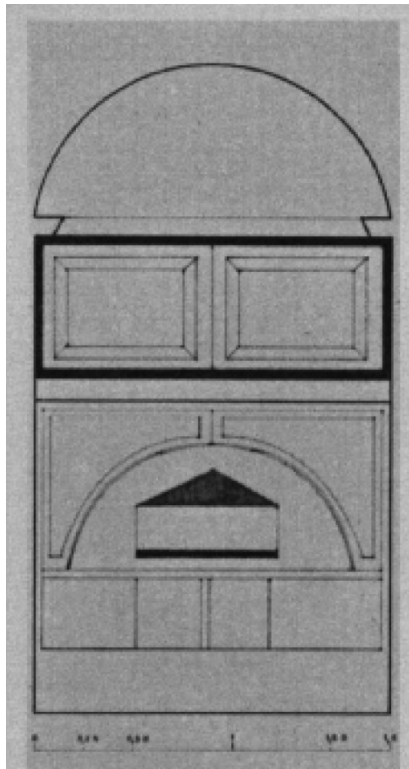
Figure 17: drawing of DELLA CORTE of 07\_ES\_S\_I from 1958. The double line (see red arrow) could no longer be detected.

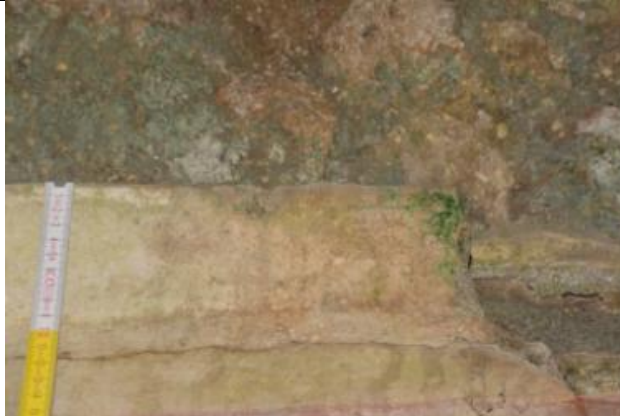
At the breaking edge of the cornice is an intense green infestation to be found.  
photographs: 07\_ES\_W\_I\_BO\_DSC\_3173

Figure 44: intense green infestation (picture number: 07\_ES\_W\_I\_BO\_DSC\_3173).

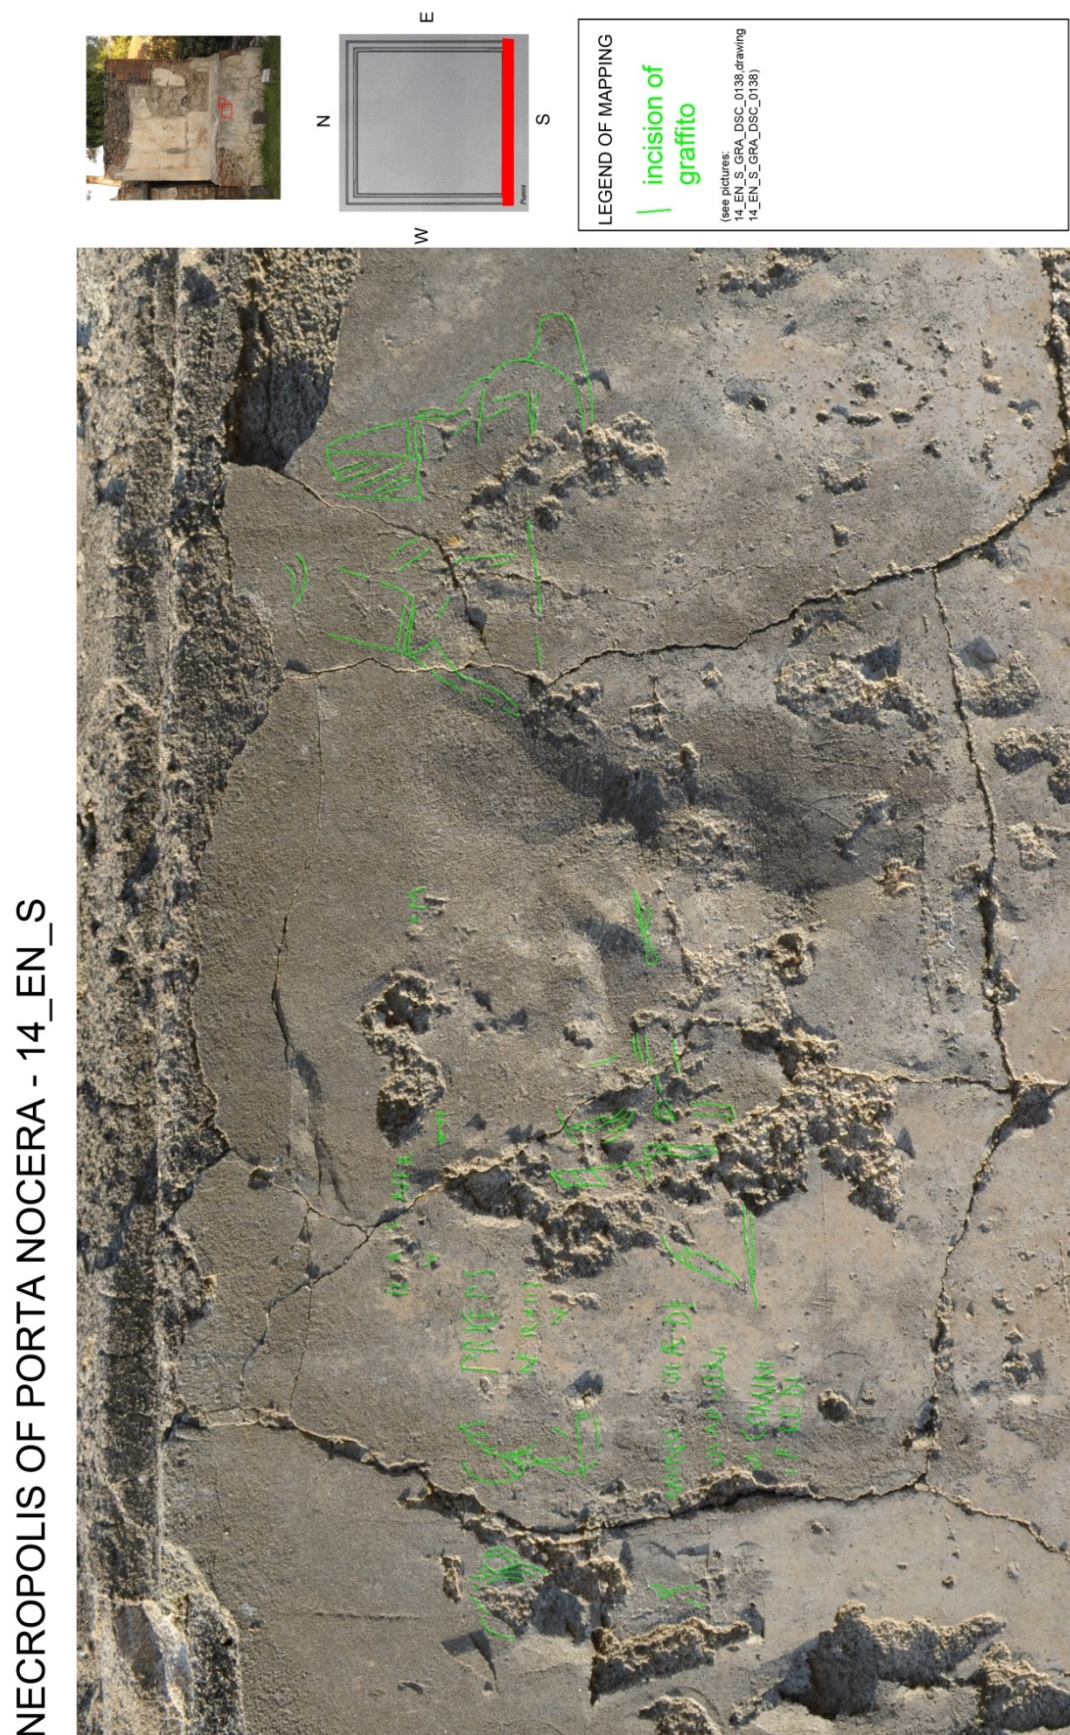
Figure 113: Map of incision of graffito at position 2 and 3.

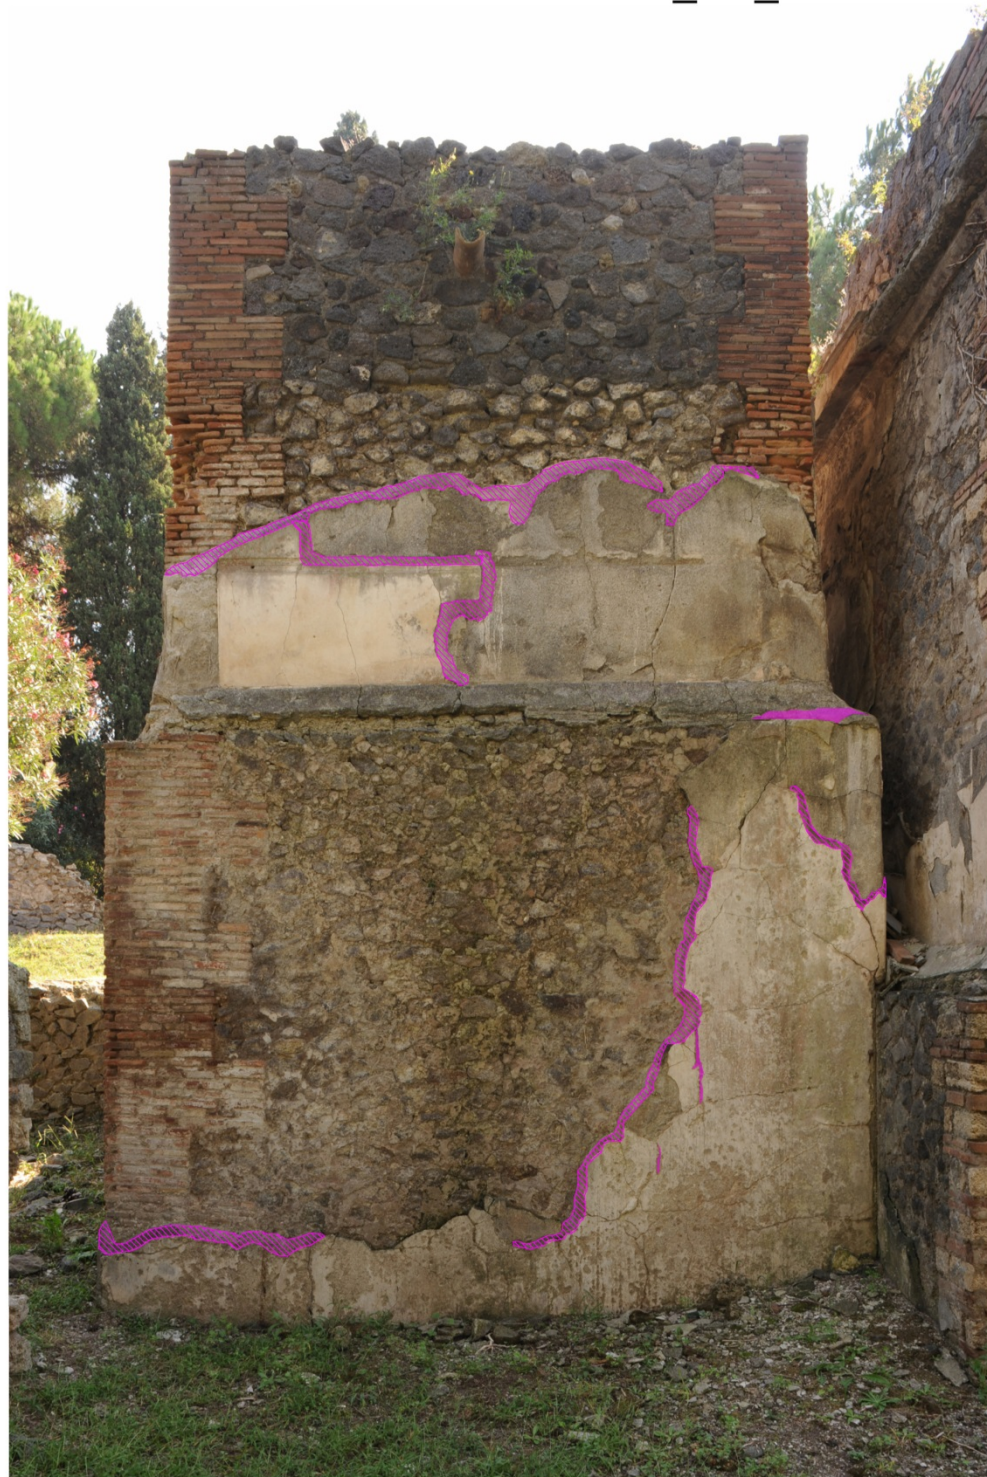
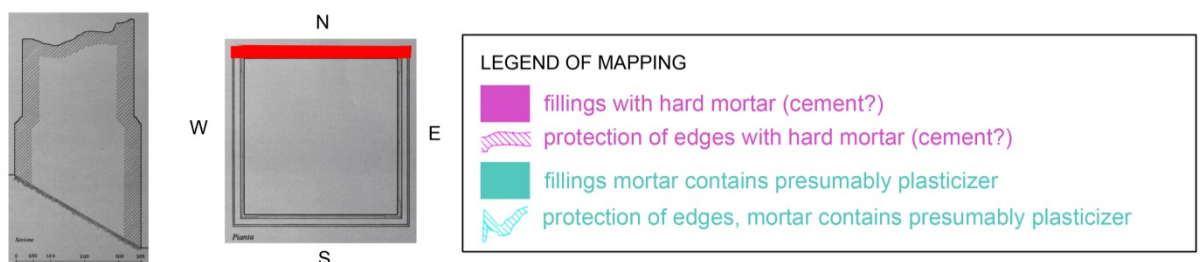
Figure 121: map of fillings and protections of edges at 14\_EN\_N.

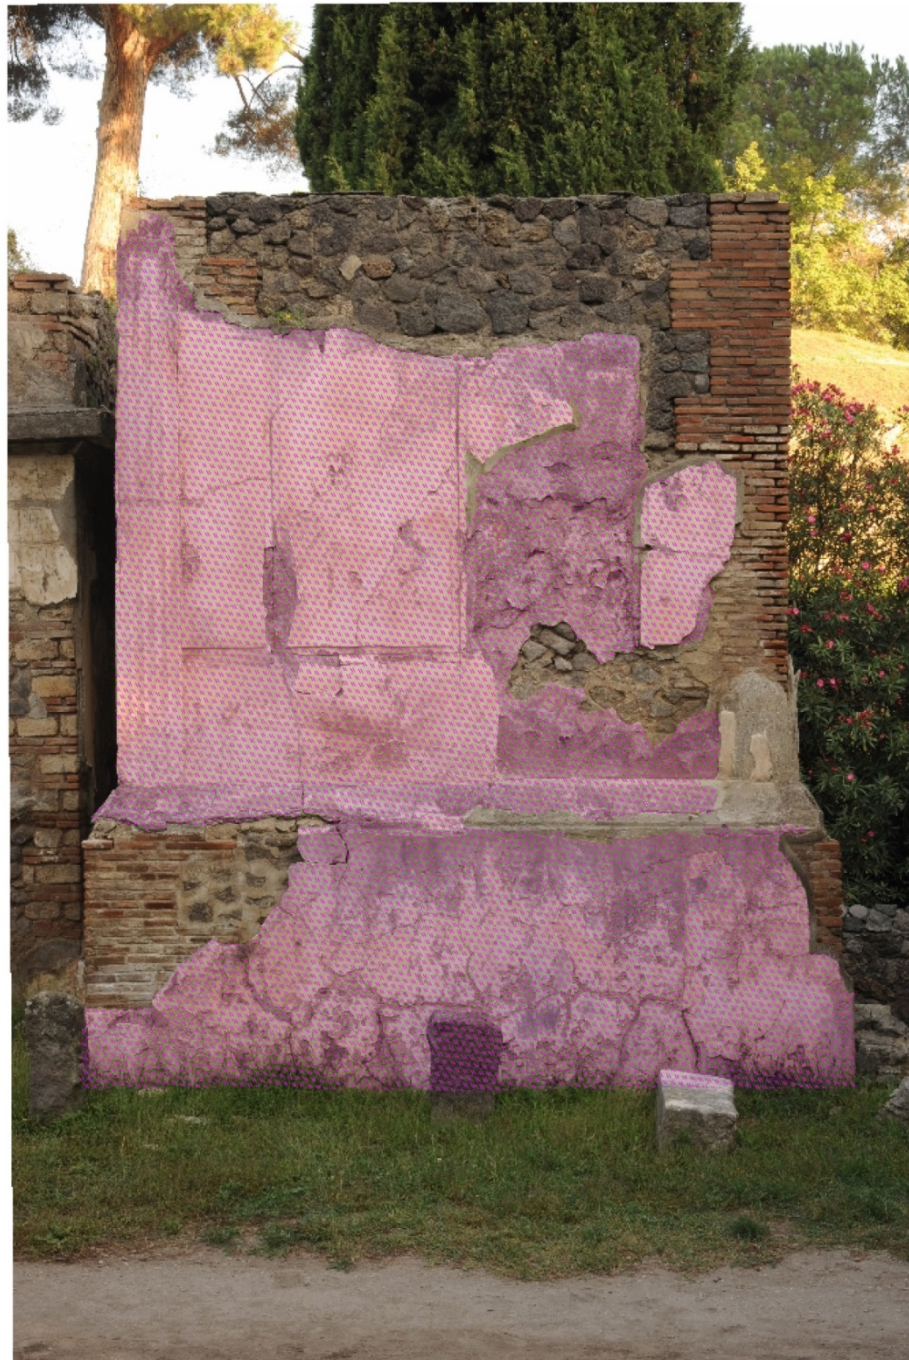
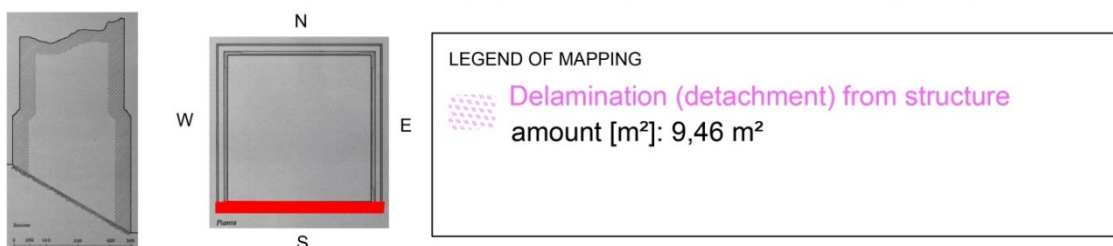
Figure 122: map 14\_EN\_S delamination (detachment) from structure.

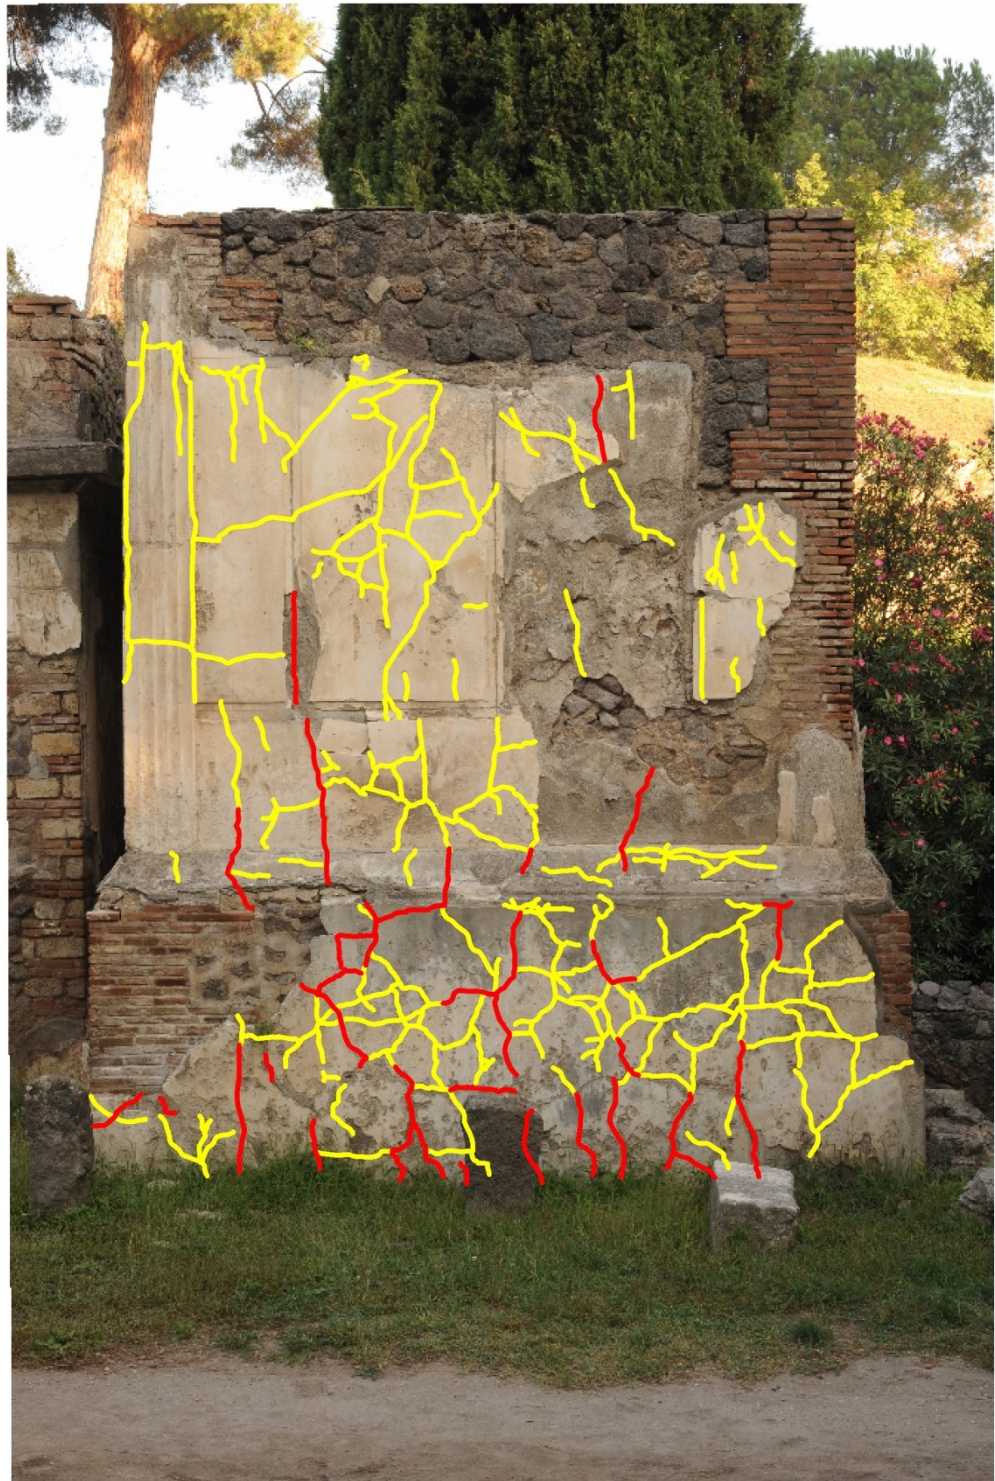
## NECROPOLIS OF PORTA NOCERA - 14\_EN\_S

( Deep Cracks (presumably reaching through all plaster layers) amount [m]: 11,22 m

✂ Cracks staying at the surface amount [m]: 45,46 m

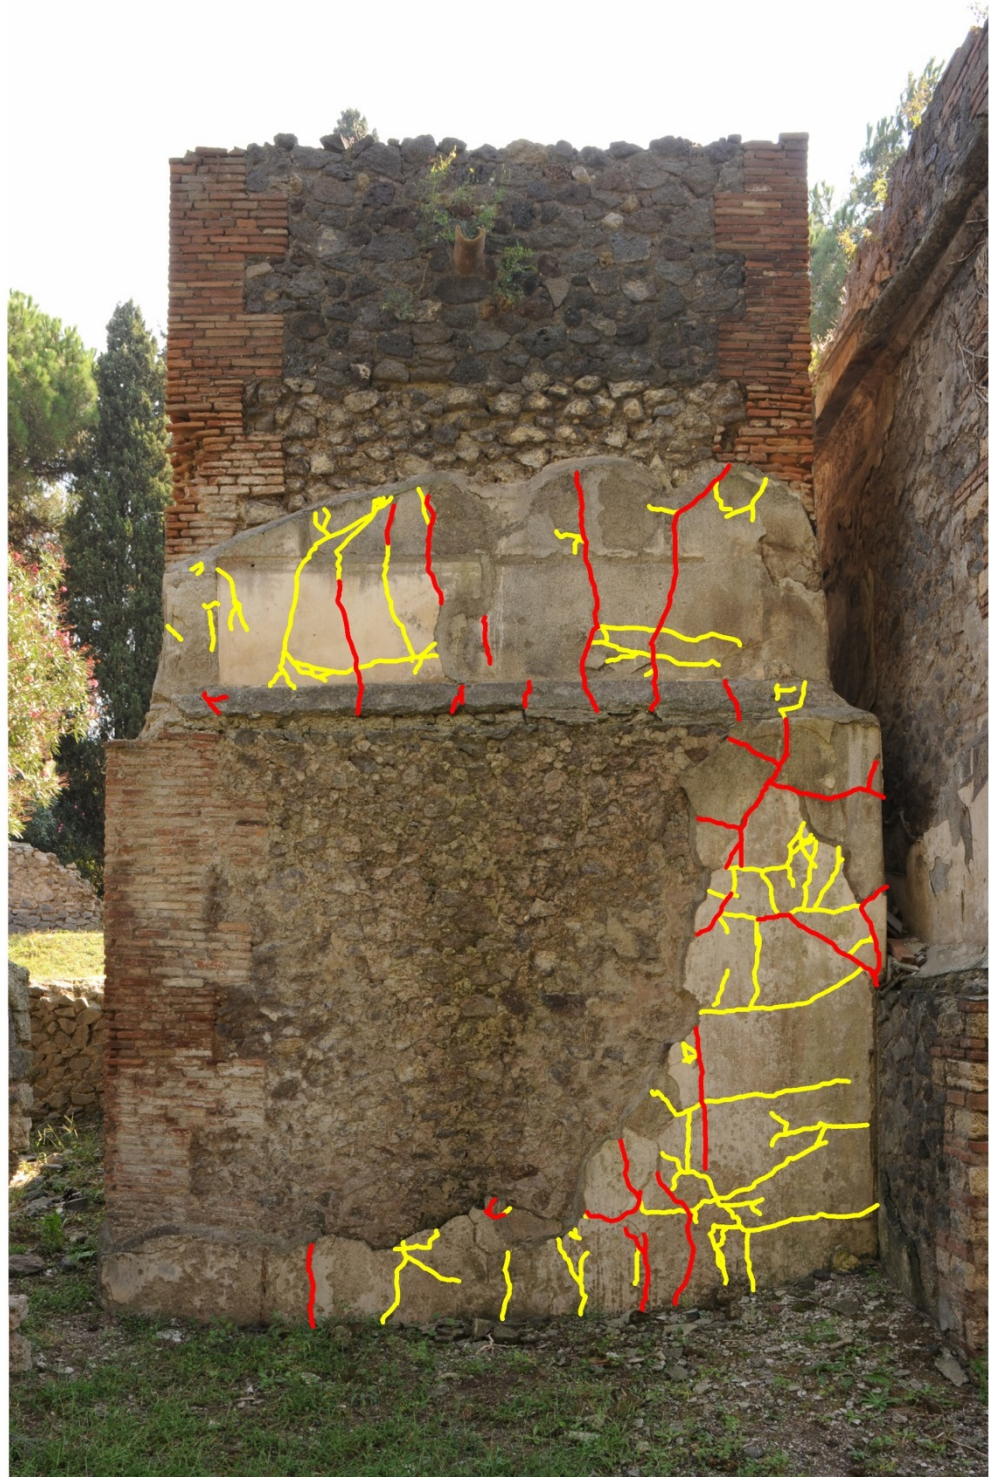
## NECROPOLIS OF PORTA NOCERA - 14\_EN\_N

- | Deep Cracks (presumably reaching through all plaster layers) amount [m]: 11,4 m
- | Cracks staying at the surface amount [m]: 20,45 m

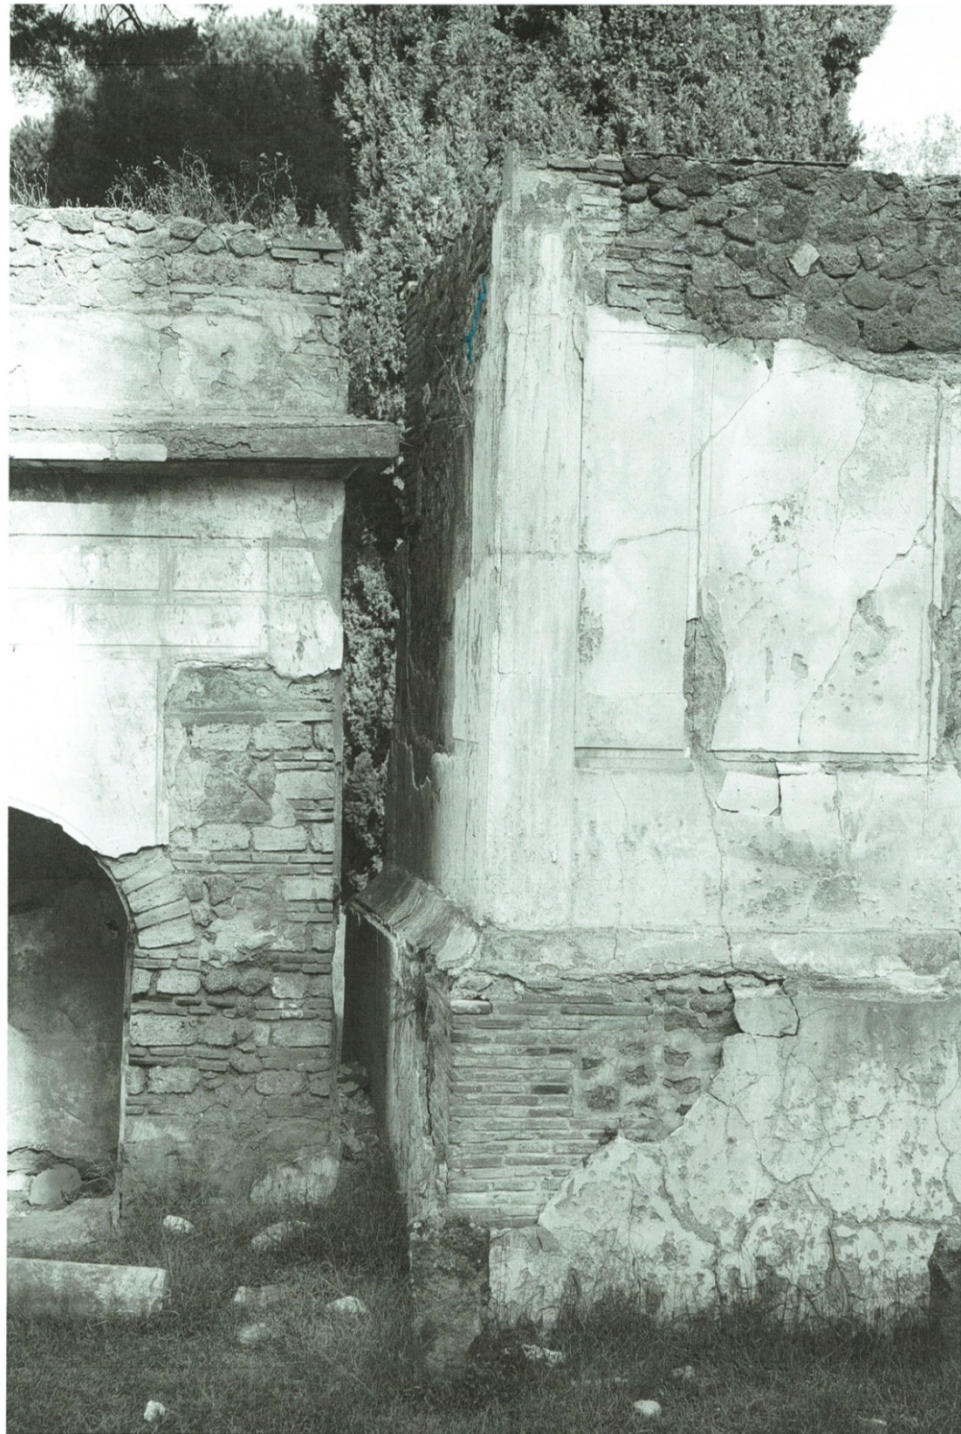
Figure 139: map 14\_EN\_W of missing mortar.

Missing mortar (Figure 138 – Figure 141) between the bricks and lava should be refilled (e.g. with lime/sand mortar). The estimated amount is listed at Table 4.

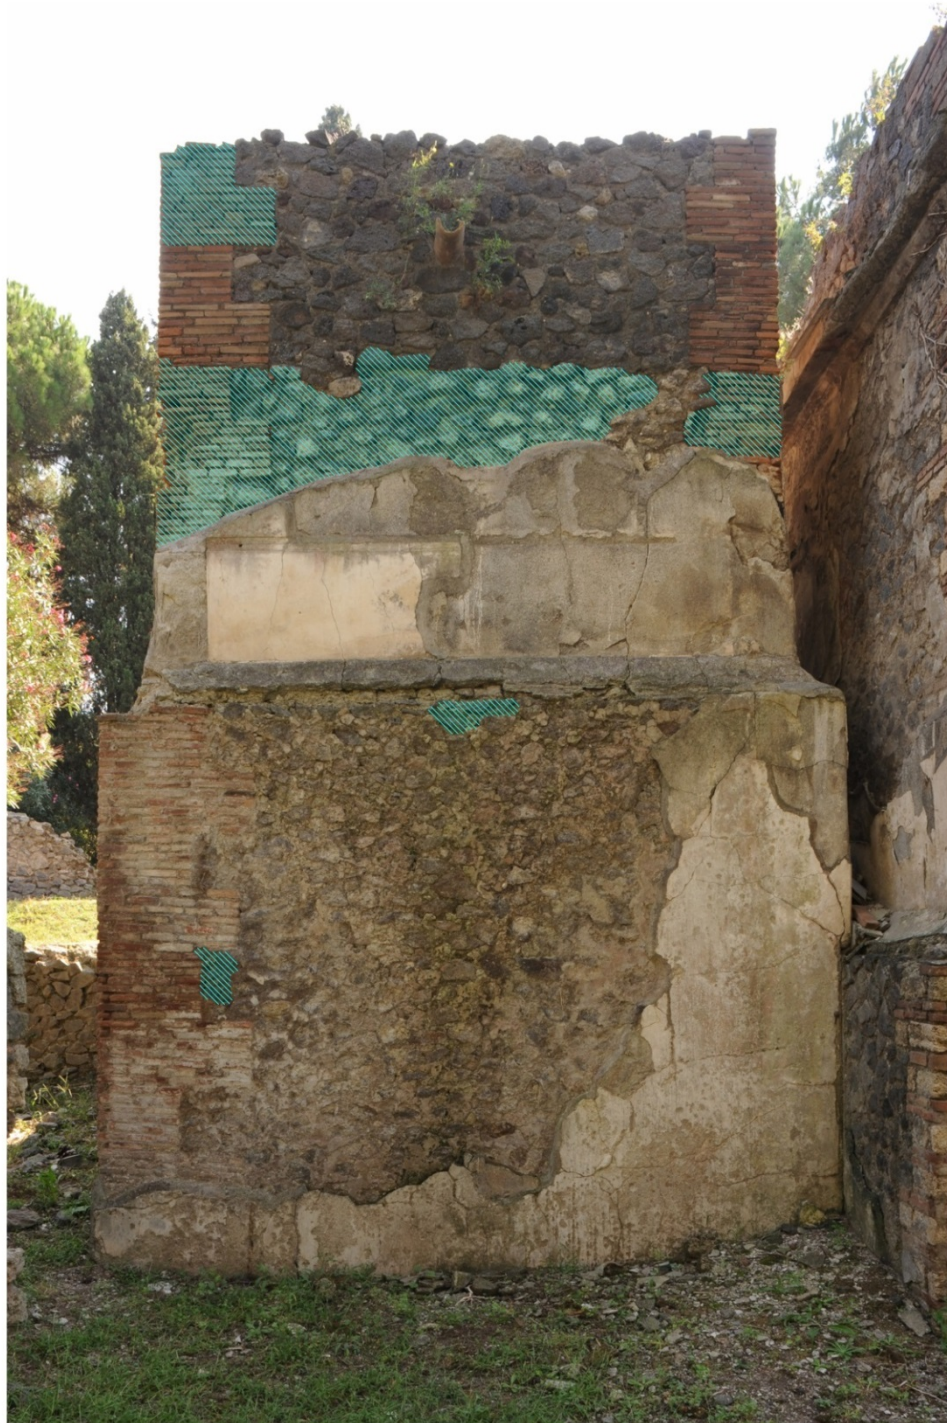
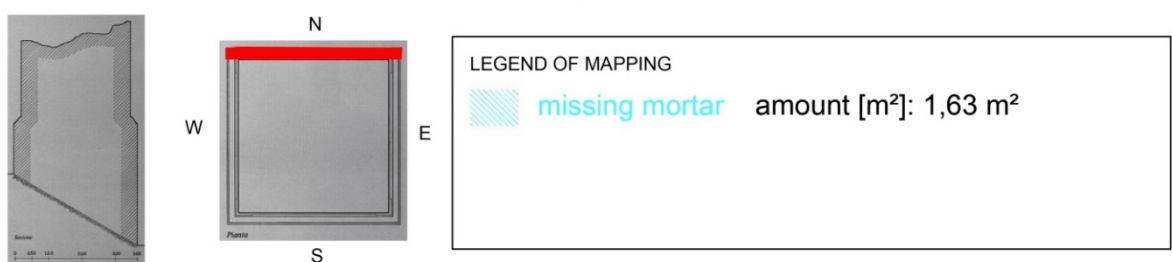
Figure 140: map 14\_EN\_N of missing mortar.

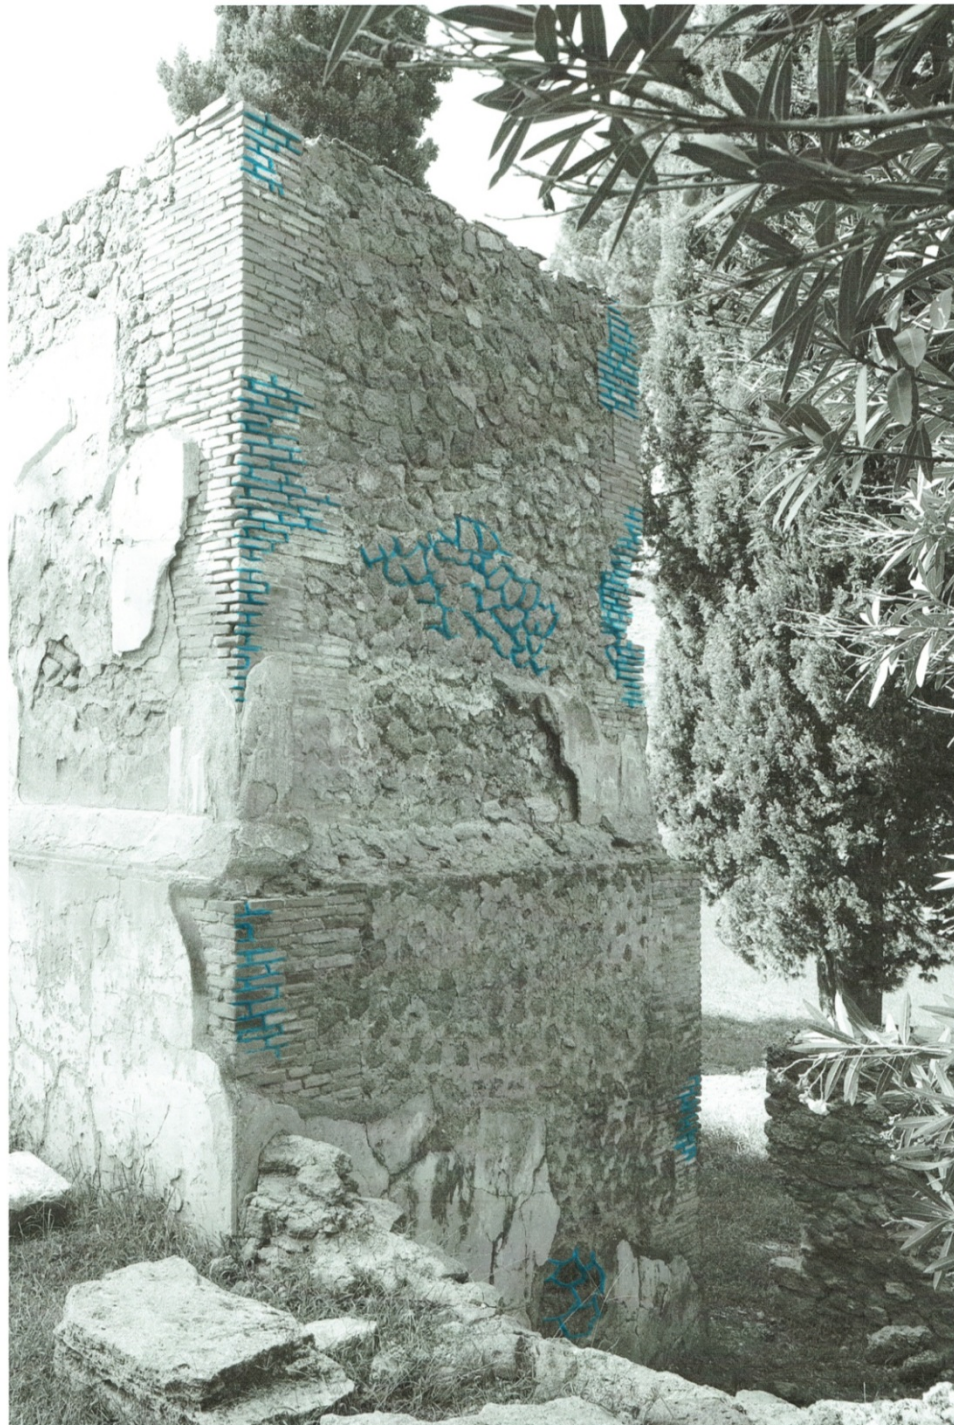
Figure 141: map 14\_EN\_E of missing mortar.

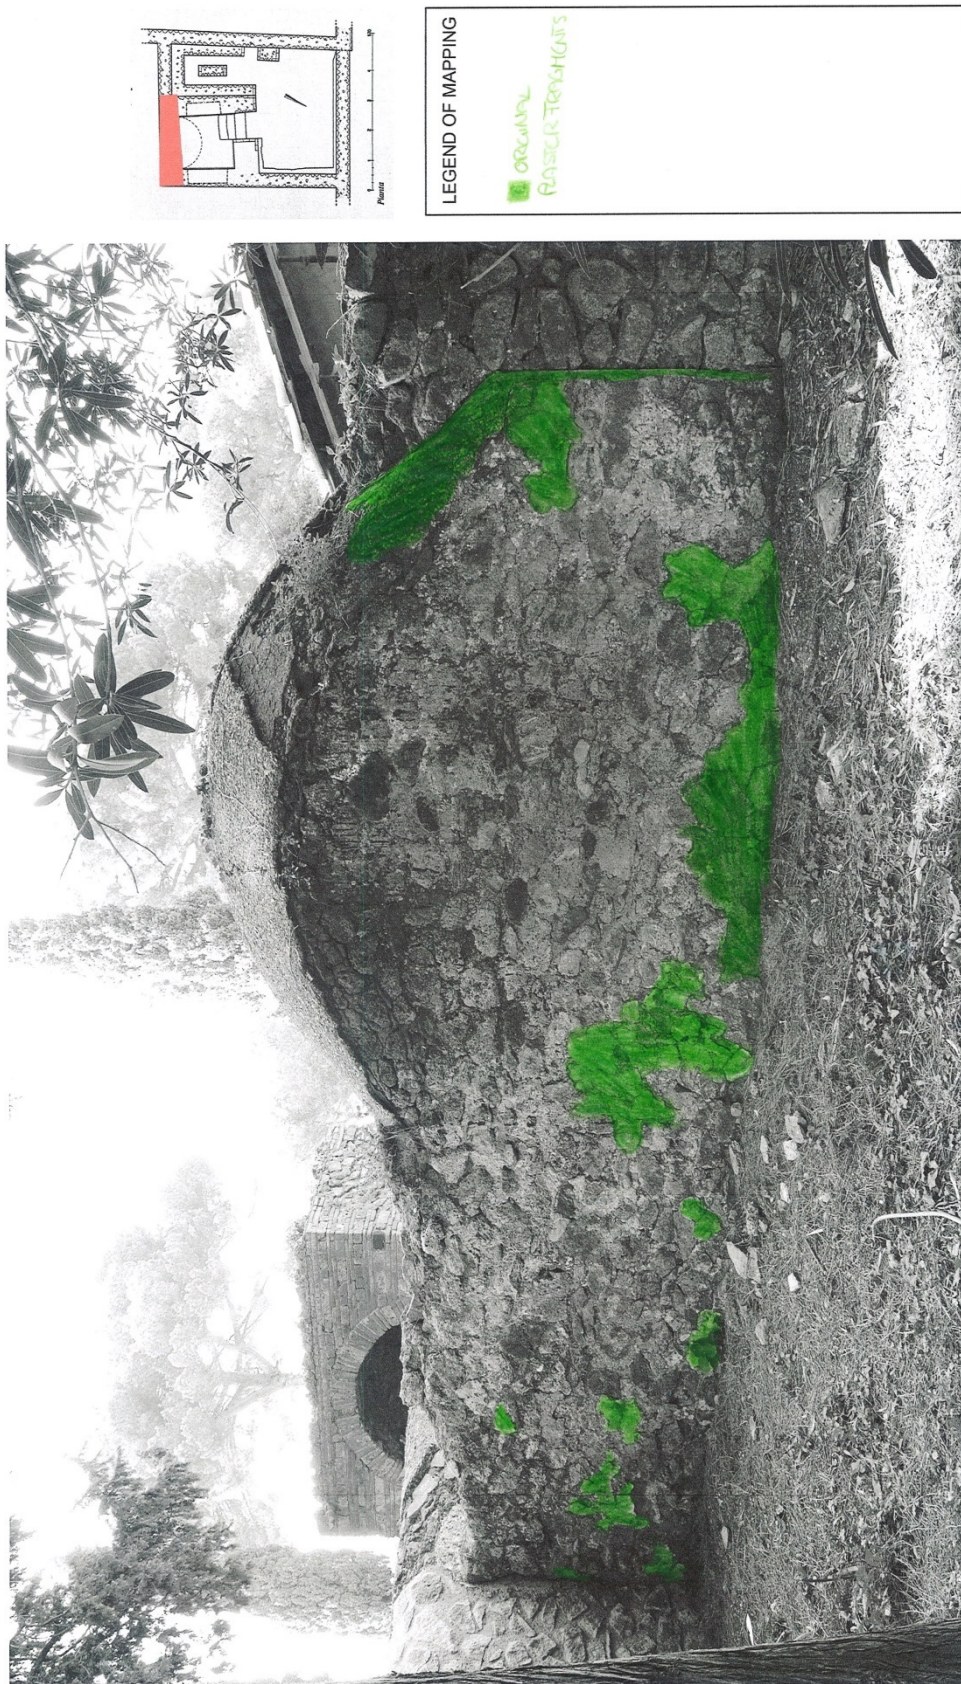
Figure 165: map 07\_ES\_S\_E of preserved original plaster fragments.

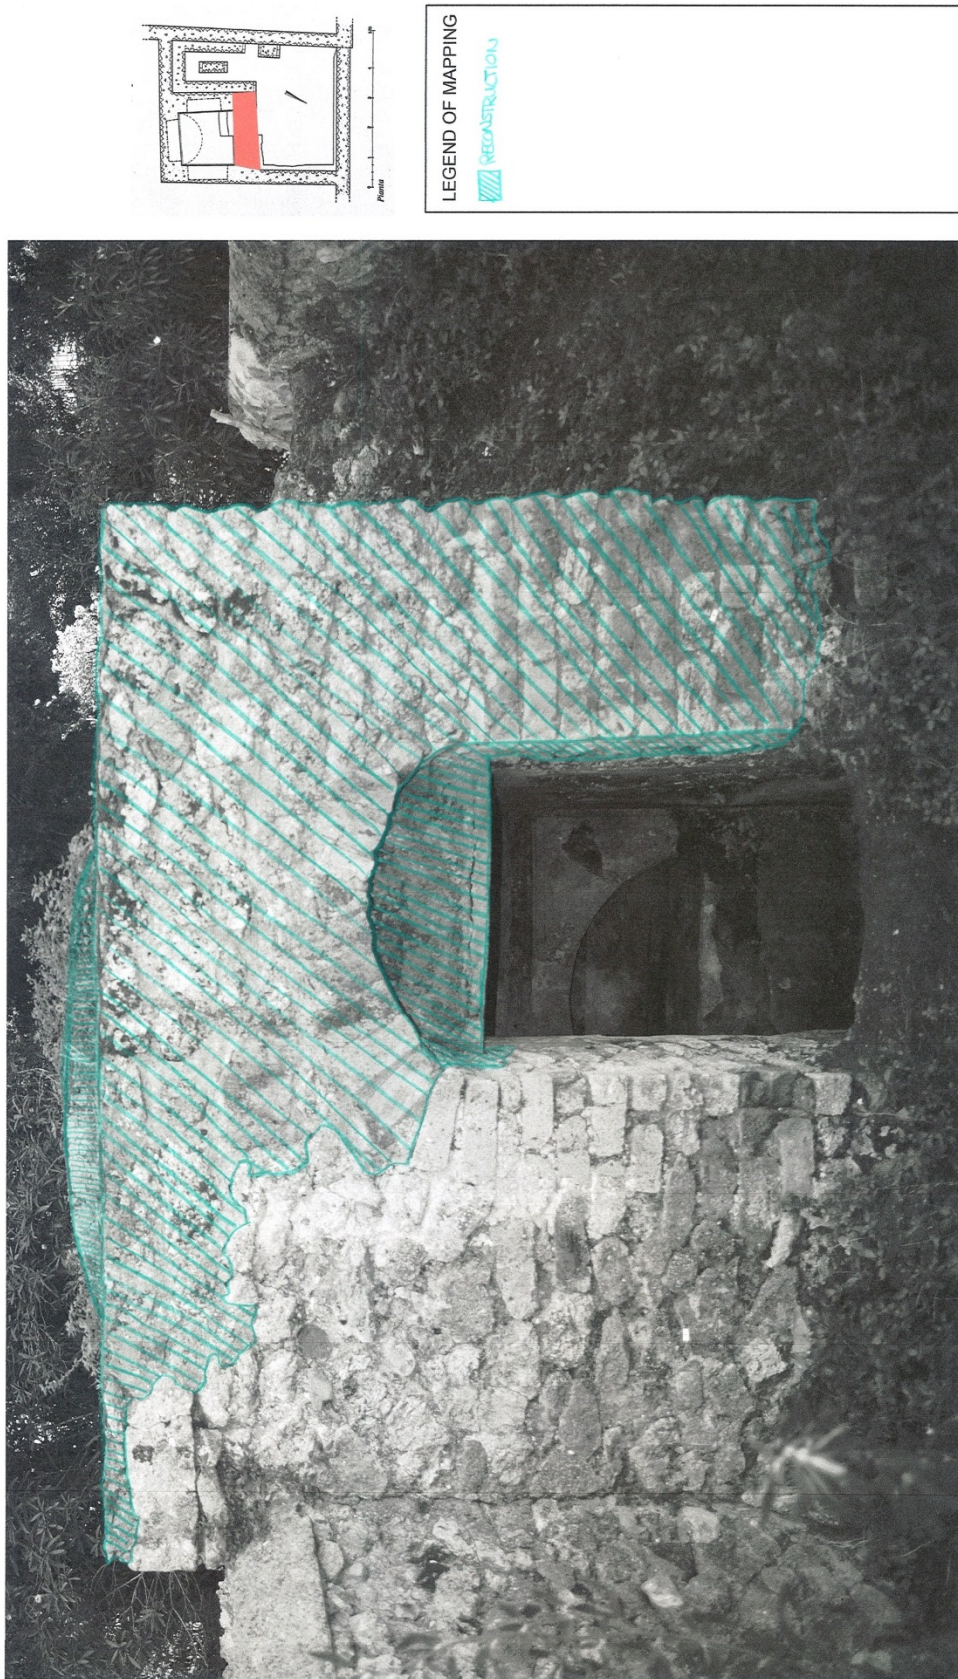
Figure 167: map 07\_ES\_N\_E of reconstruction.

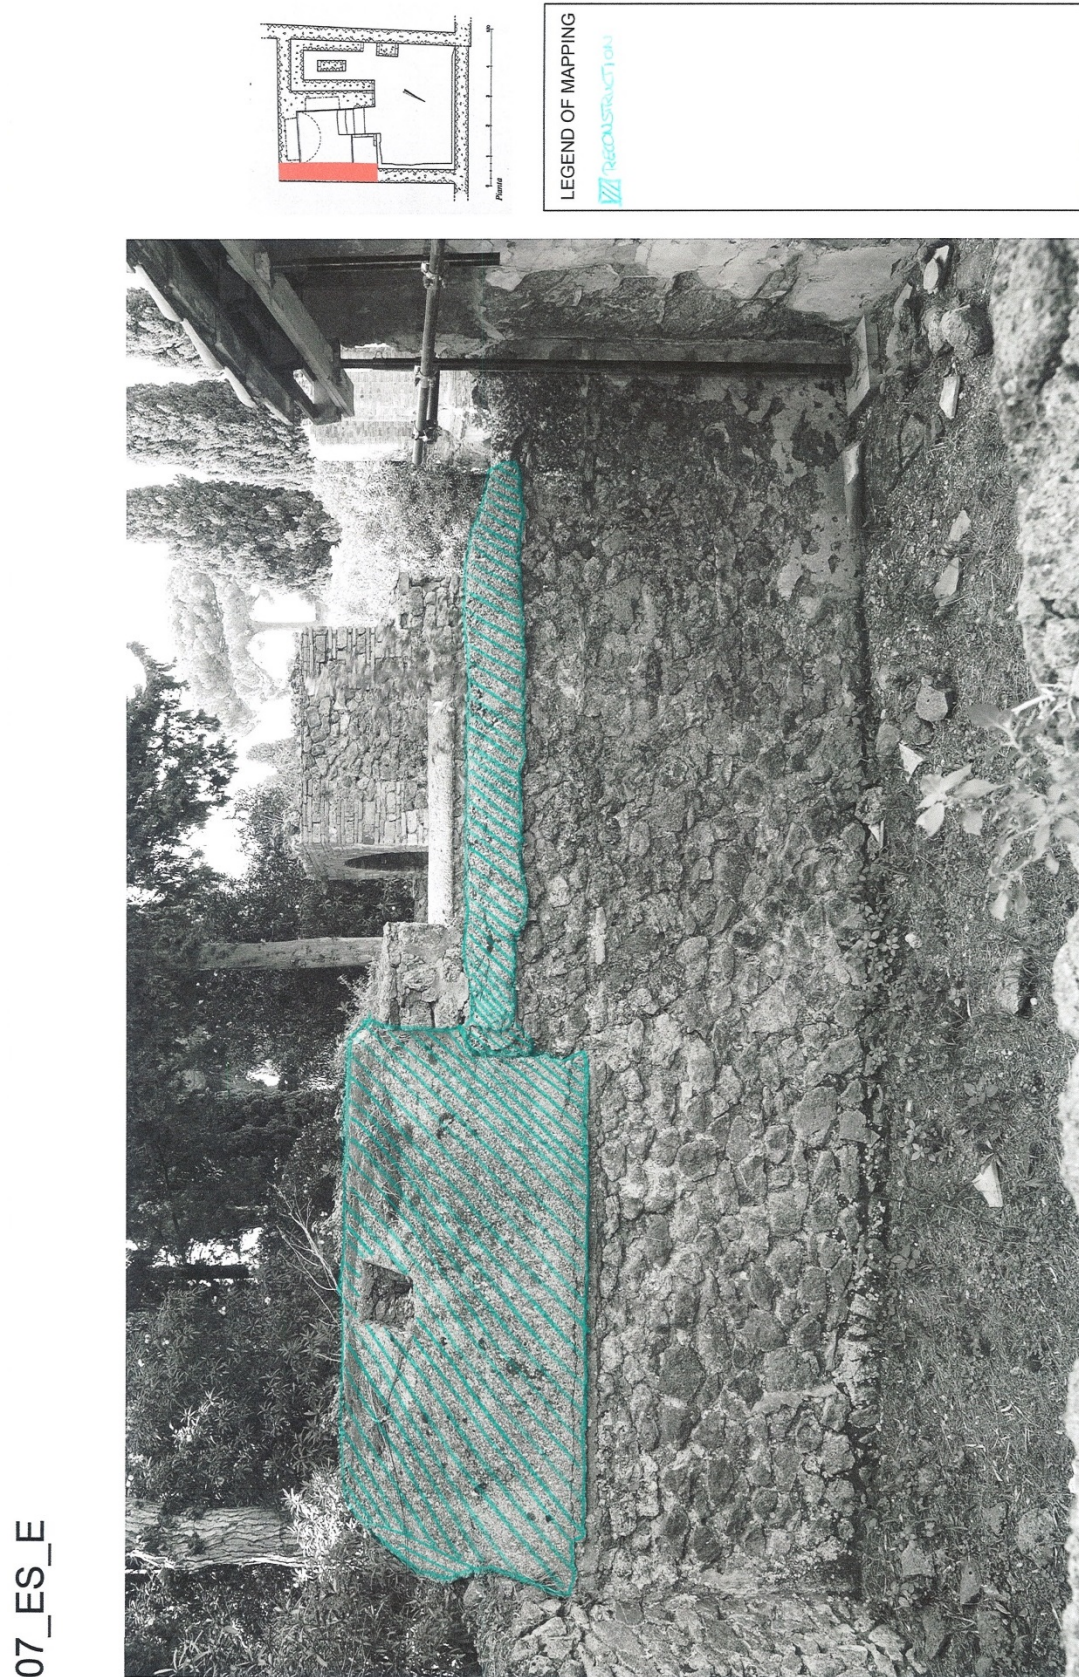
Figure 168: map 07\_ES\_E\_E of reconstruction.

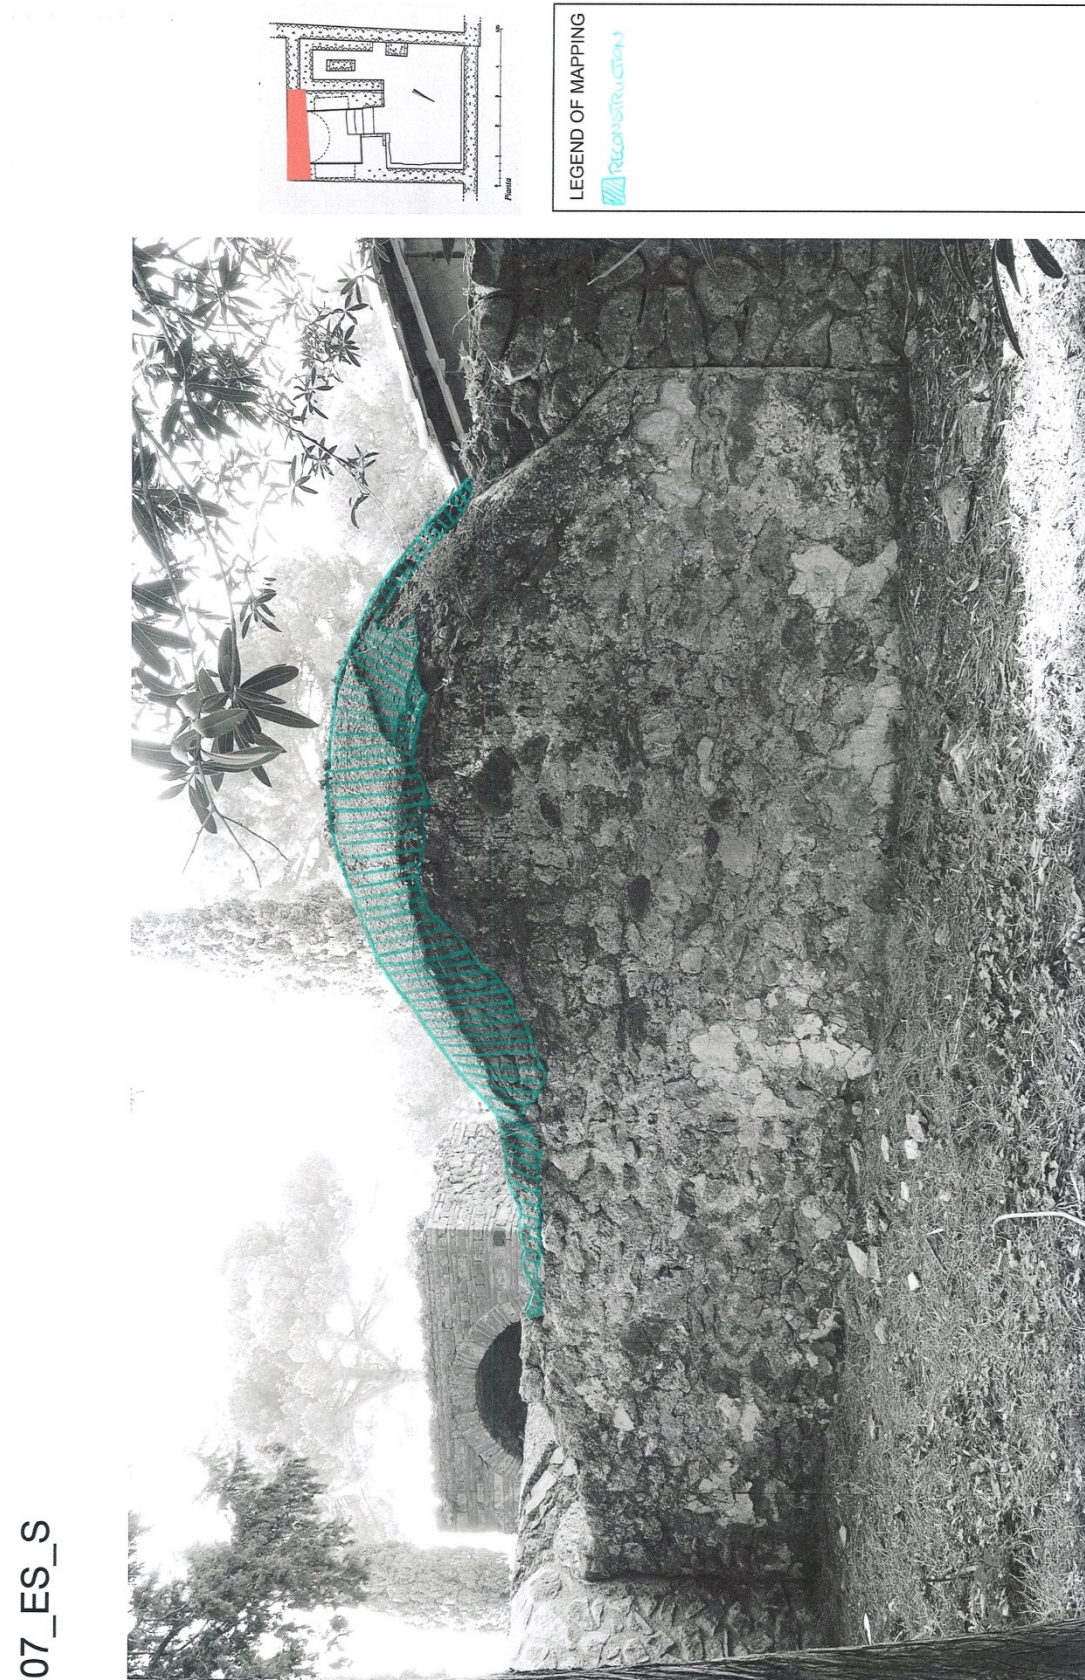
Figure 169: map 07\_ES\_S\_E of reconstruction.
