# **POMPEII SUSTAINABLE PRESERVATION PROJECT**

**Documentation of the funerary monuments  
14\_EN and 07\_ES**

**Christina Elsässer**

Munioch, February 25<sup>th</sup>, 2015

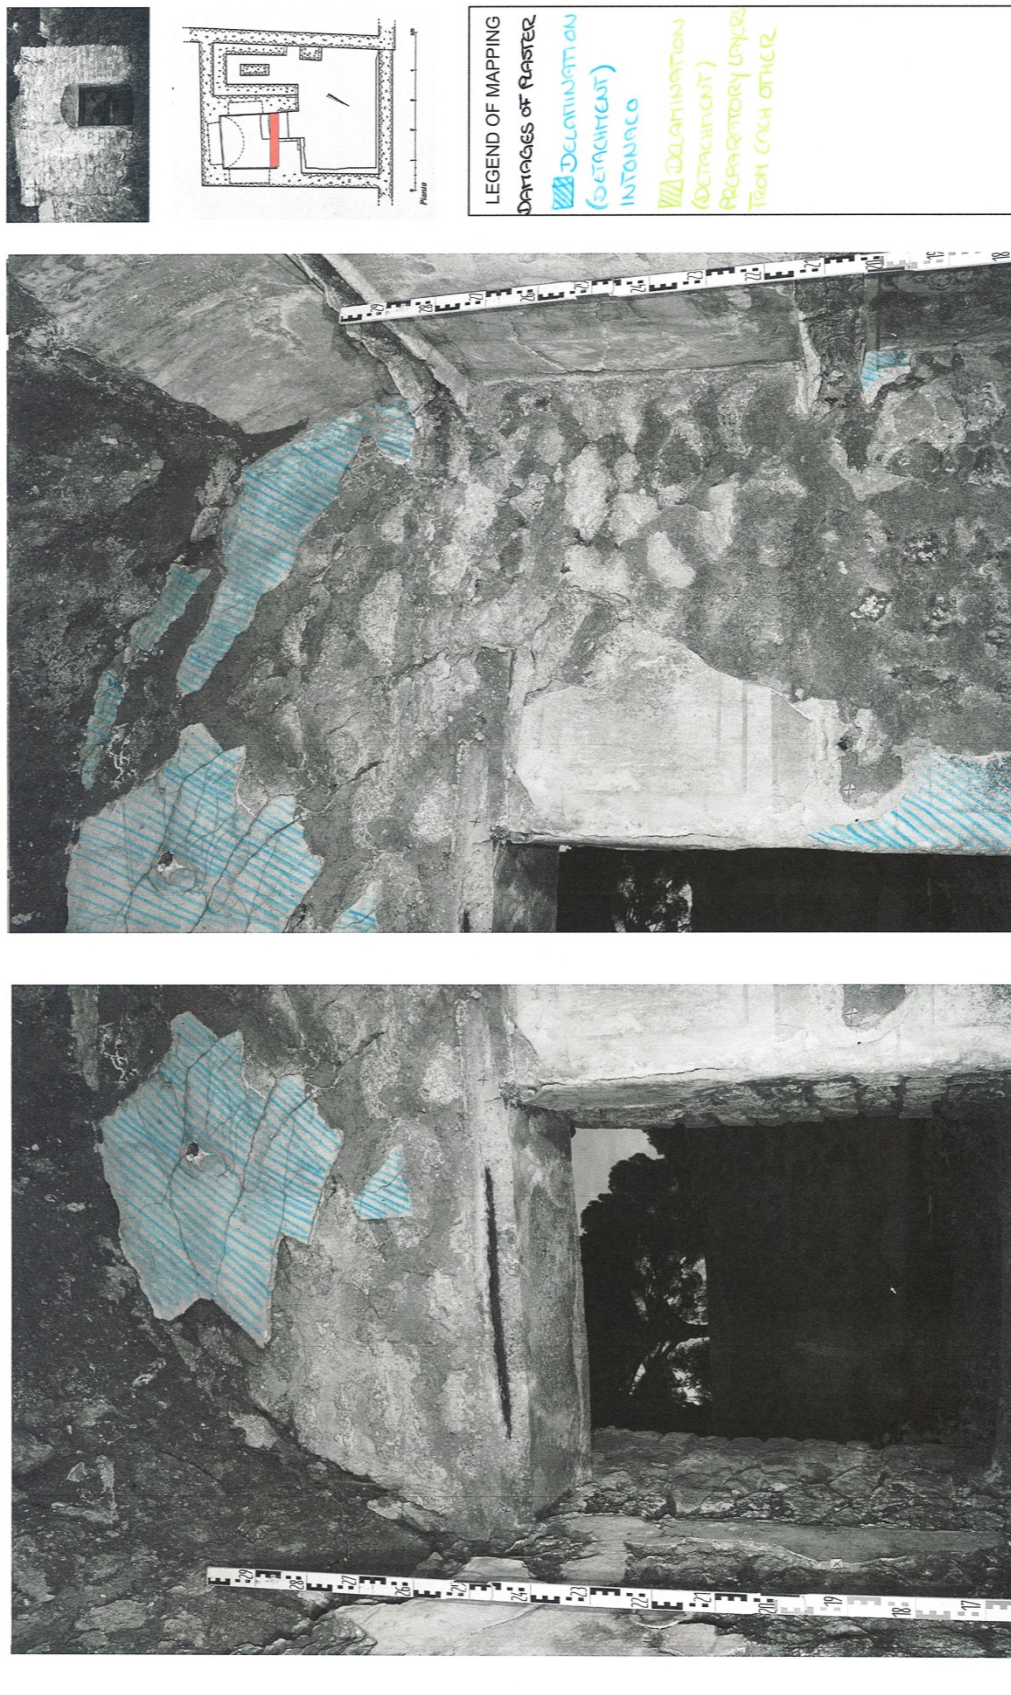
Figure 180: map 07\_ES\_N\_I\_2 of delamination (detachment) Intonaco from preparatory layers (blue) and delamination (detachment) preparatory layers from each other's (green).

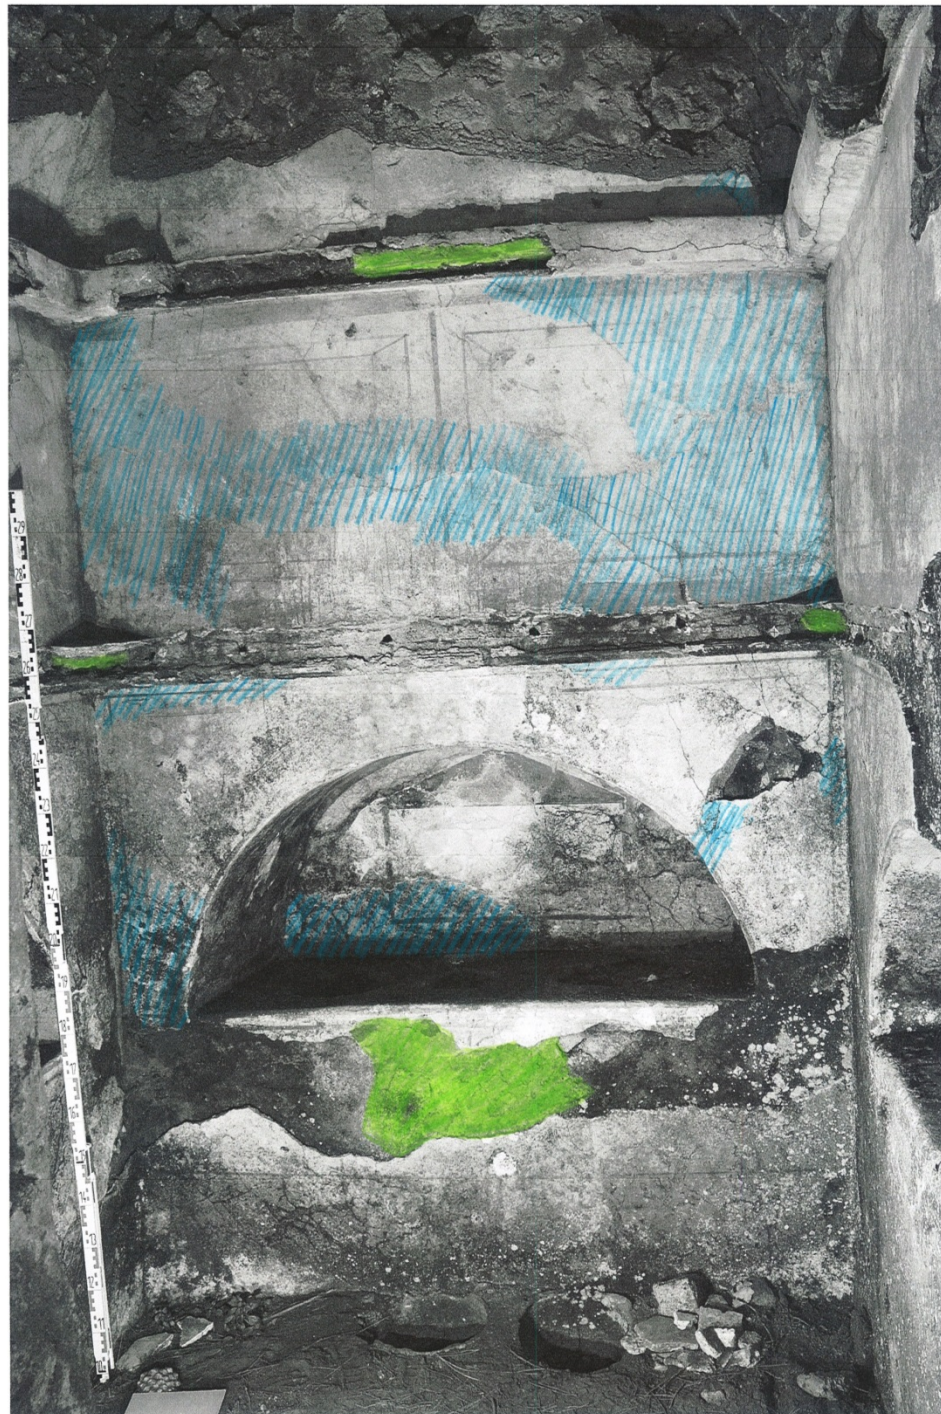
Figure 183: map 07\_ES\_S\_I of delamination (detachment) Intonaco from preparatory layers (blue) and delamination (detachment) preparatory layers from each other's (green).

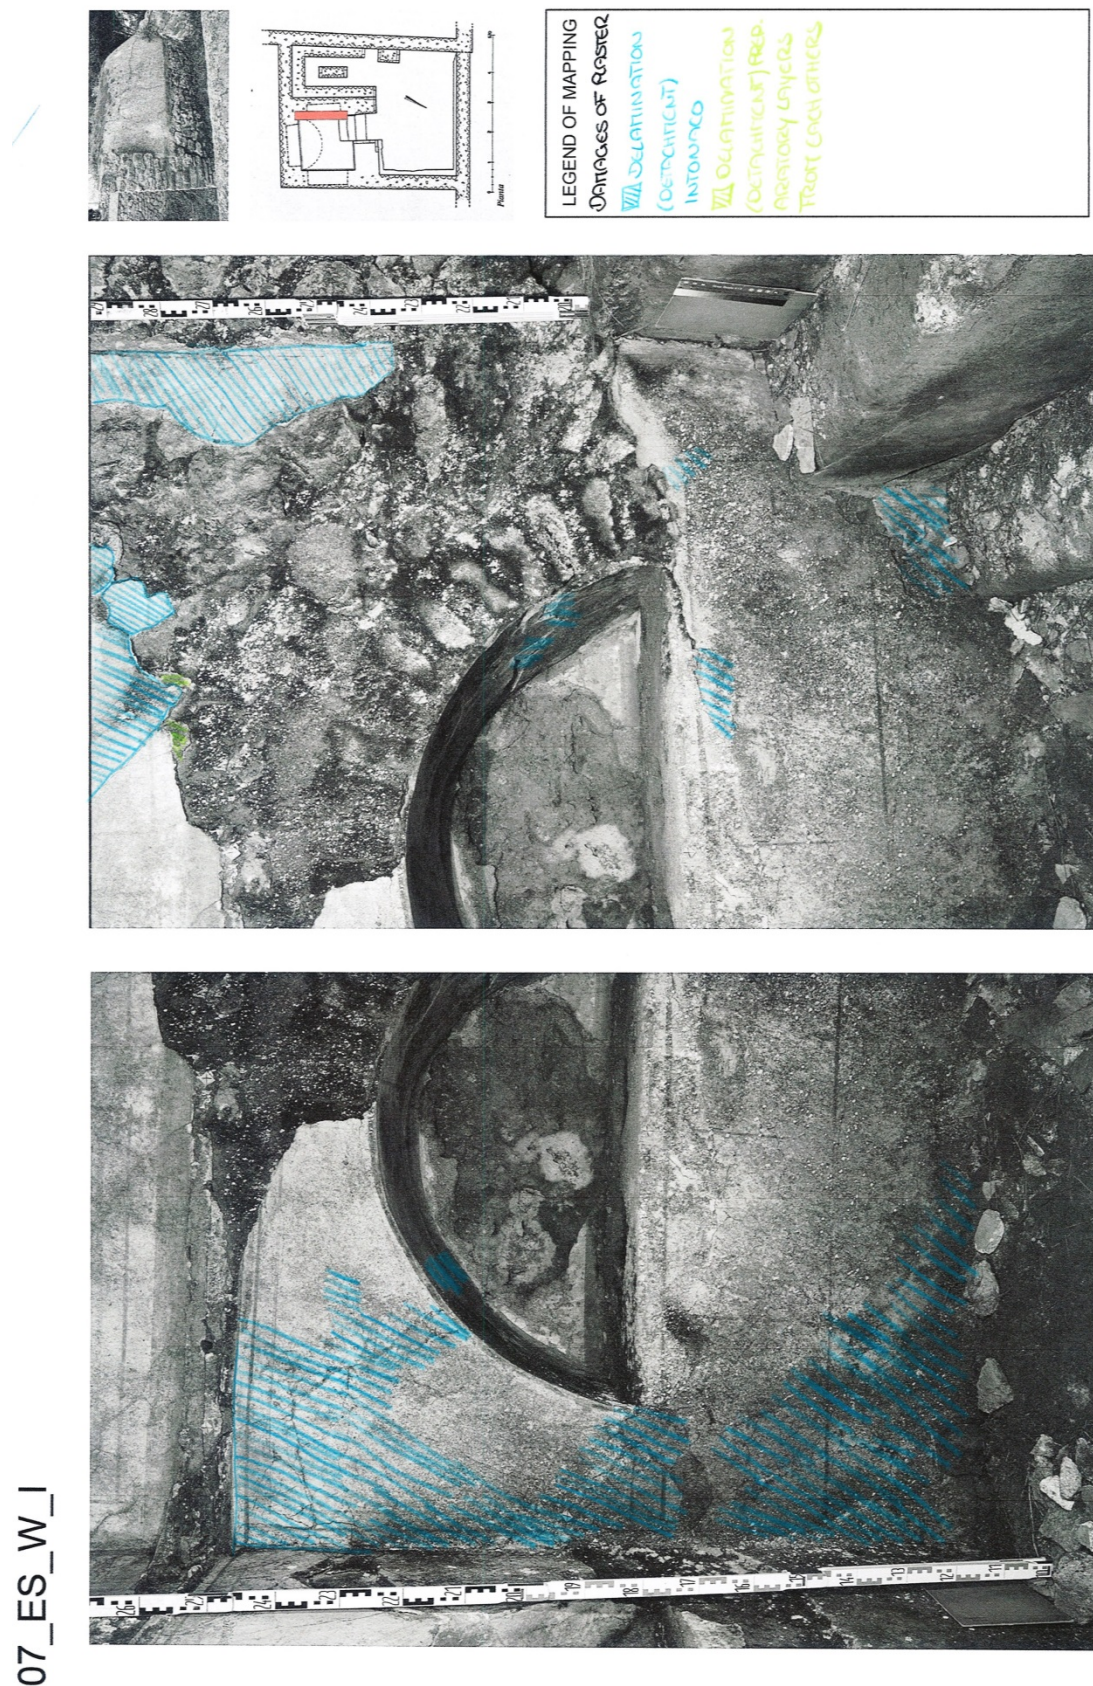
Figure 184: map 07\_ES\_W\_I\_1 of delamination (detachment) Intonaco from preparatory layers (blue) and delamination (detachment) preparatory layers from each other's (green).

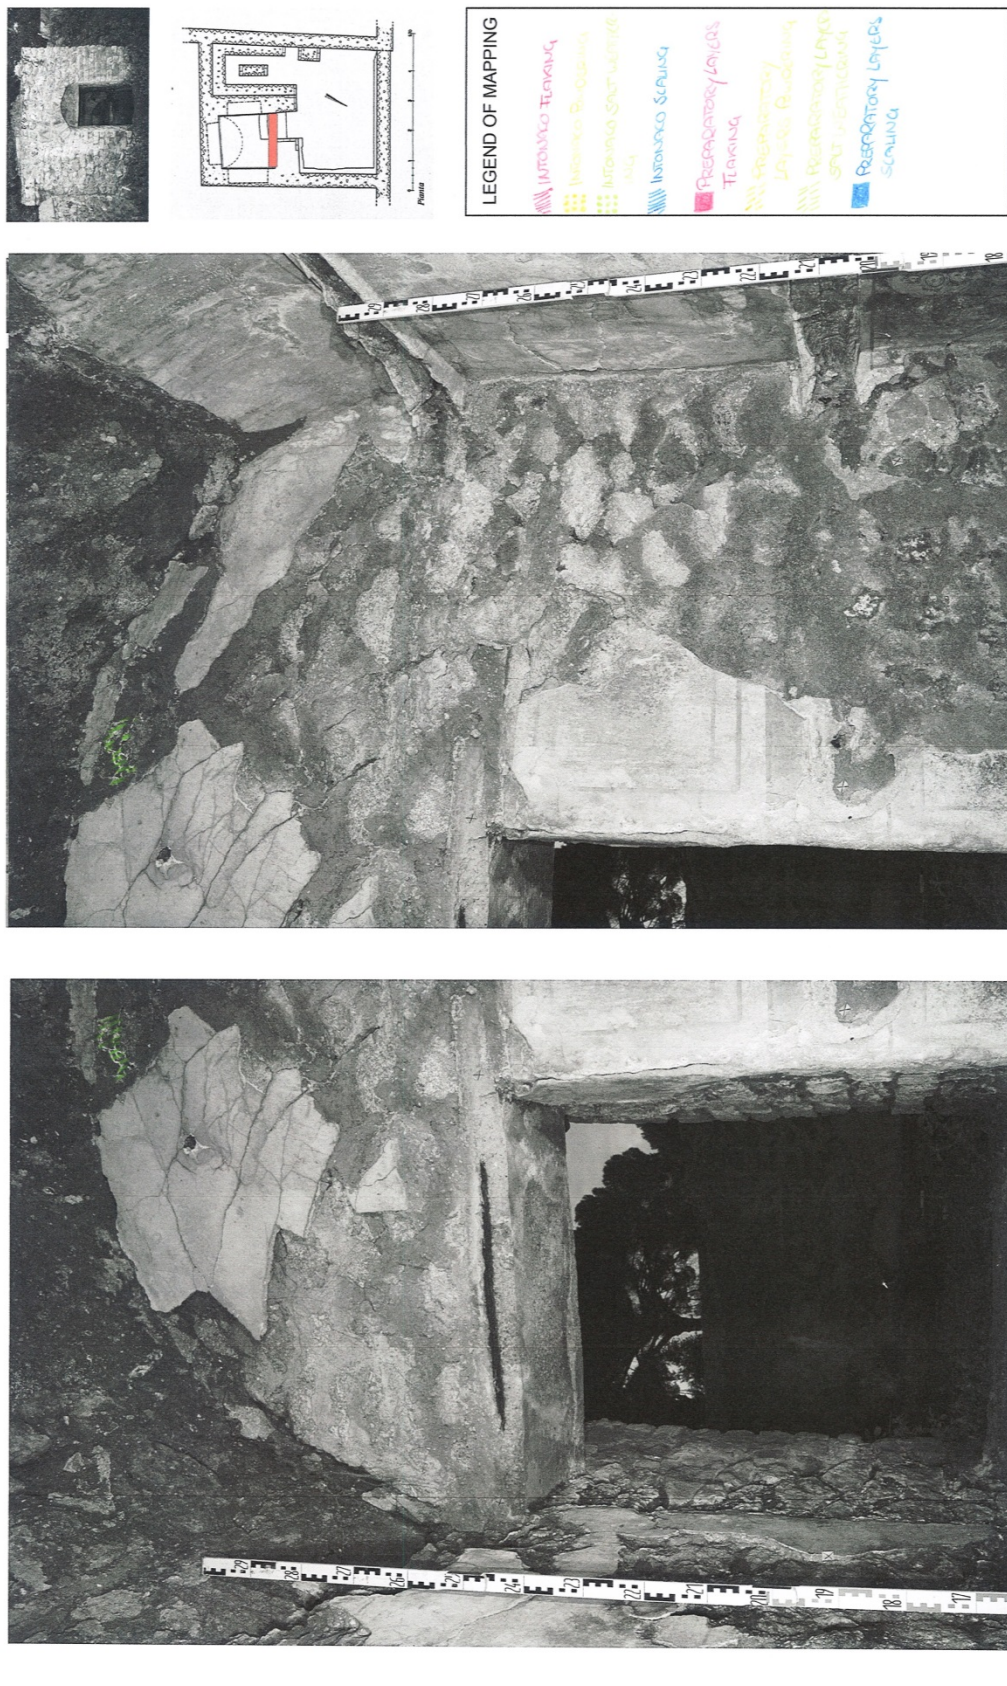
Figure 187: map 07\_ES\_N\_I\_2 of scaling (blue) and salt weathering layers (green).

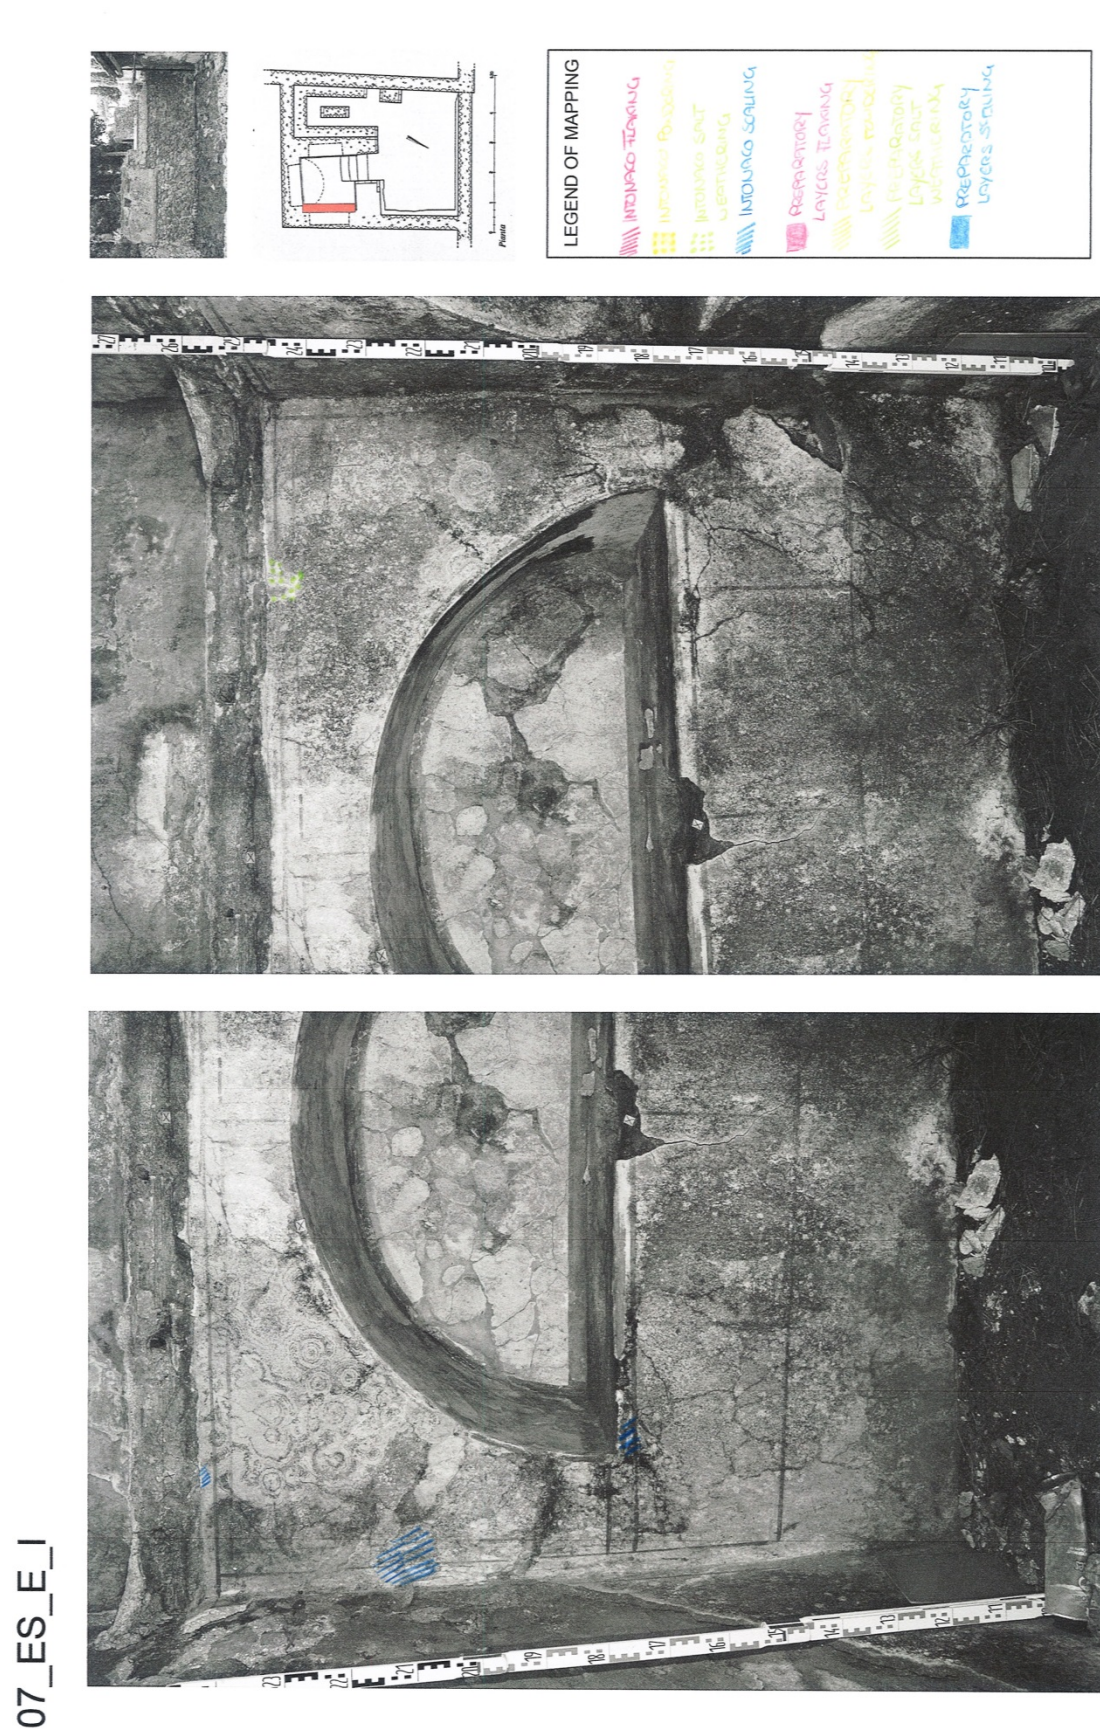
Figure 188: map 07\_ES\_E\_I\_1 of scaling (blue) and salt weathering layers (green).

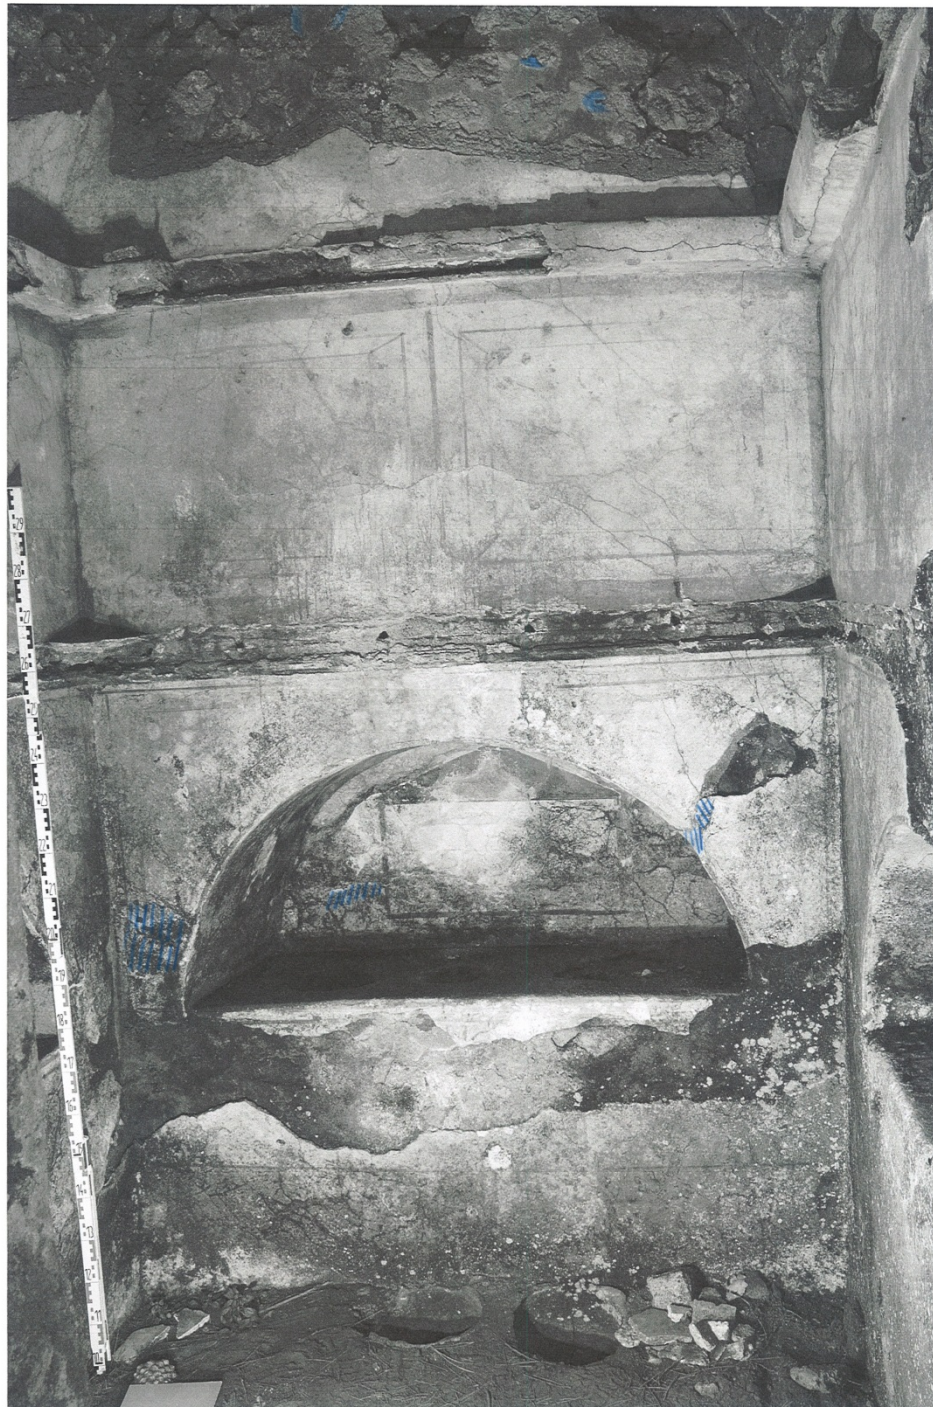
Figure 190: map 07\_ES\_S\_I of scaling (blue) and salt weathering layers (green).

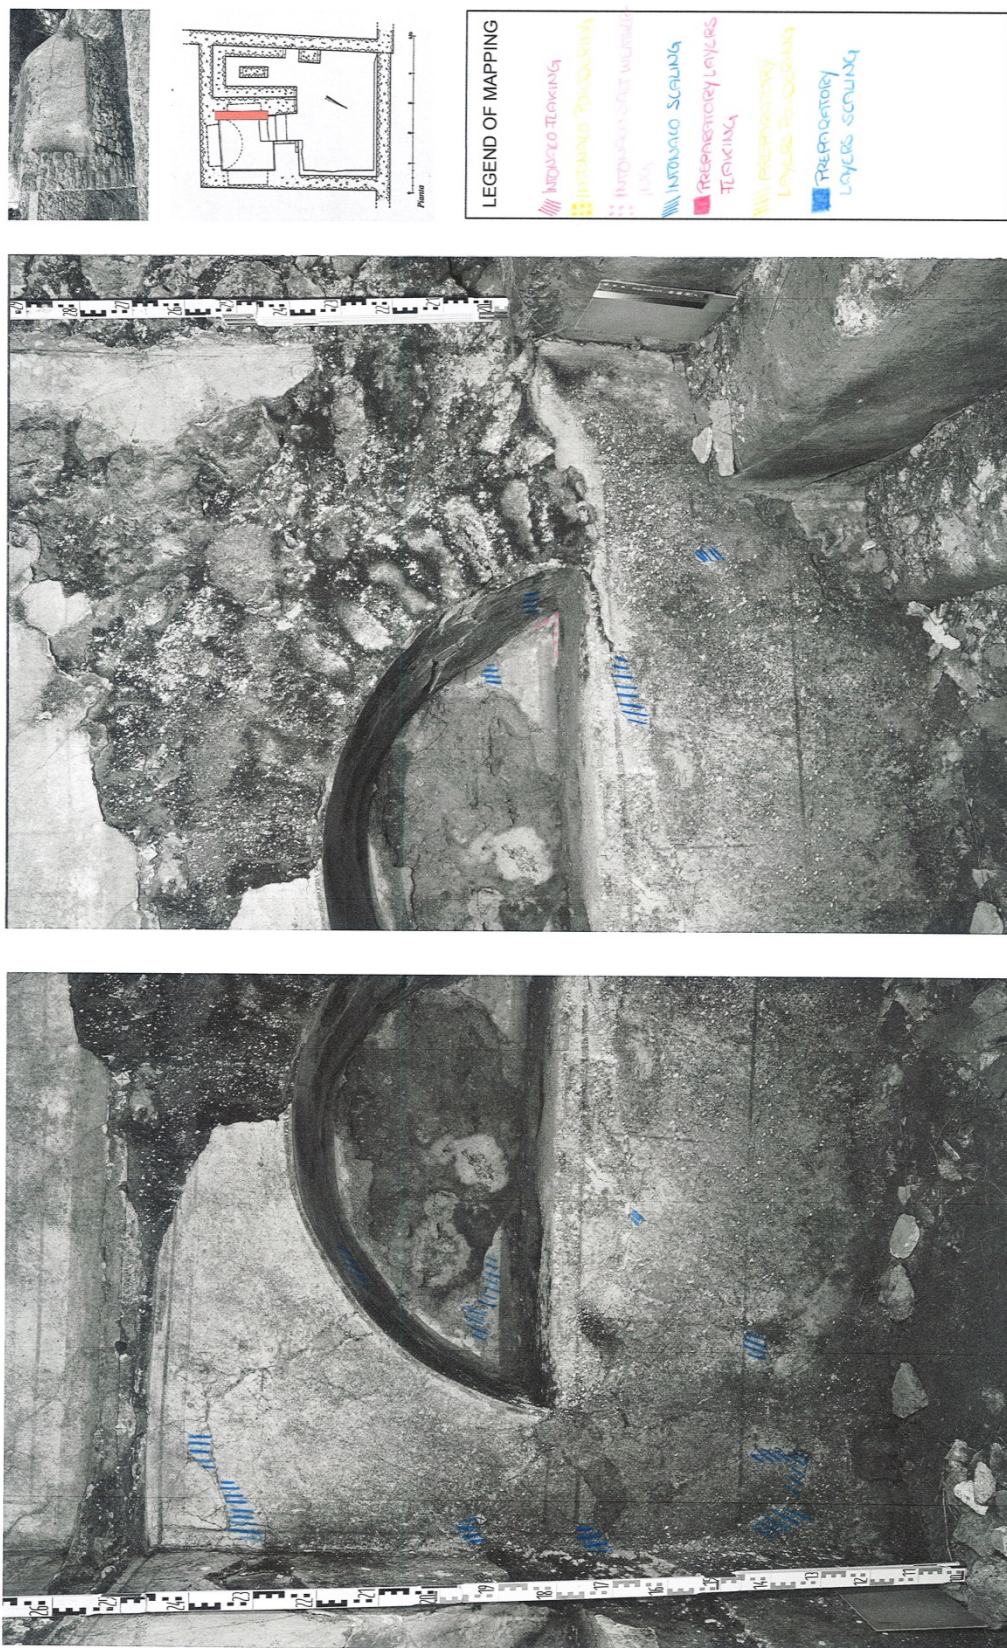
Figure 191: map 07\_ES\_W\_I\_1 of scaling (blue) and salt weathering layers (green).

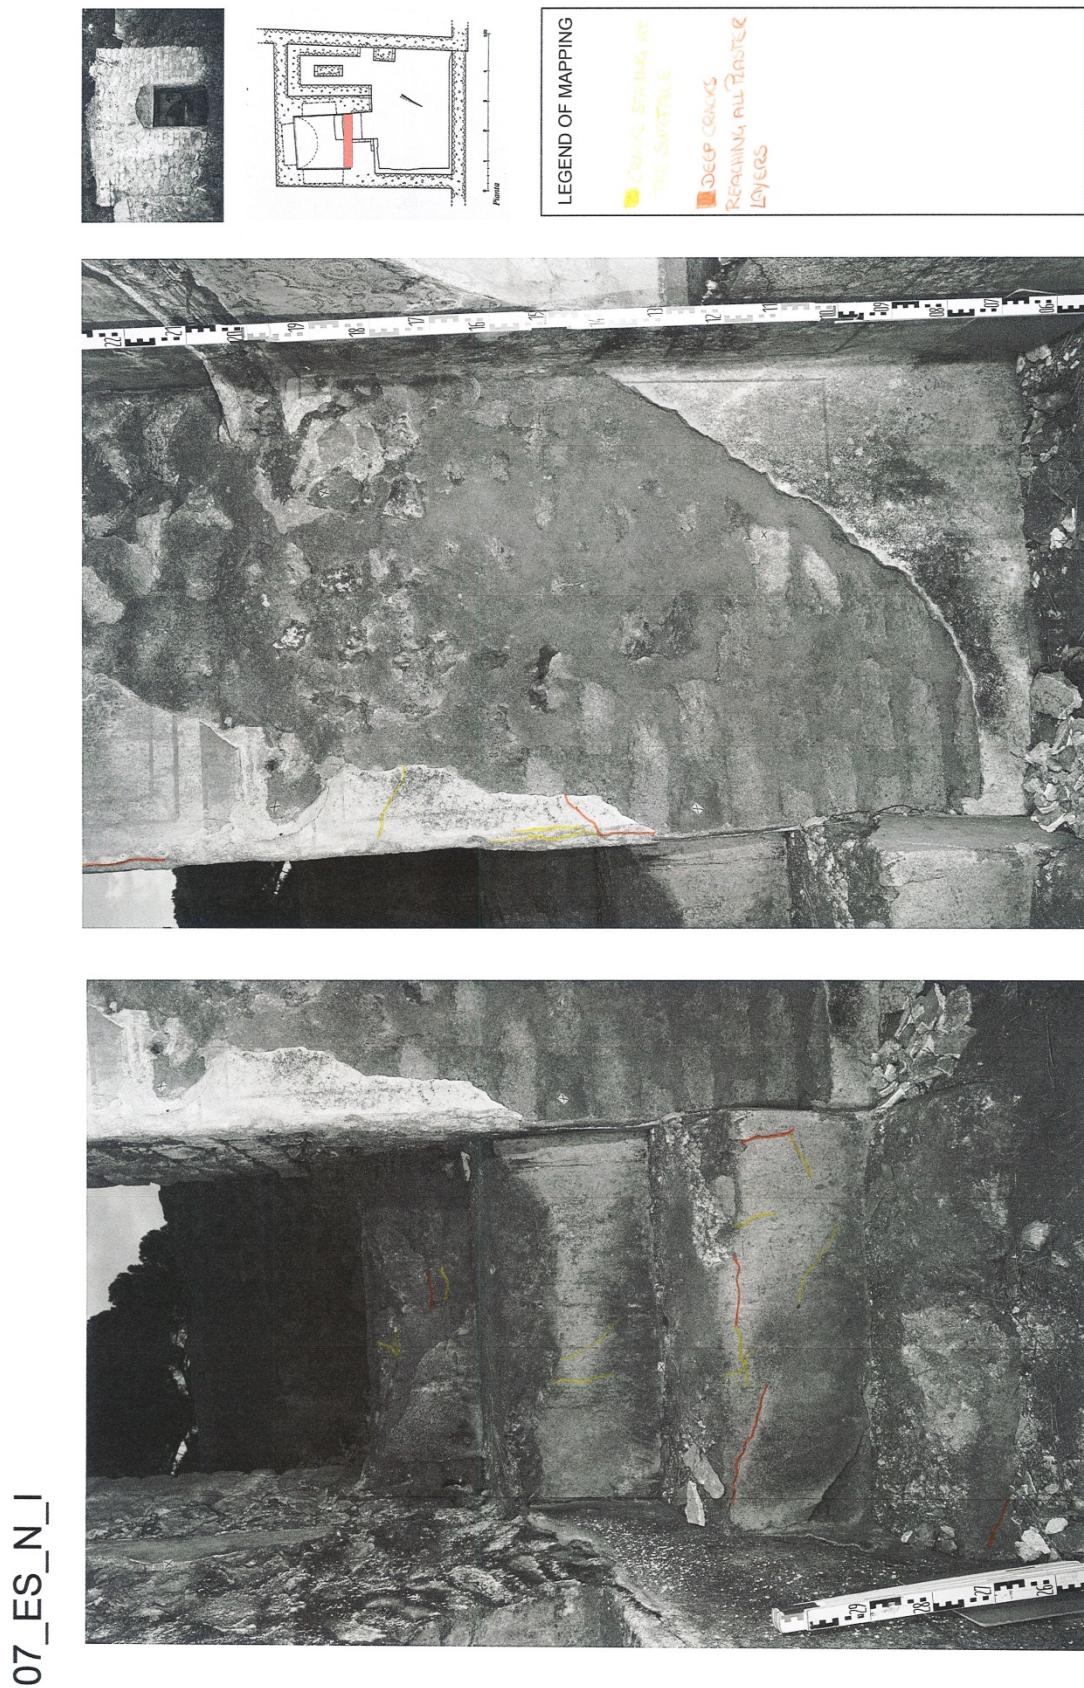
Figure 193: map 07\_ES\_N\_I\_1 of cracks.

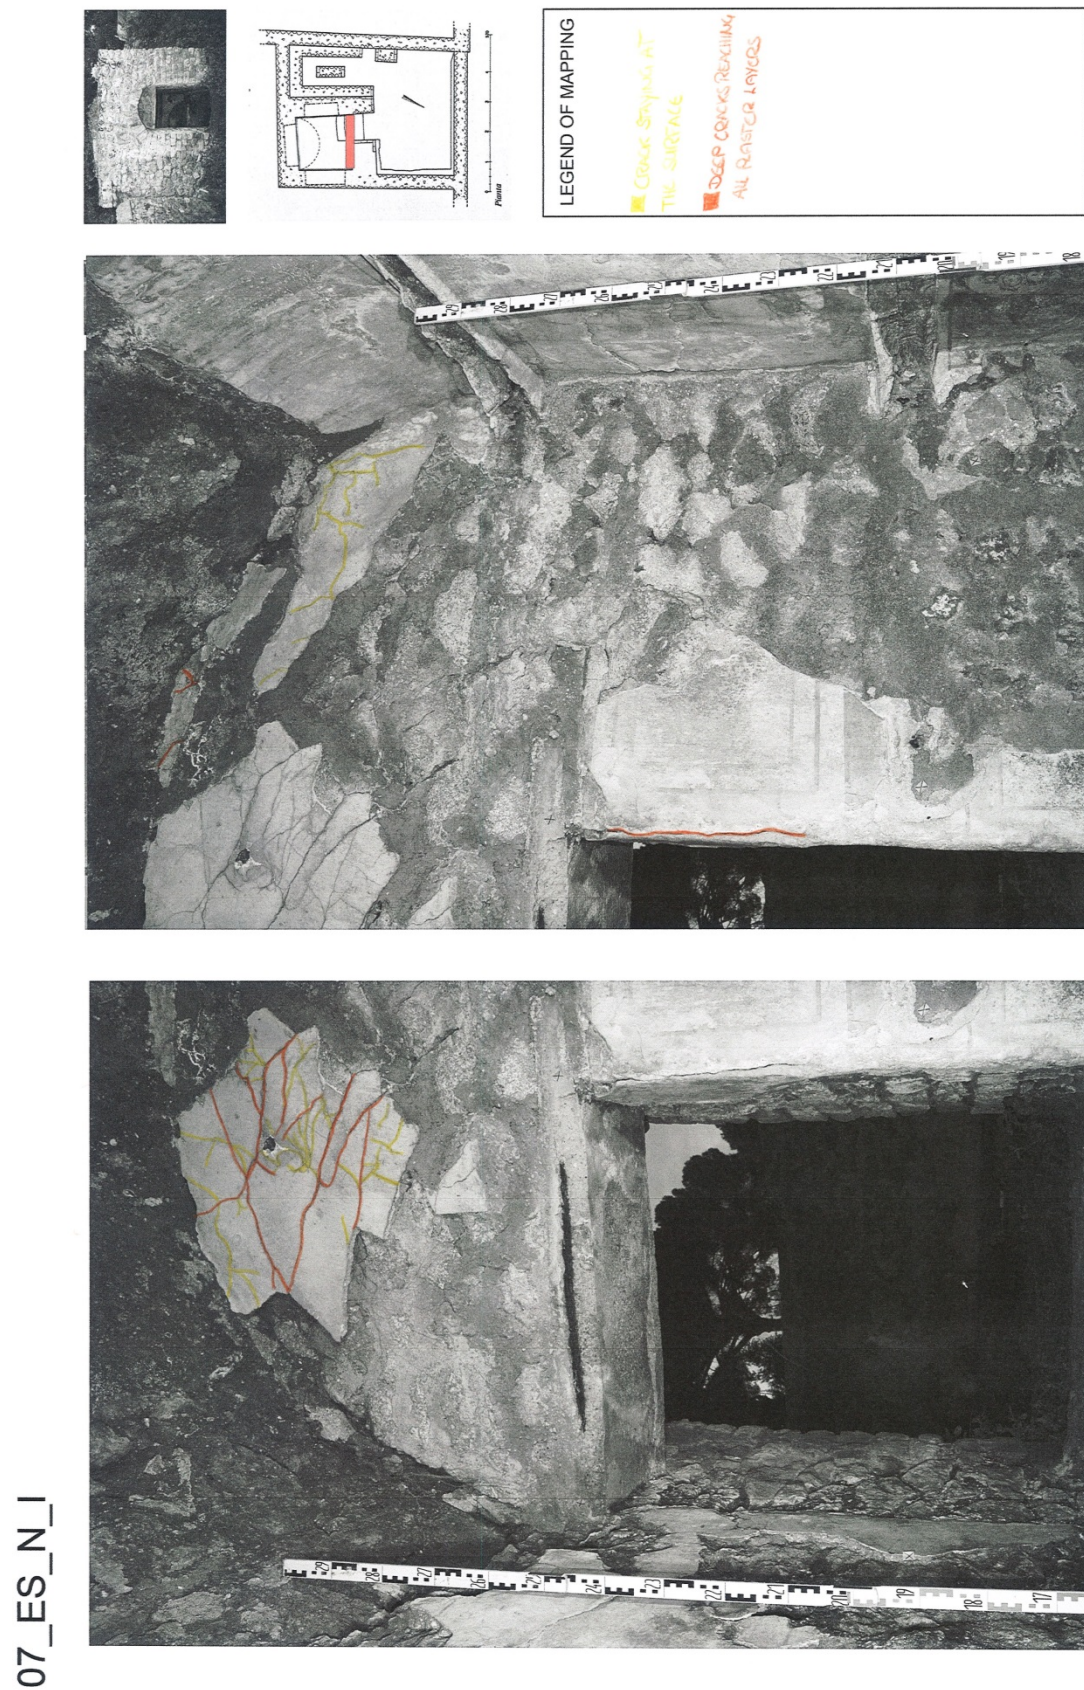
Figure 194: map 07\_ES\_N\_I\_2 of cracks.

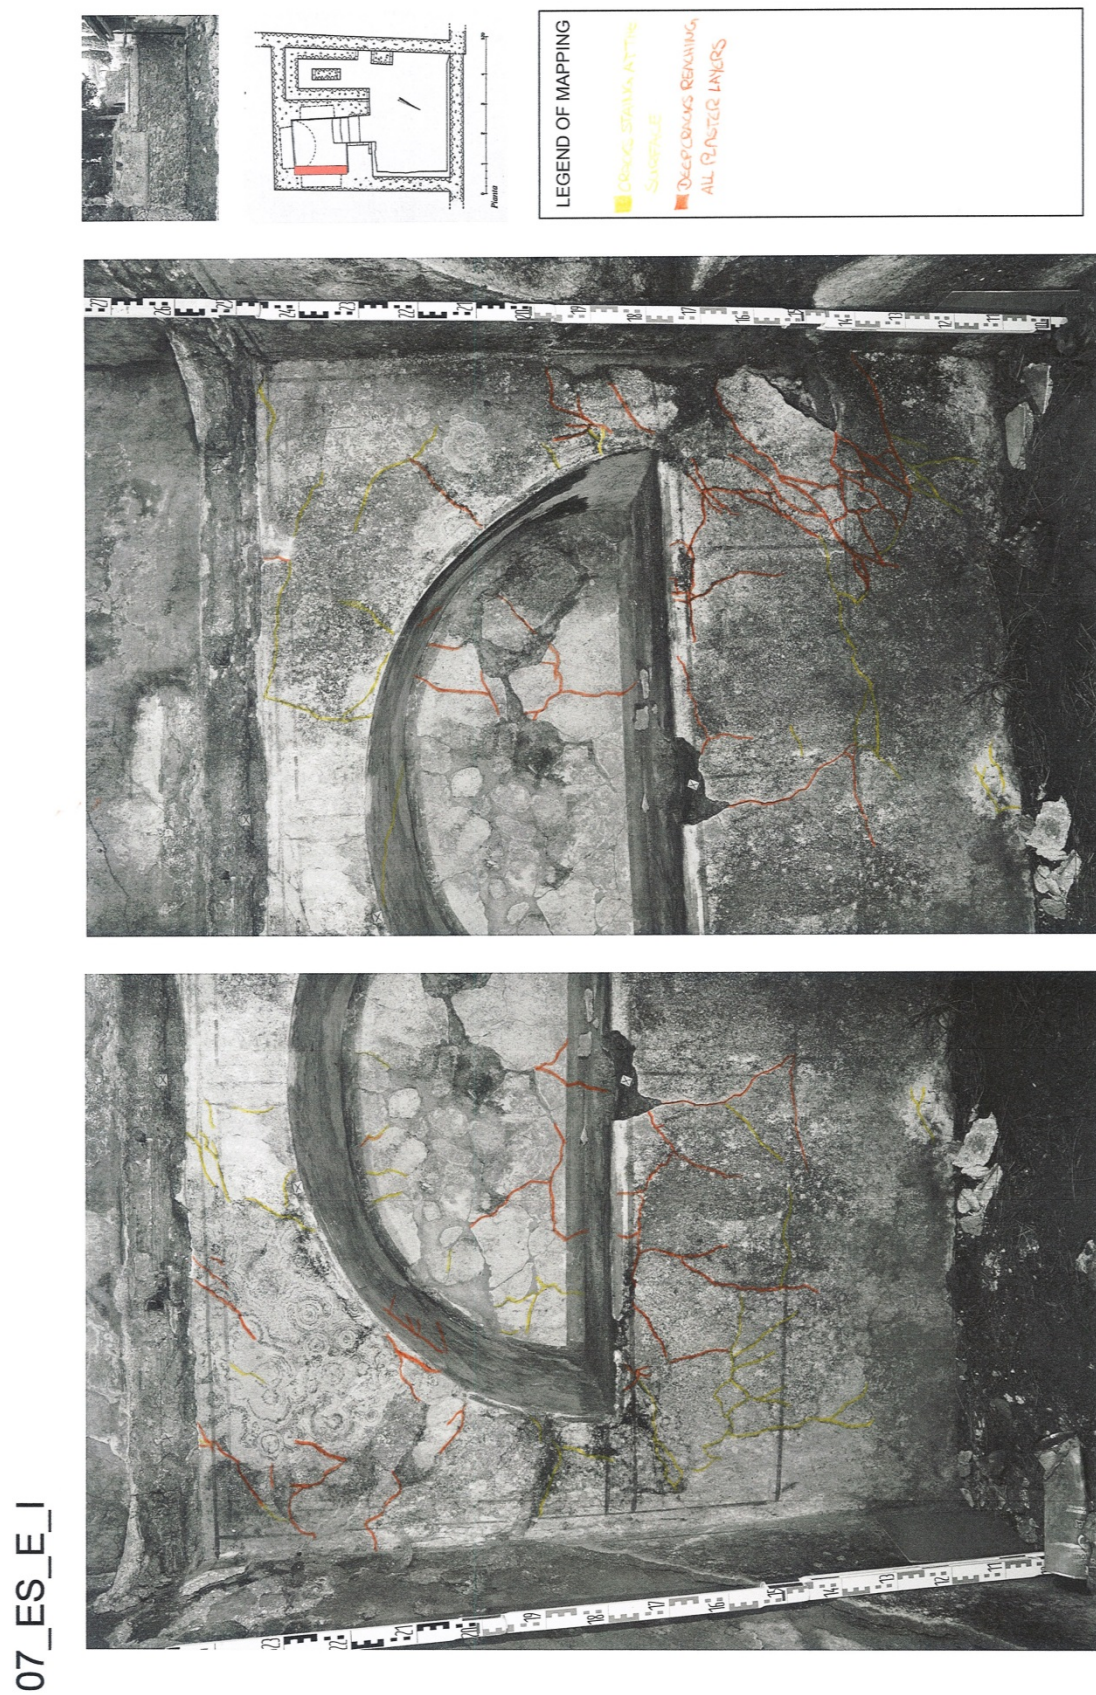
Figure 195: map 07\_ES\_E\_I\_1 of cracks.

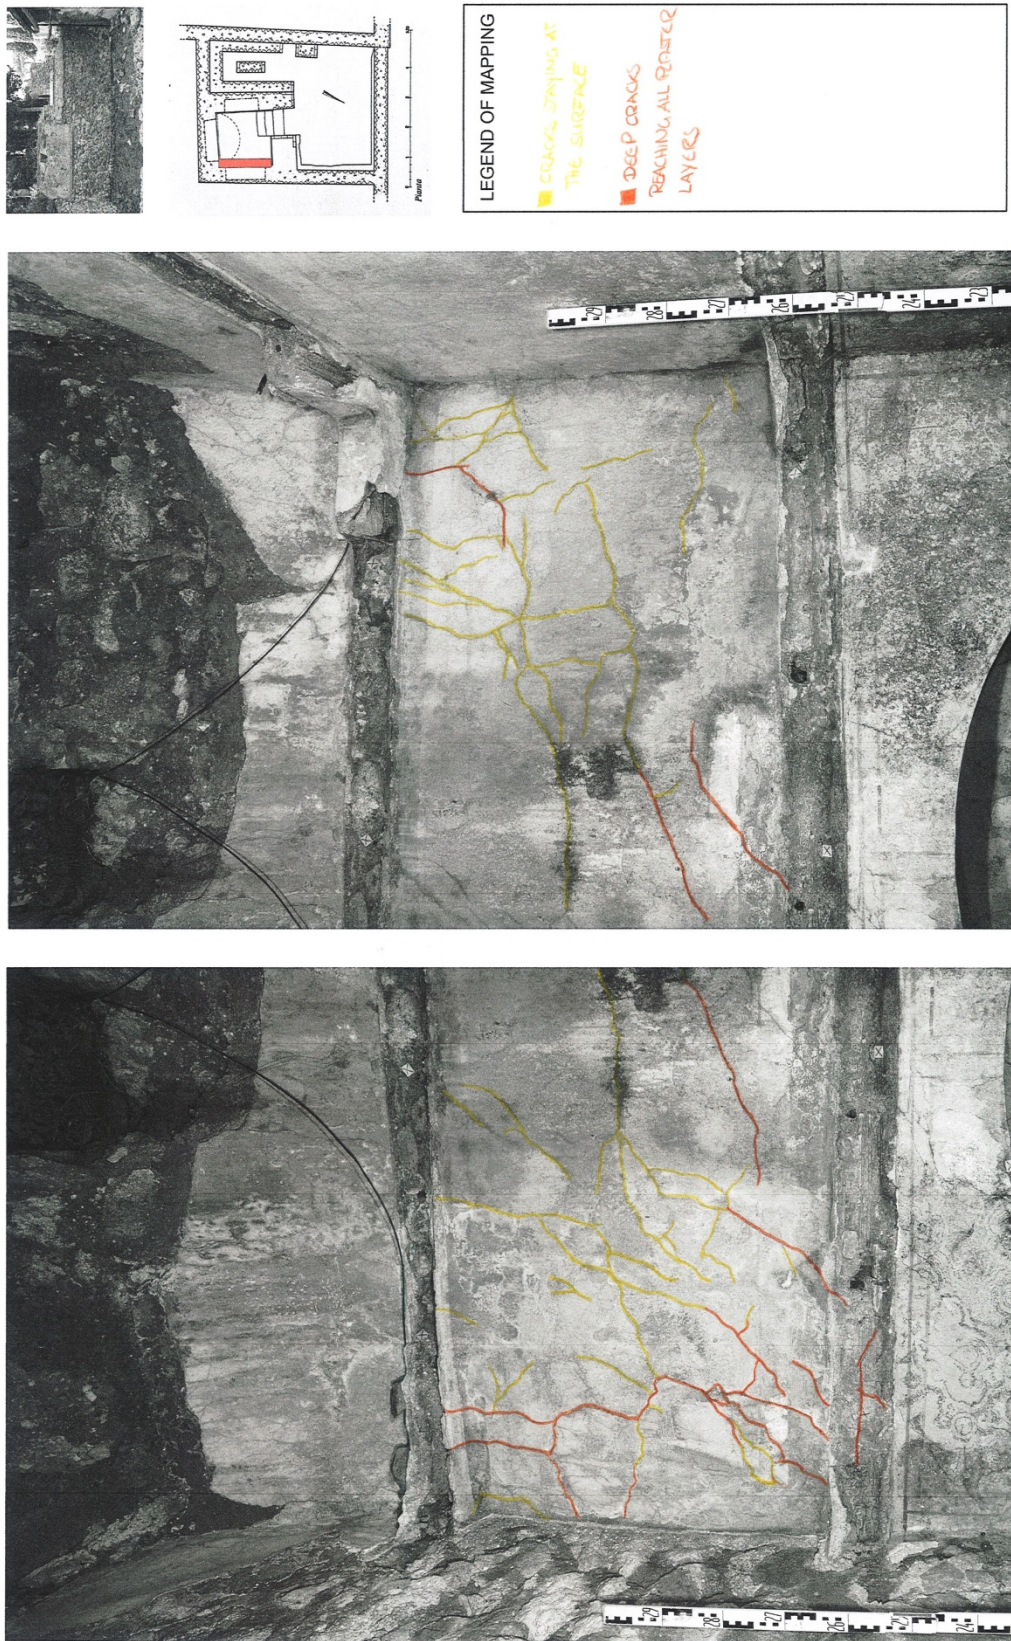
Figure 196: map 07\_ES\_E\_I\_2 of cracks.

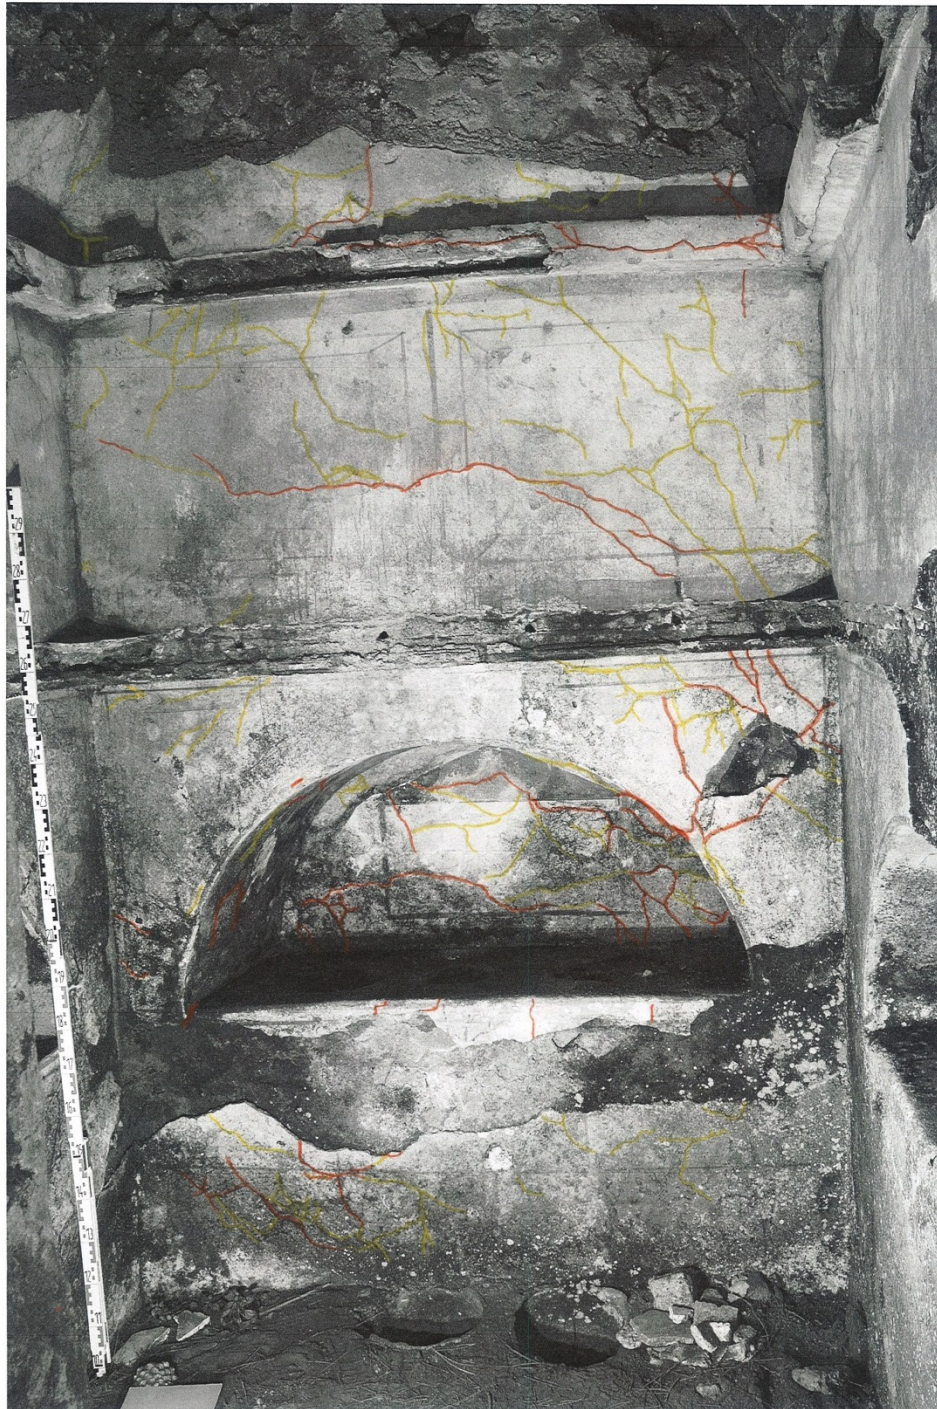
Figure 197: map 07\_ES\_S\_I of cracks.

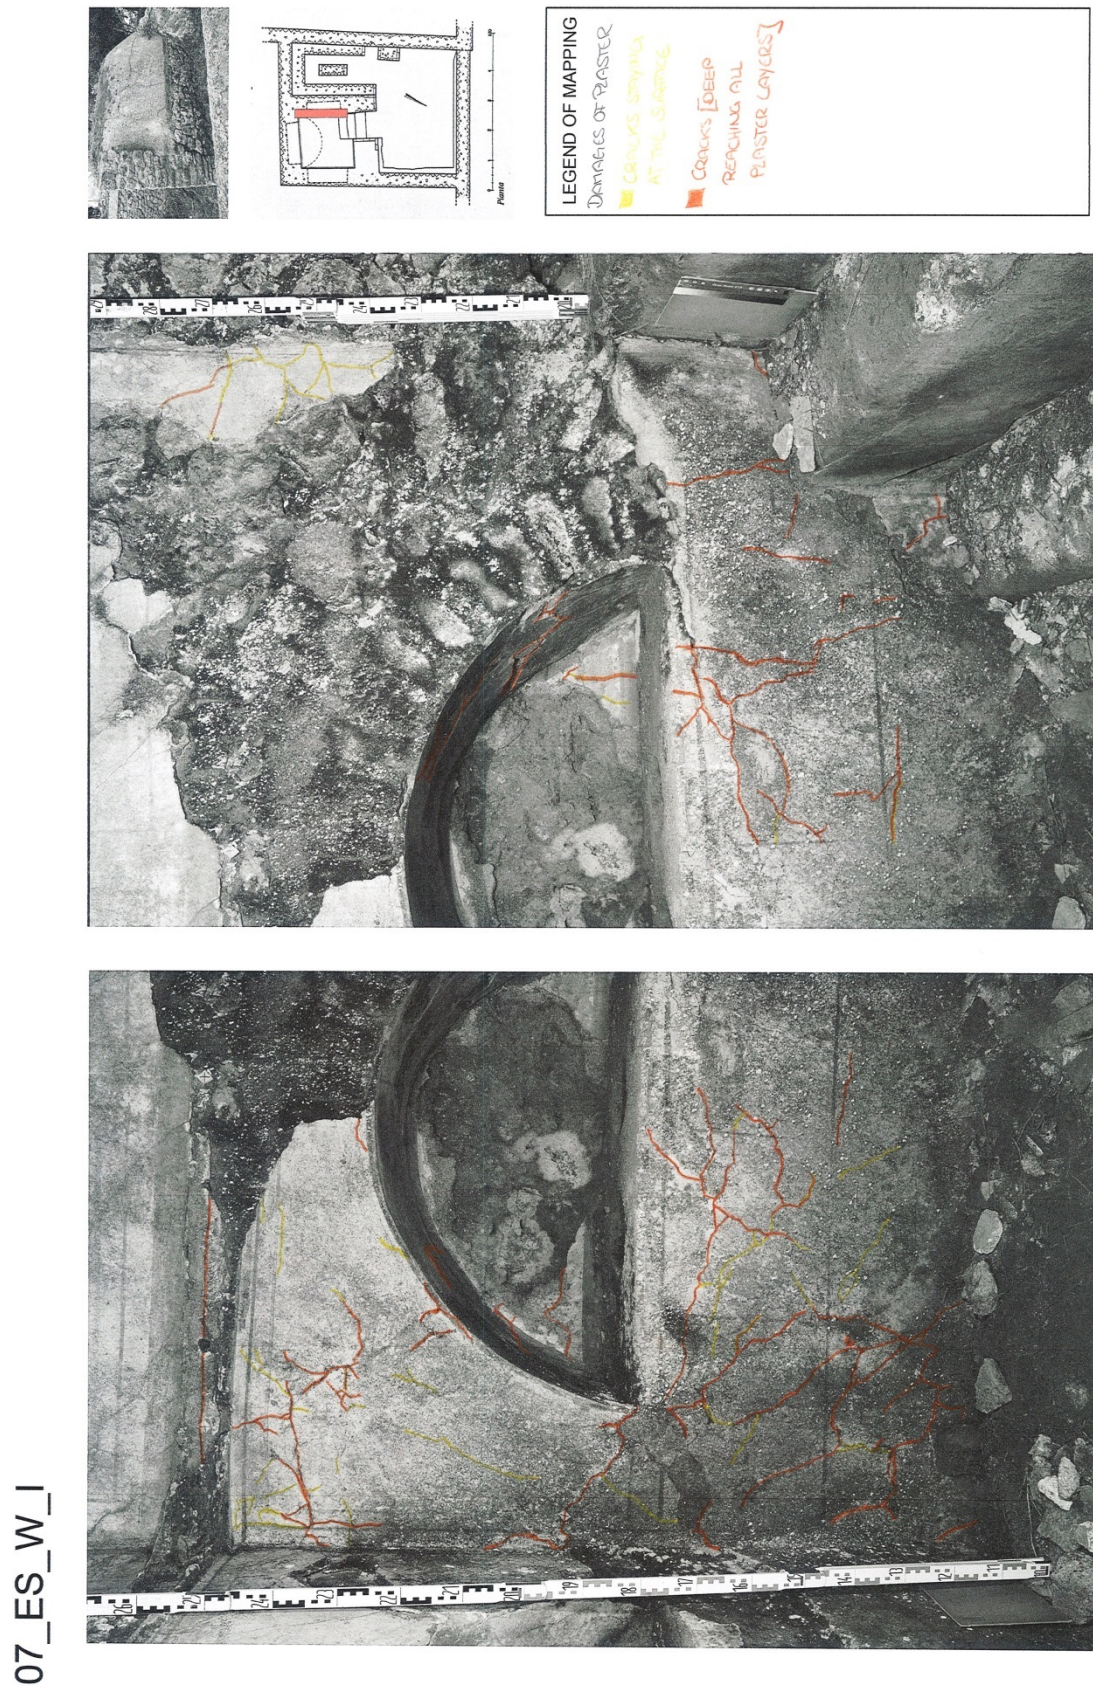
Figure 198: map 07\_ES\_W\_I\_1 of cracks.
