# **POMPEII SUSTAINABLE PRESERVATION PROJECT**

**Documentation of the funerary monuments  
14\_EN and 07\_ES**

**Christina Elsässer**

Munioch, February 25<sup>th</sup>, 2015

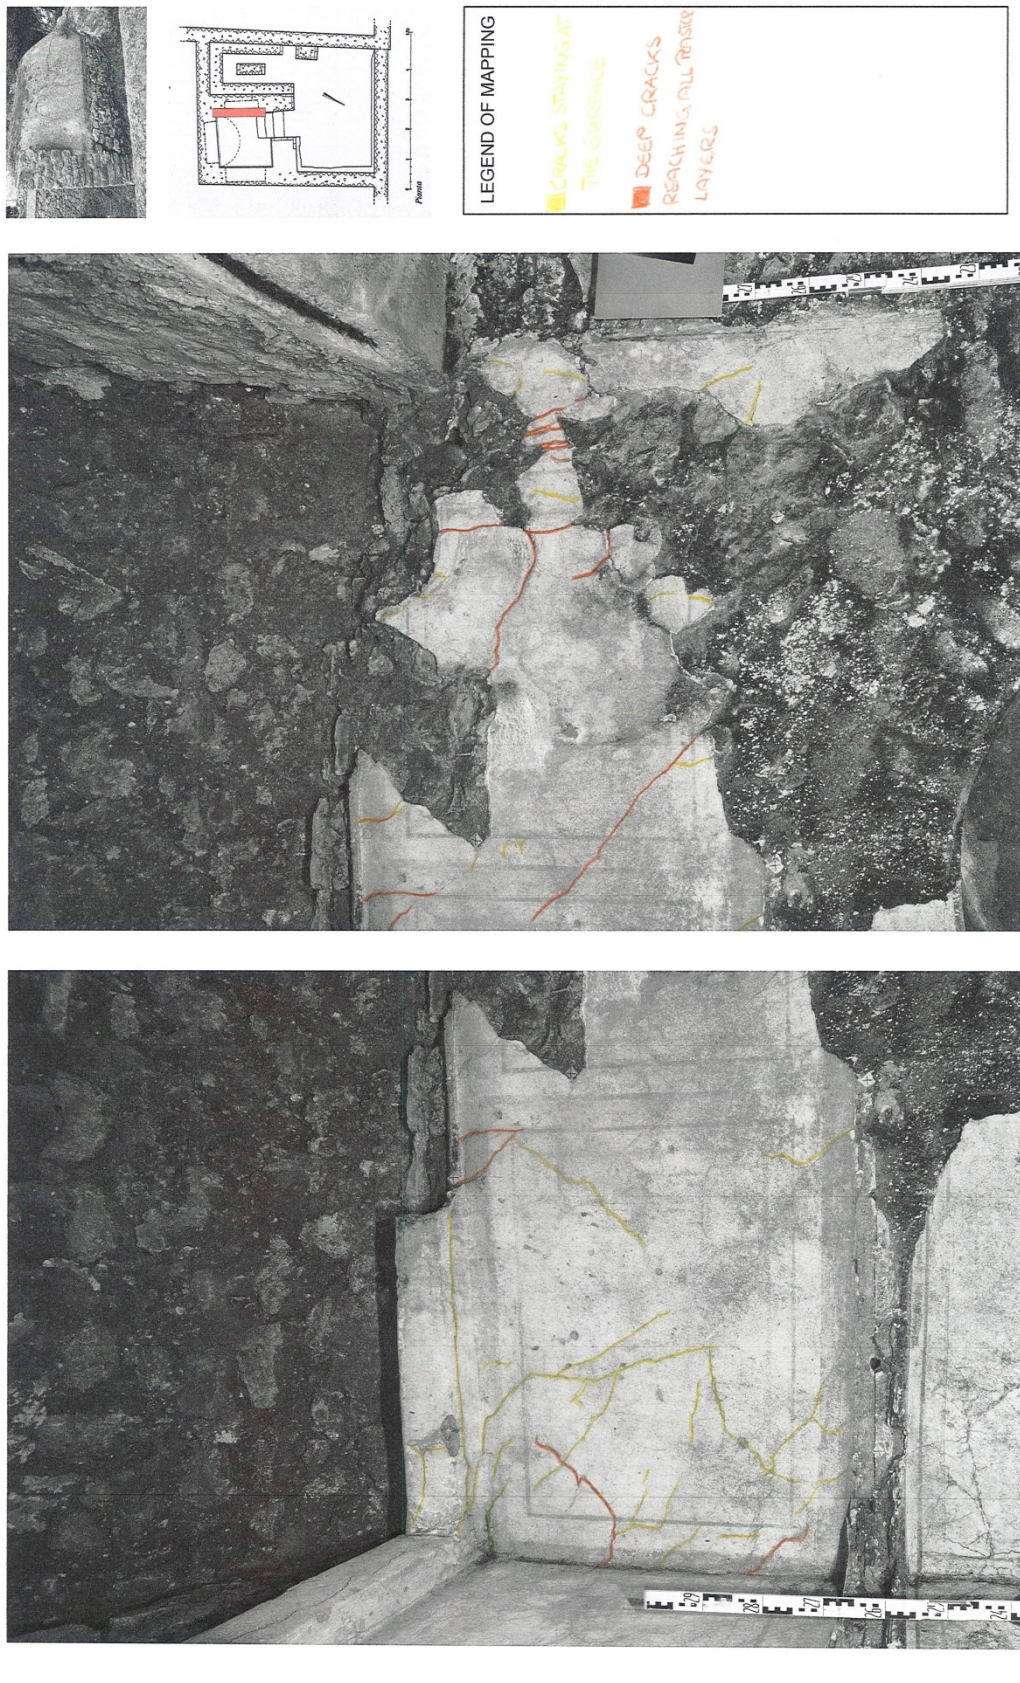
Figure 199: map 07\_ES\_W\_I\_2 of cracks.

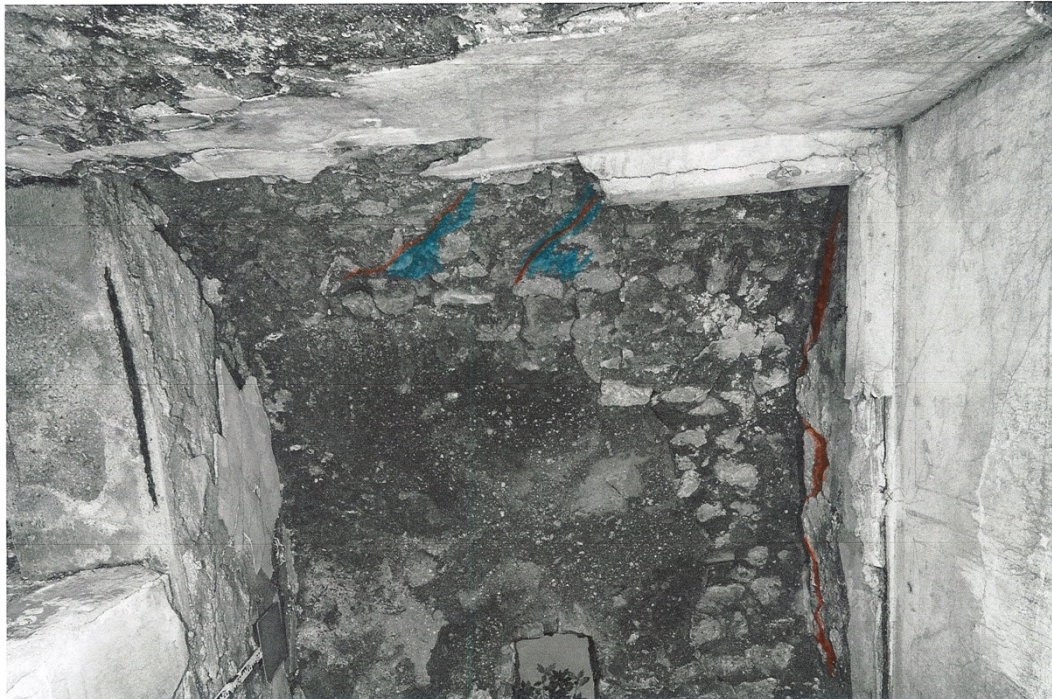
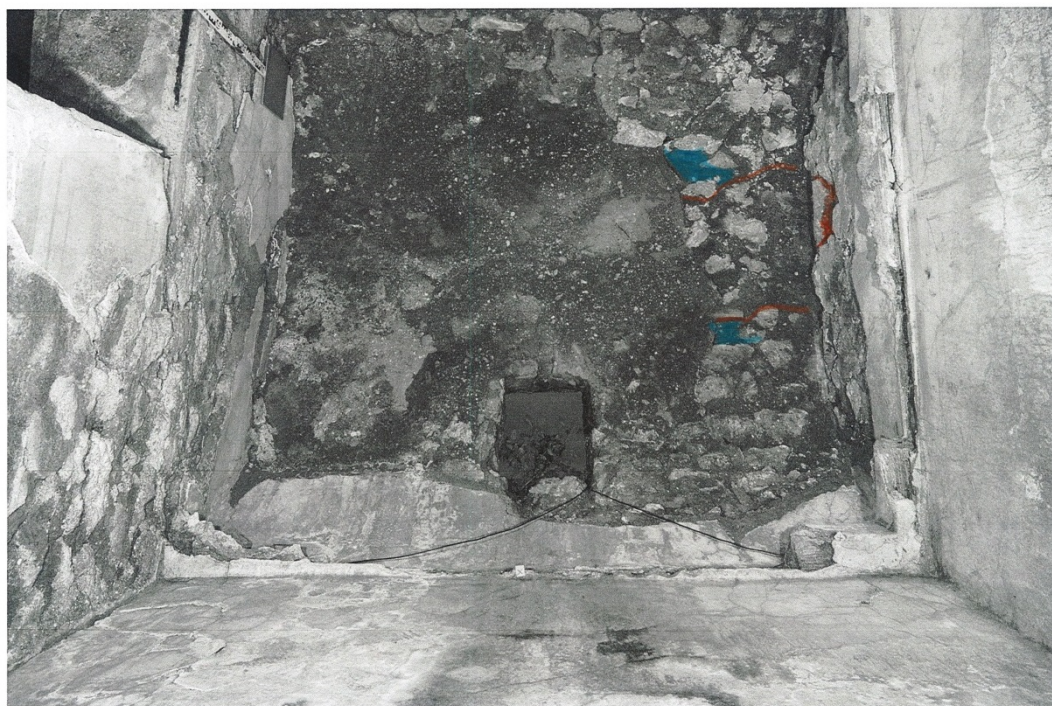
Figure 200: map 07\_ES\_T\_I of masonry damages. Missing mortar is mapped blue and cracks in masonry red.

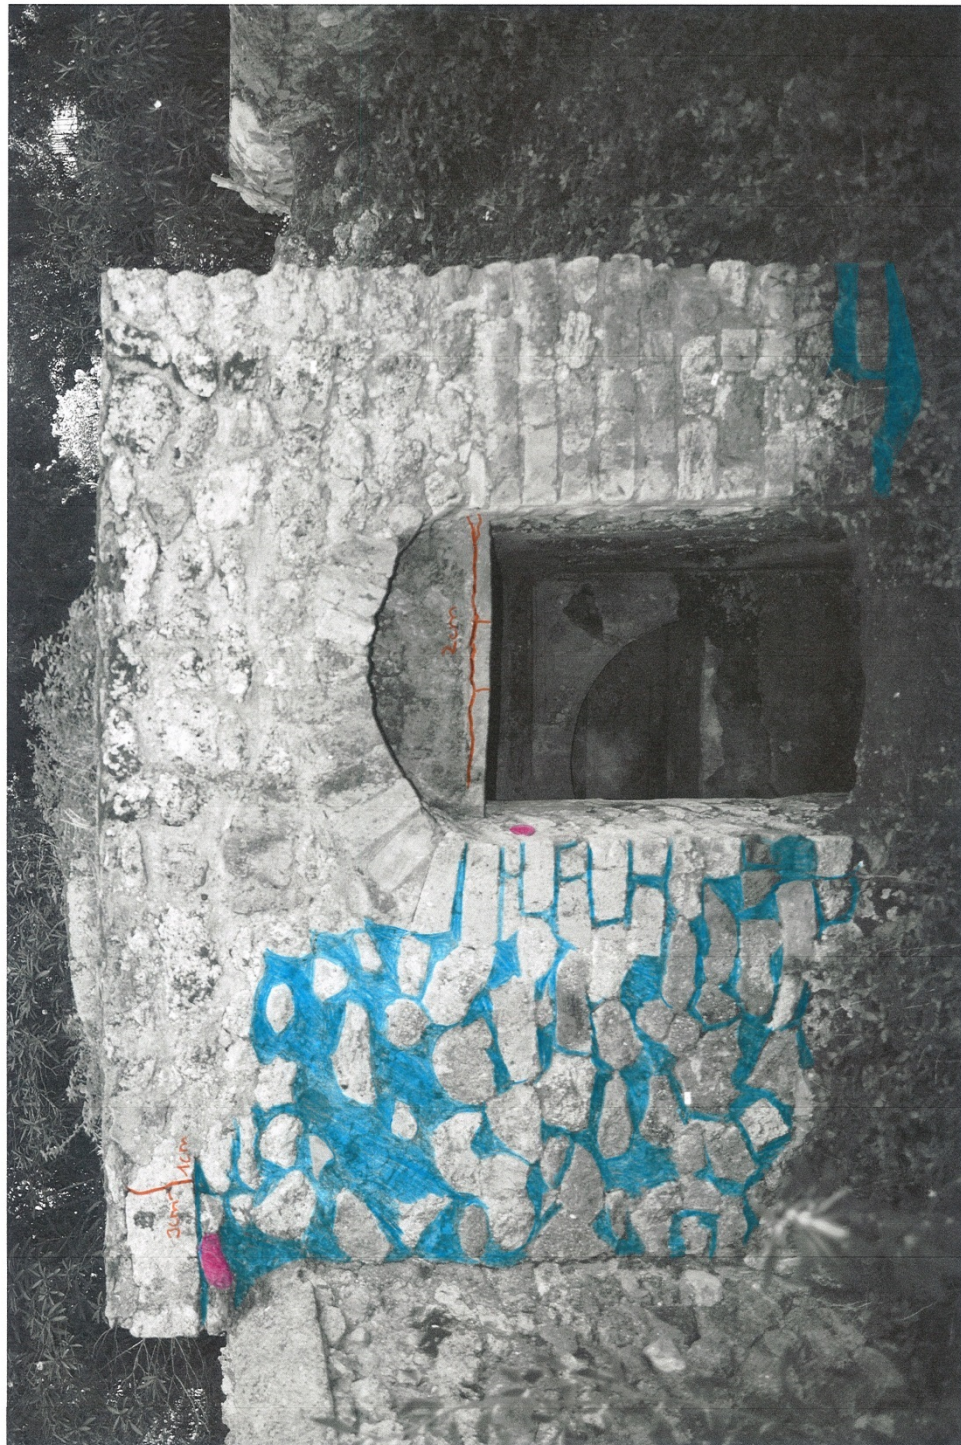
Figure 201: map 07\_ES\_N\_E of masonry damages.

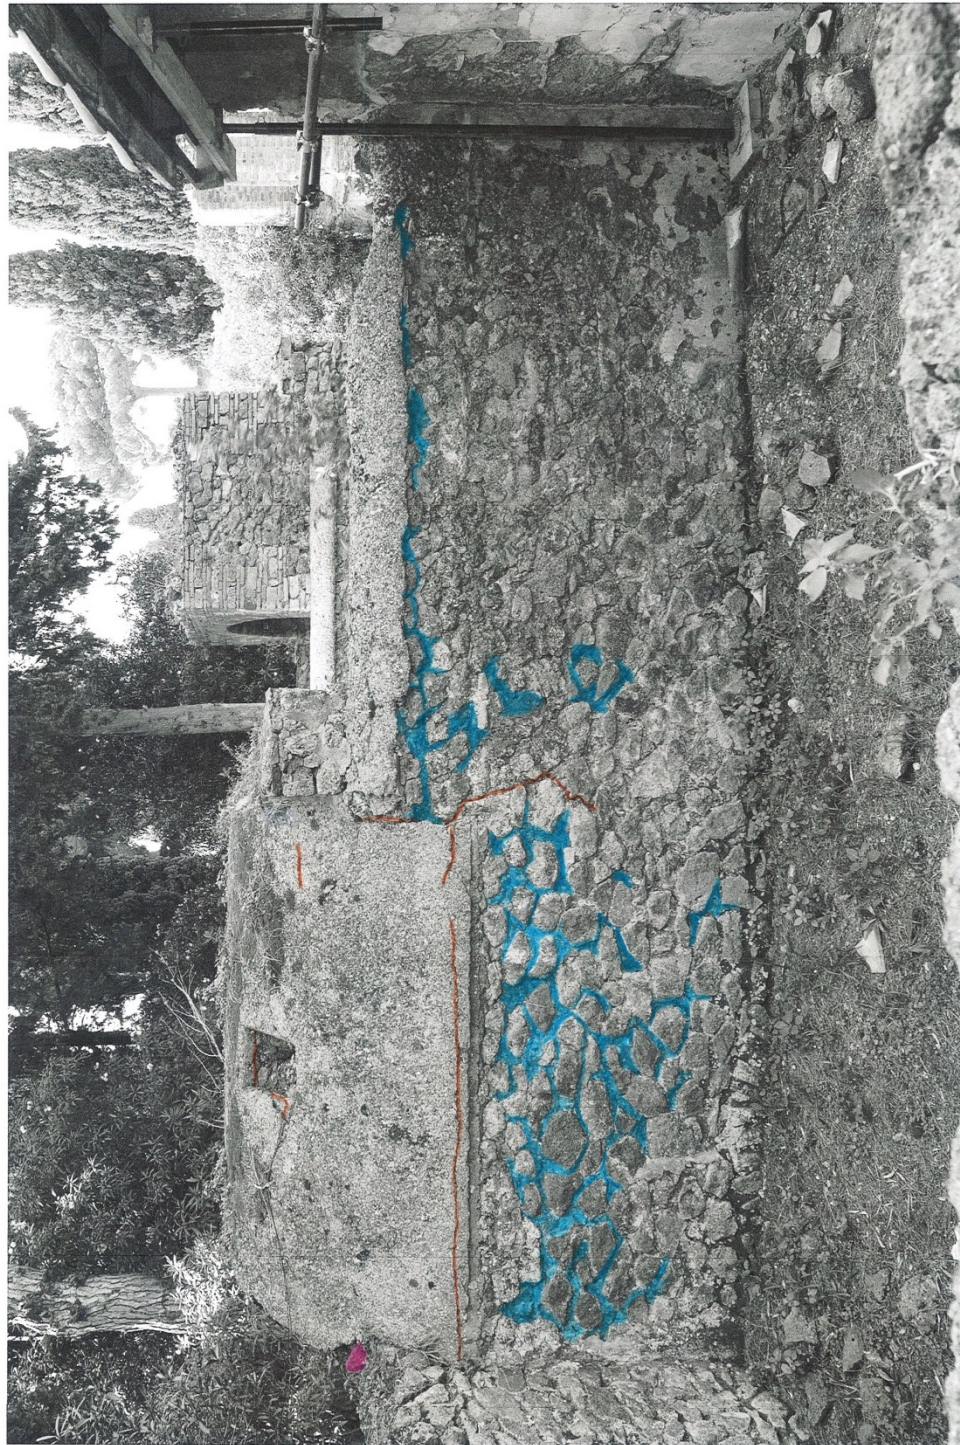
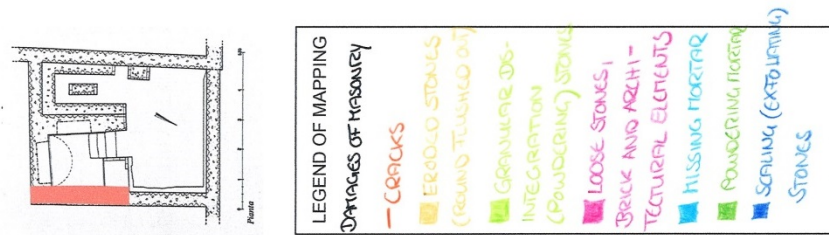
Figure 202: map 07\_ES\_E\_E of masonry damages.

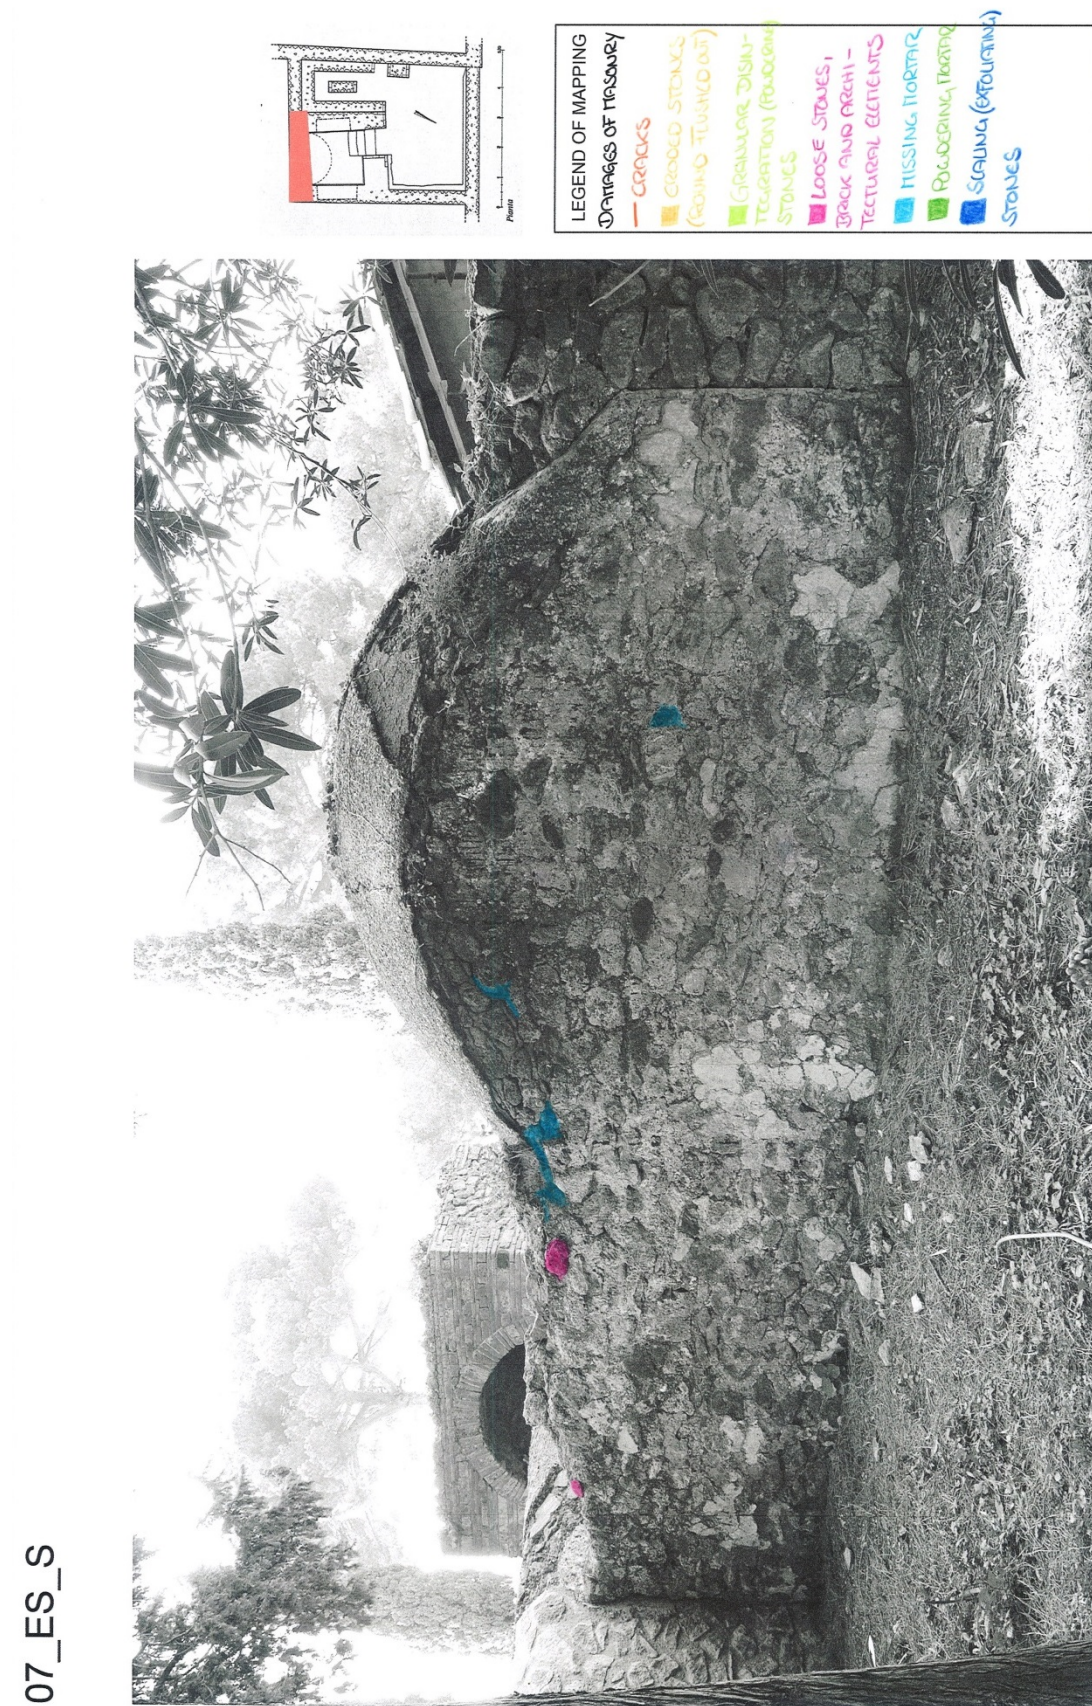
Figure 203: map 07\_ES\_S\_E of masonry damages.

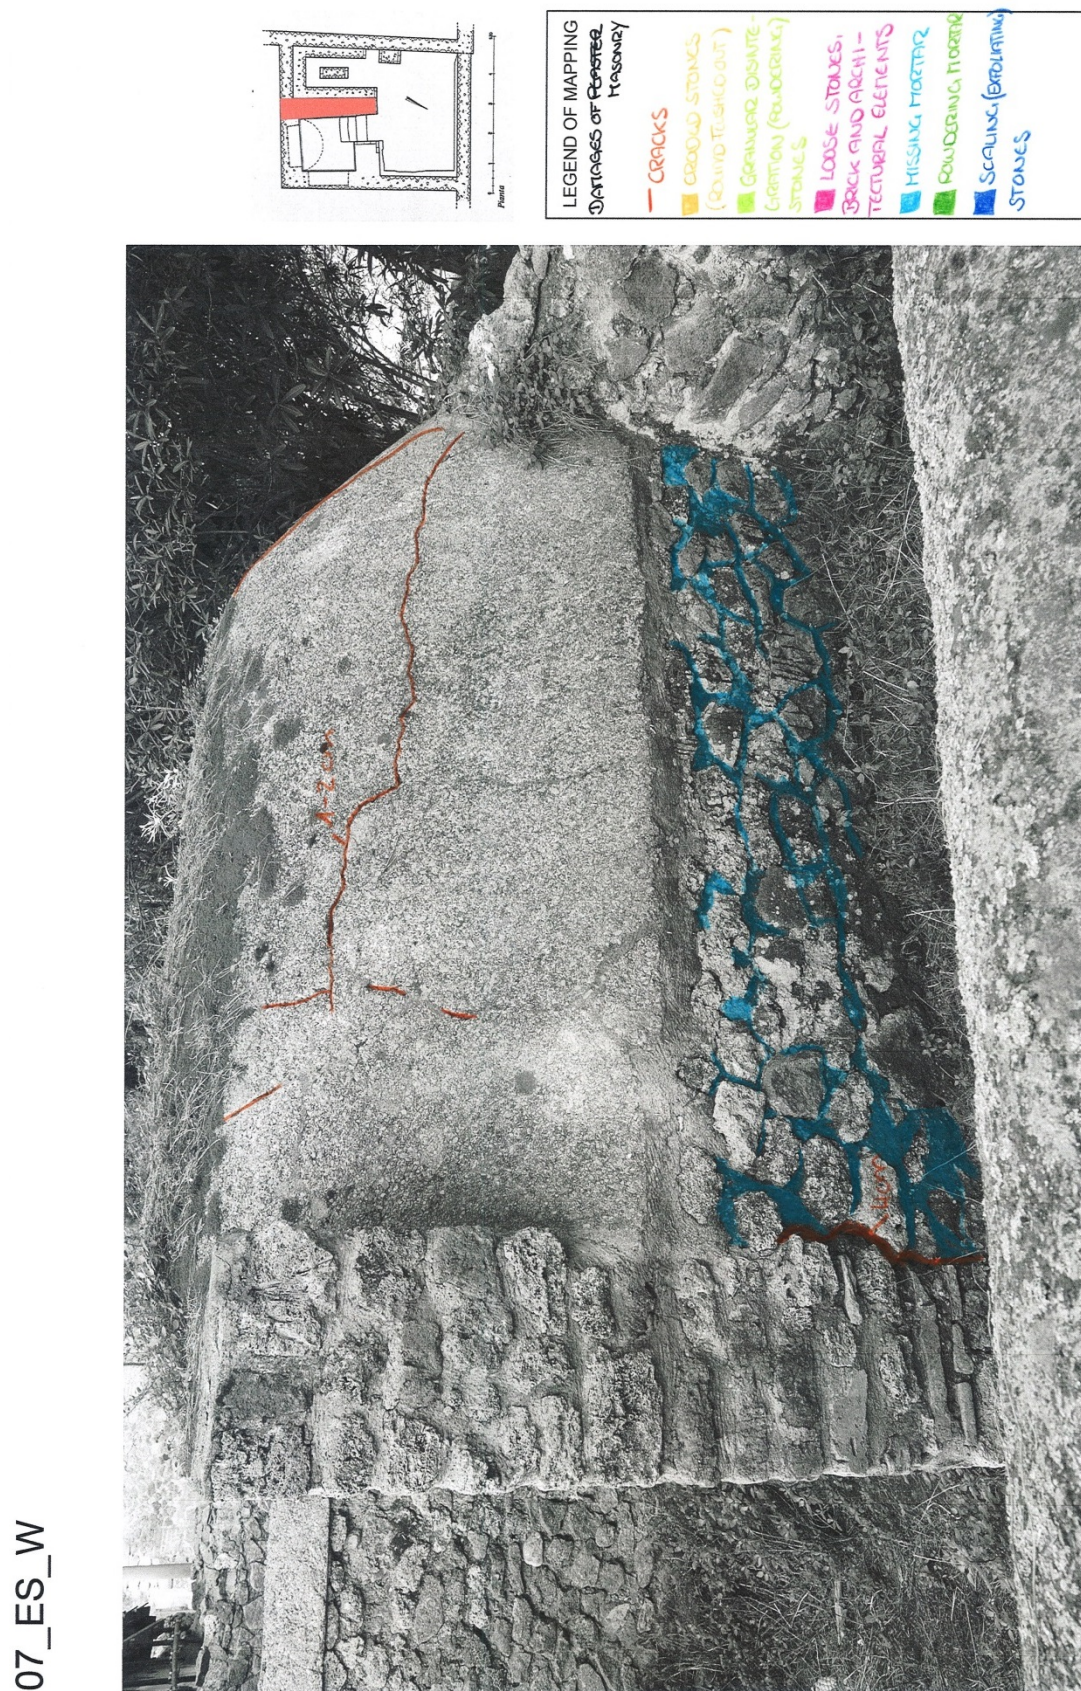
Figure 204: map 07\_ES\_W\_E of masonry damages.

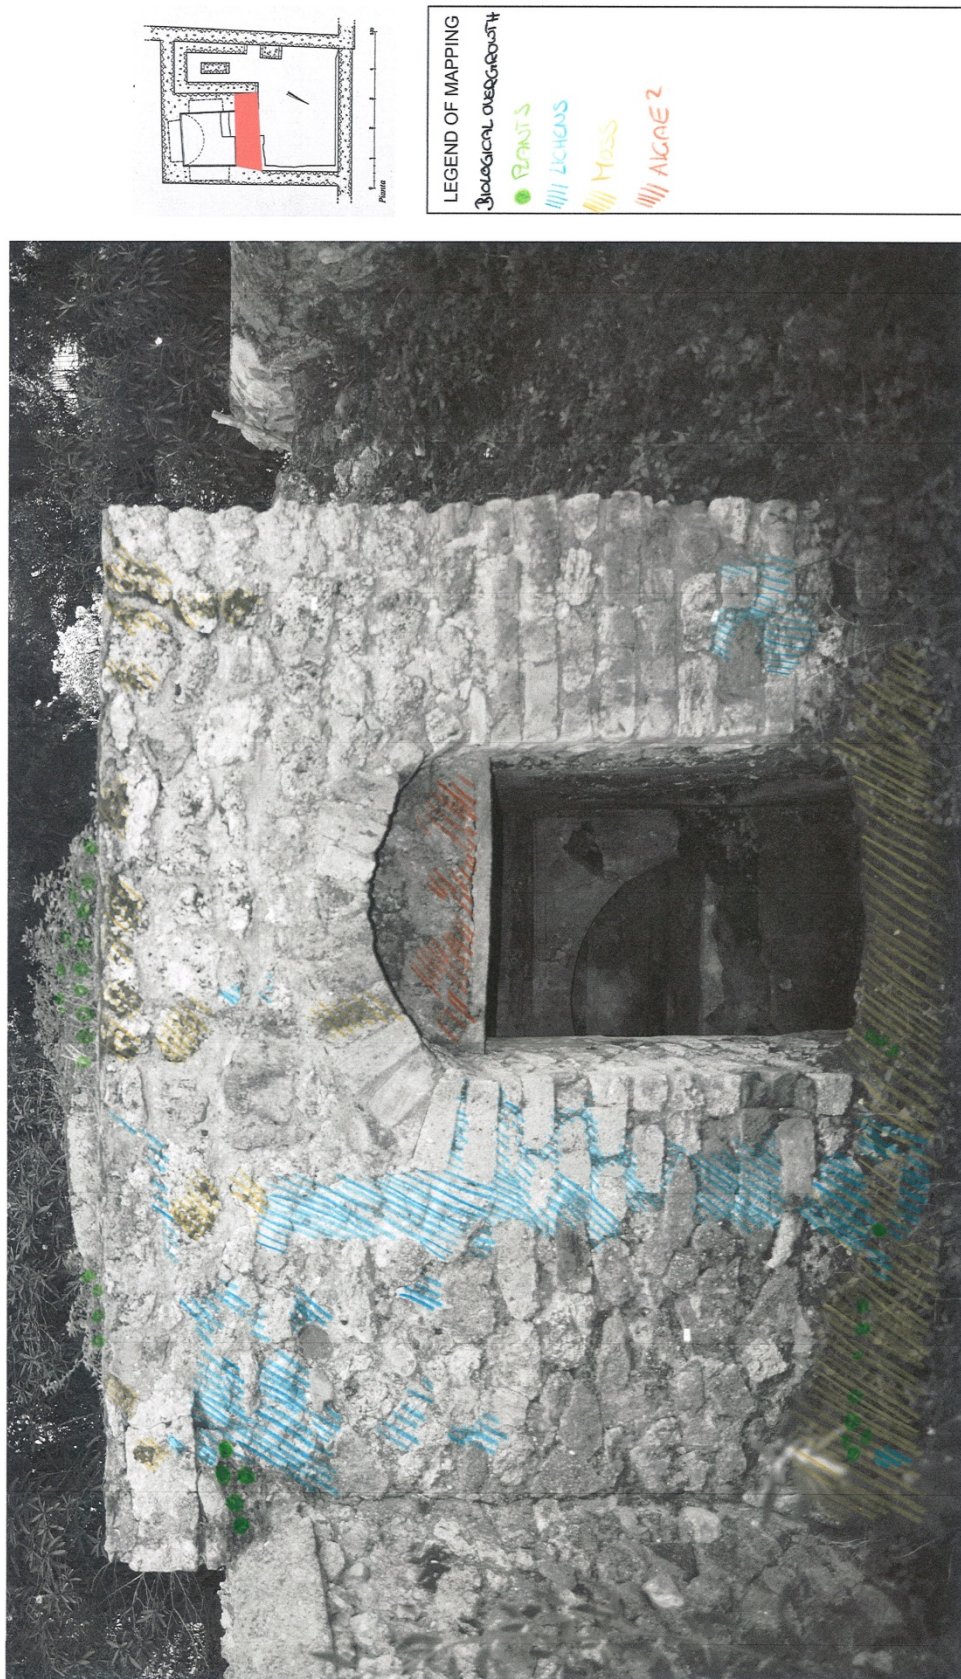
Figure 220: map 07\_ES\_N\_E of biological overgrowth.

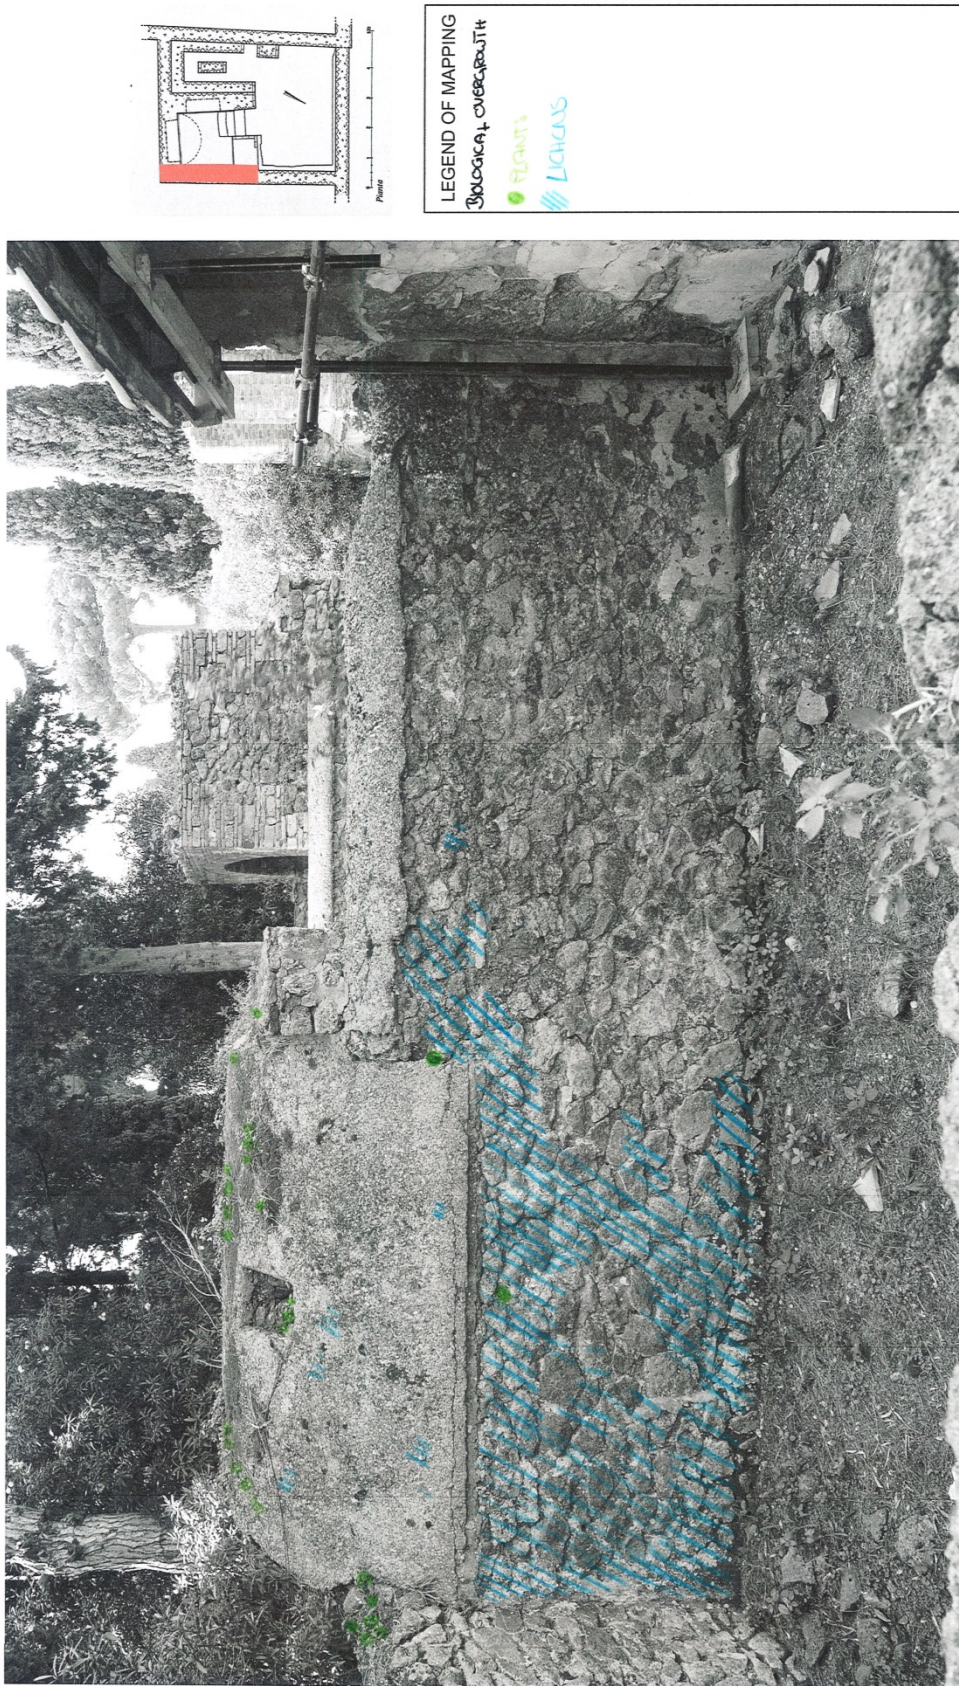
Figure 221: map 07\_ES\_E\_E of biological overgrowth.

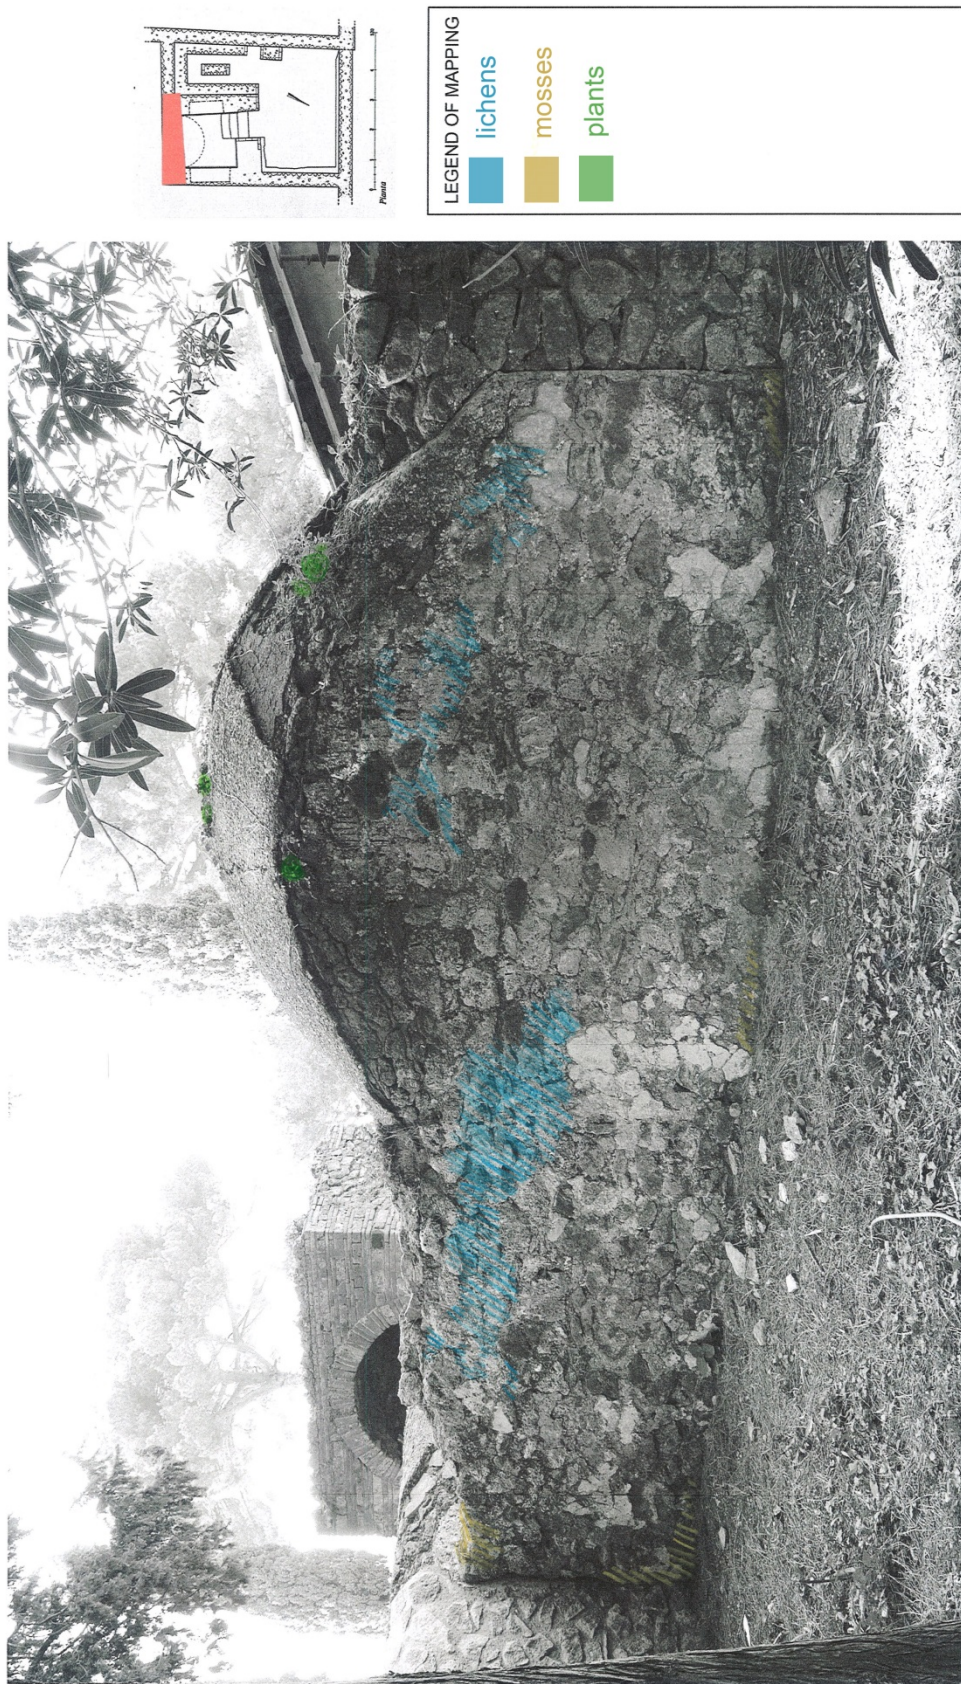
Figure 222: map 07\_ES\_S\_E of biological overgrowth.

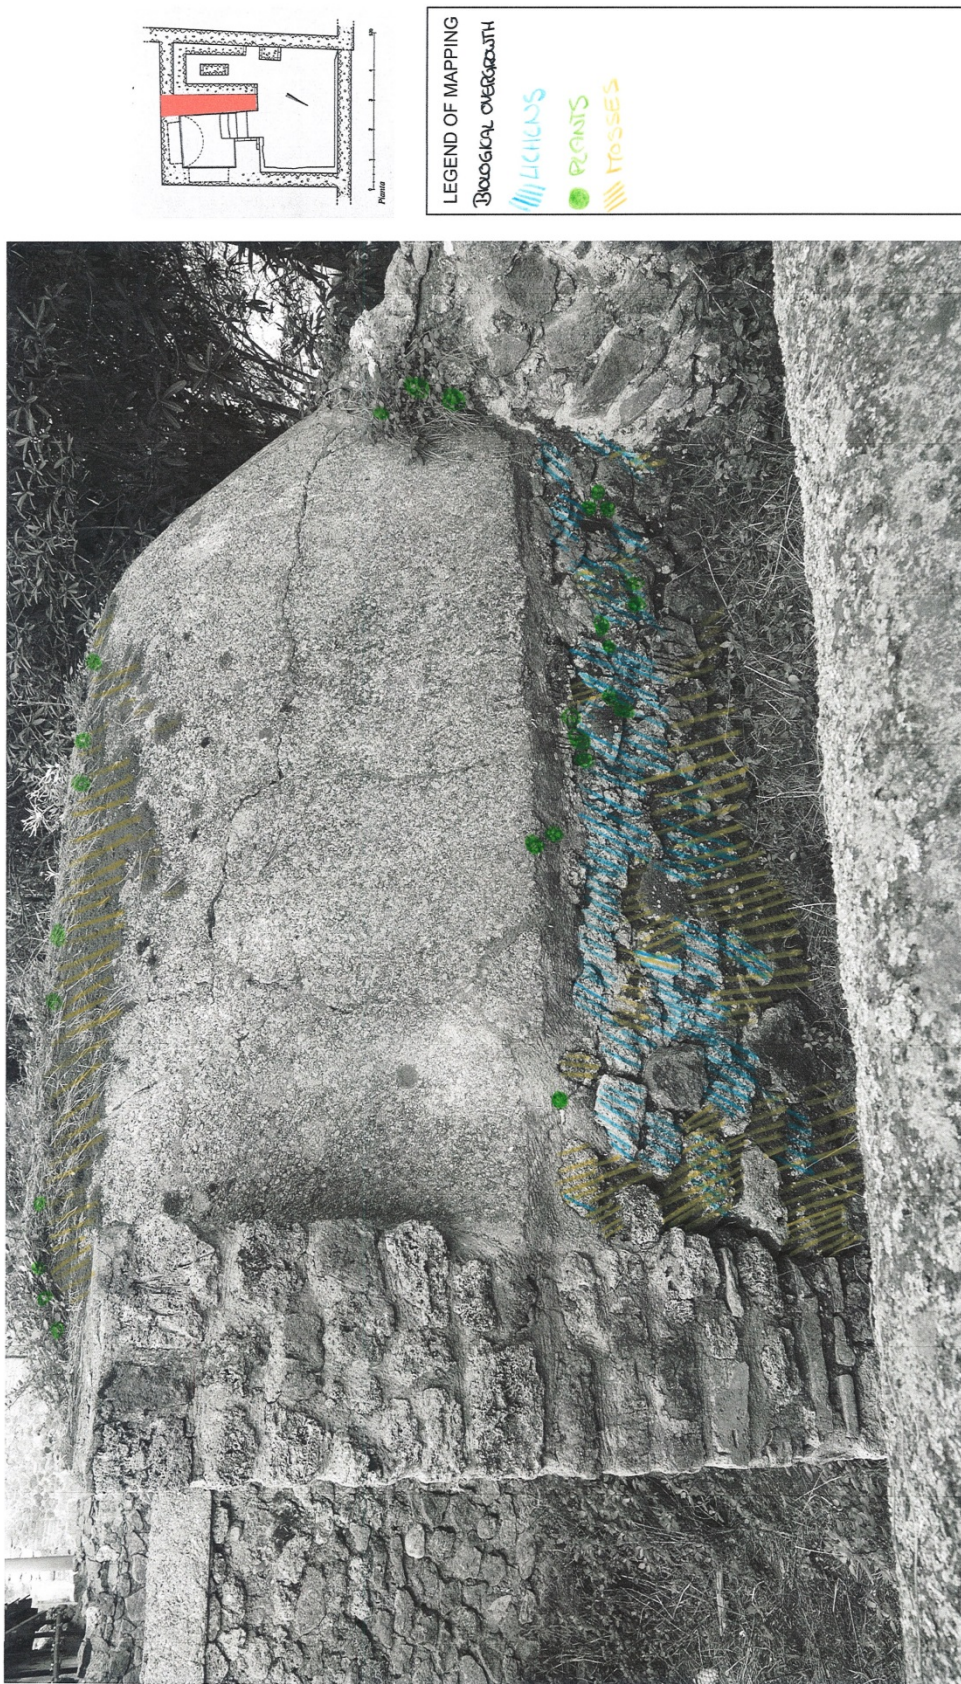
Figure 223: map 07\_ES\_W\_E of biological overgrowth.
