IBP REPORT

539

ASSESSING THE LONG-TERM PERFORMANCE OF APPLIED EXTERNAL THERMAL INSULATION COMPOSITE SYSTEMS (ETICS)

Fraunhofer Institute for Building Physics IBP

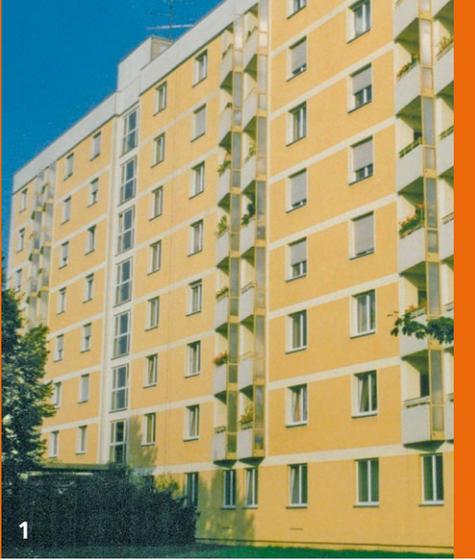
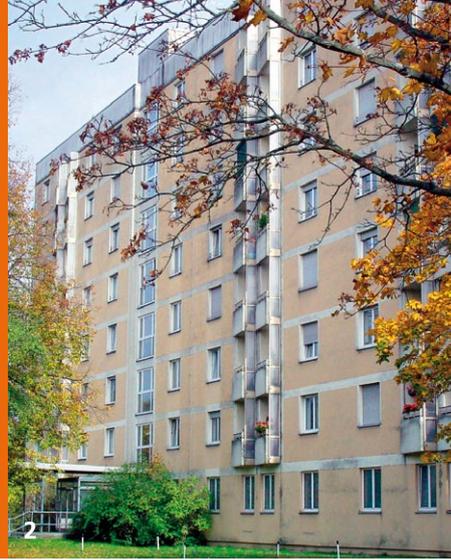
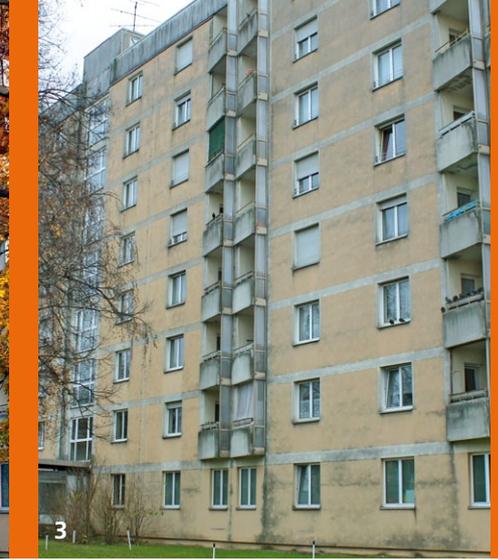
There are systems that did not receive any renovation coating during 14 up to 29 years, yet do not show any technical defects like cracks, blistering or larger areas of render detachment. A building in Munich (Fig. 1–3), which was not refurbished since the application of the mineral insulation system in the 1990s, can still be classified in category 1. However, significant grey discolorations due to soiling may occur (just like with conventionally rendered façades), and in most cases a certain extent of weathering of the paint coats can be determined. In addition, other typical phenomena may occur at ETIC systems: for instance, insulation fixings or individual panel joints can become apparent at the surface and at the building's

1–3 West façade of property no. 16 in Munich, 4 years (left), 19 years (centre) and 29 years (right) after application of the ETIC system, no intermediate renovation of the façade.
