# **POMPEII SUSTAINABLE PRESERVATION PROJECT**

#### **CONSERVATION SURVEY of the PORTA NOCERA NECROPOLIS**

(Including tombs of the Western area and of the Eastern area, next to the so called “*Fondo Pacifico*”)

22 September - 16 November 2014

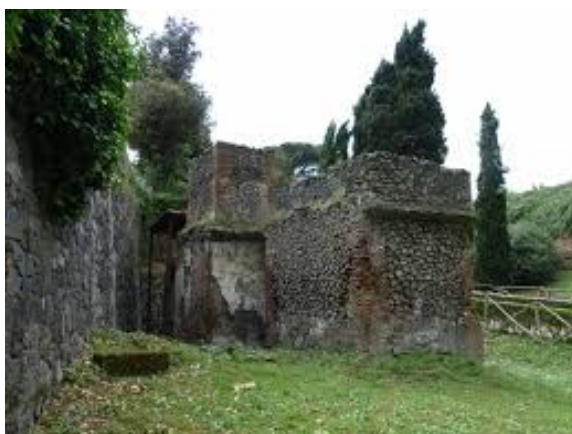
Fig 30 - Tomb 27OS - "partially buried".

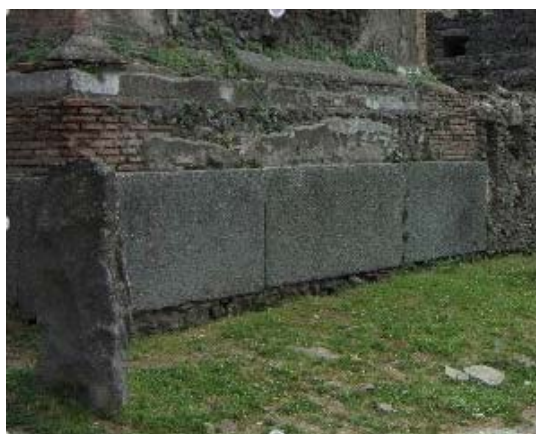
Fig 31 - Tomb 1 OS – in the bottom part, the foundations are visible, it is also visible the action of erosion by the water.

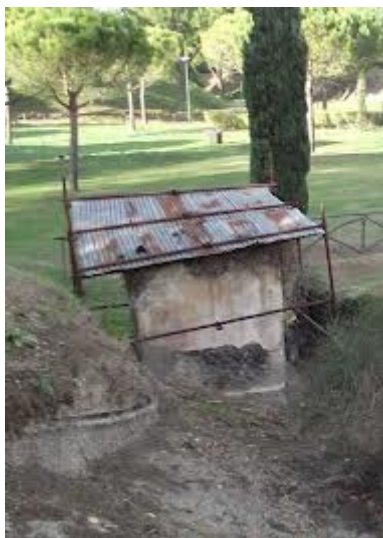
Fig 102 - Tomb FPNA, temporary roofs, in relatively good conditions

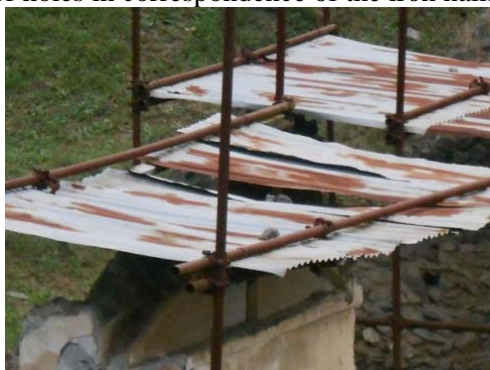
Fig 104 - Tomb FPN F, temporary roof in bad condition

Only one tomb has a good protection (*Tomb FPSGB*), while the metal cover of the other four tombs needs to be replaced: two of these covers are collapsed, deformed and very damaged (*Tomb FPNF* and *Tomb FPNG*), and the other two are leaking (*Tomb FPNA* and *Tomb FPND*).

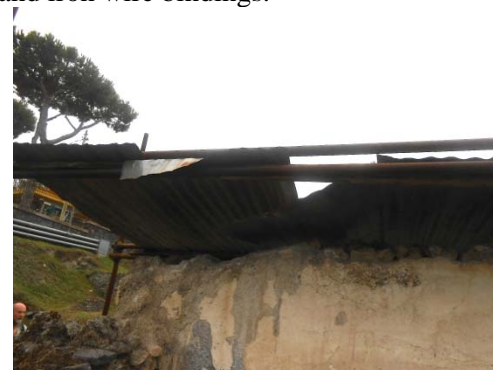
Fig 105 - Tomb FPN D metal cover in very bad conditions

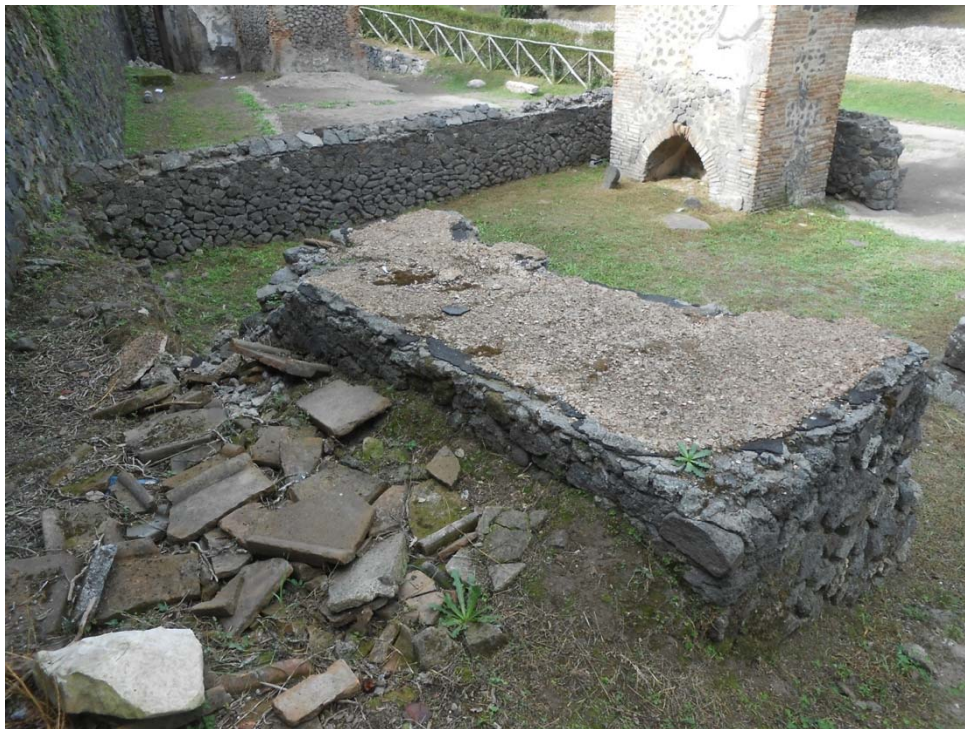
Fig 109, 110, 111 - Tomb 25OS General view and details of the modern impermeabilisation, which is repeated on many of the other tombs.

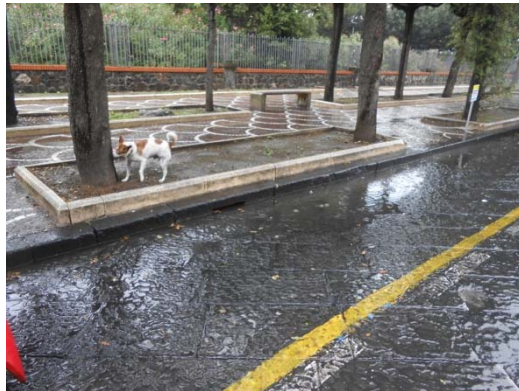
Fig 129 – water stagnation in Via Plinio, just above the area of the necropolis.

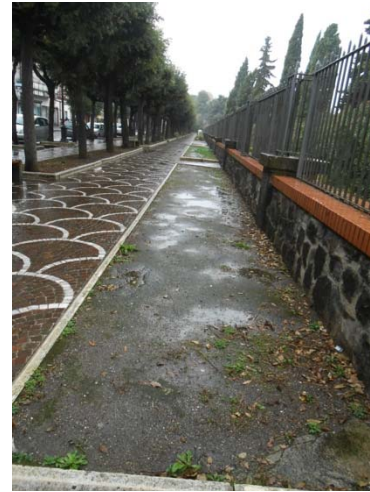
Fig 130 – water infiltration and stagnation in the flower beds along Via Plinio and beside the boundaries wall of the pedestrian path (over the excavation).

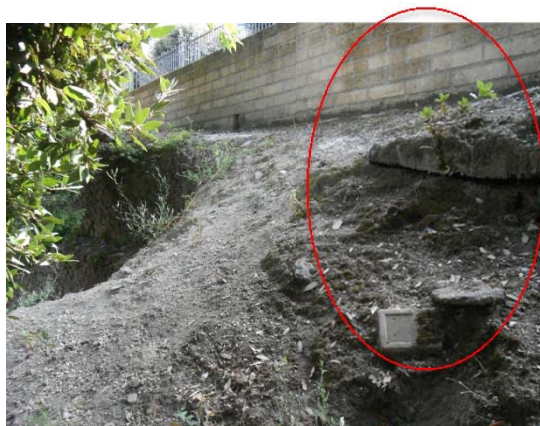
Fig 129 - North side of the pedestrian walkway wall. At the right of the image a phenomenon of erosion of the ground.

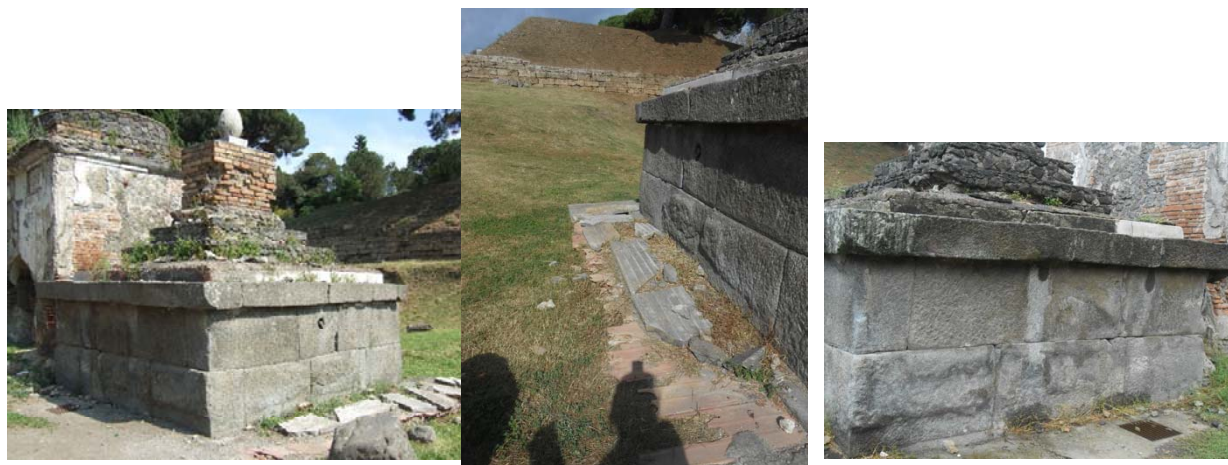
Fig 131 -132 -133 - Tomb 2EN, modern channels on the outside of the tomb. Is not clear if these channels have been made as a drainage, to reduce humidity in the inside chamber (decorated with mural paintings), or if they are used to simply collect and convey rain water.

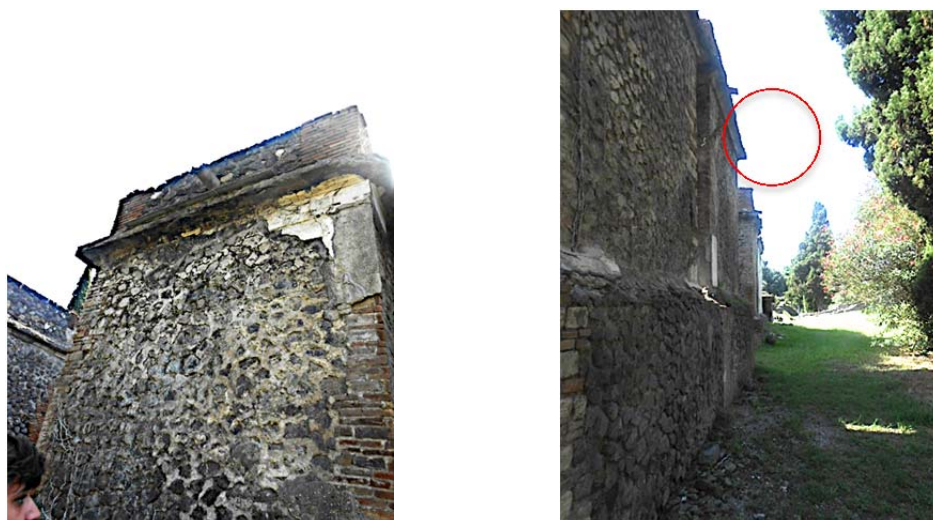
The water, collected and managed in this way, falls slightly far from the bottom surfaces of the monument, and can cause, along the time, future problems of salt migration, salt crystallization, detachment of plasters, disintegration of the mortars or the stone, etc etc.

Fig 134 e 135 – back of the Tombs 6EN and 10EN – modern rain drains to collect the water from the top surface of the monument

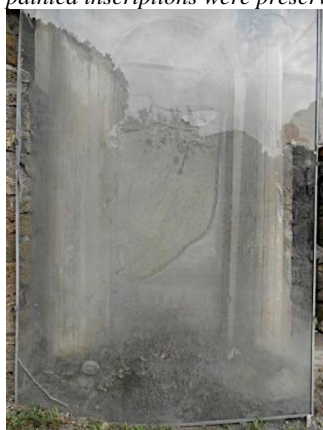
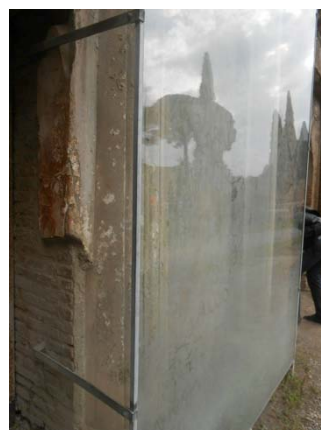
*Fig 138 and 139 – Tomb 19ES – detail of the glass protection and its metal structure (left and right side). Due to the dust and humidity always present in the archaeological site, the glasses become dirty and opaque and the decoration is not visible anymore. Unfortunately it is not possible to clean the glasses, as they are not demountable.*

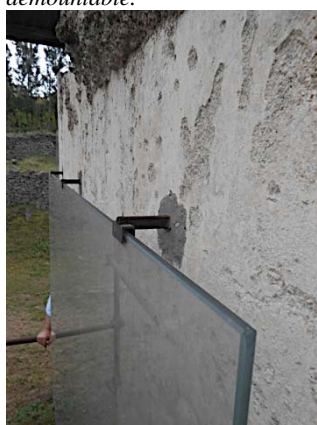
*Fig 140 - Tomb FPND, detail of the modern glass protection with the metal elements to hold the glass in place.*

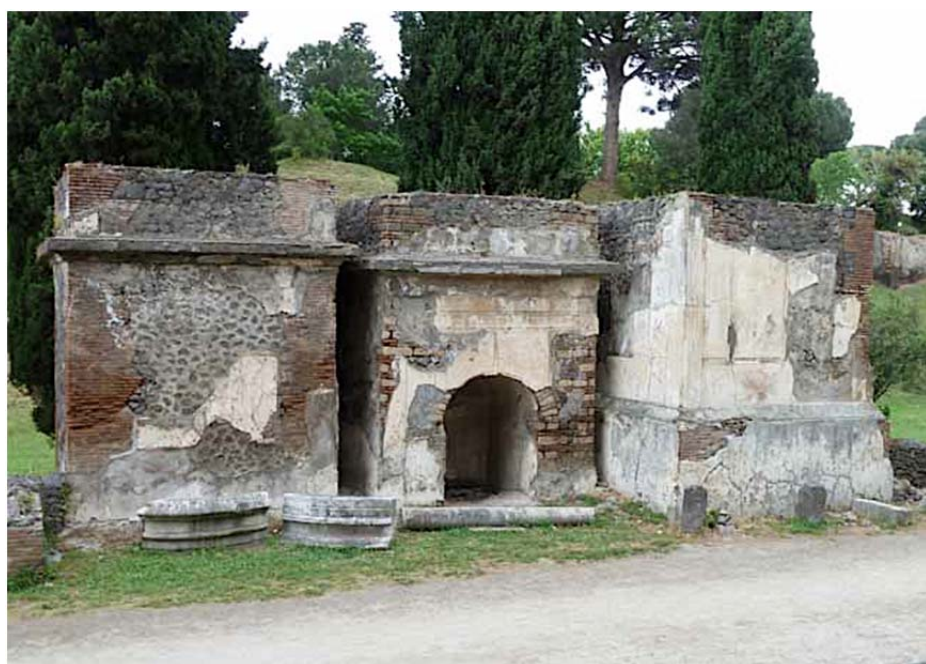
*Fig 143– Same view of the tombs in present time, 2014. All the funerary monuments (Tombs 10EN, 12EN and 14EN) have lost almost all the decorative (and protective) original stucco coating.*

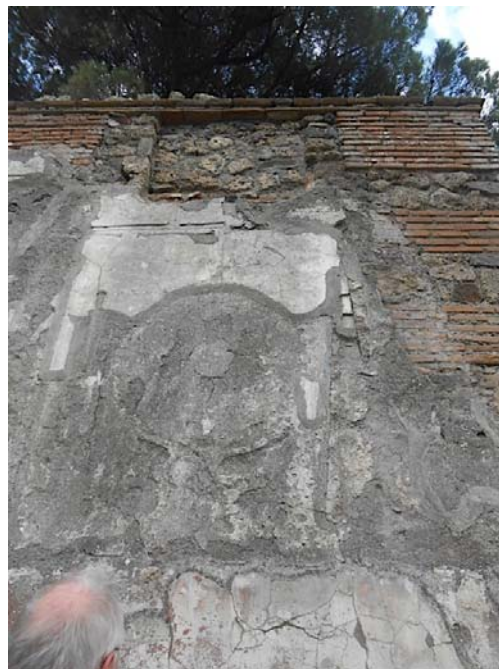
Fig 146 - Tomb 13ES, same view with what remains today of such a beautiful and elaborated decoration.

A wrong decision in the final phases of the intervention on this monument, could ruin it forever, producing a definitive loss of the few details which still tell us how the decoration was. A very careful and well thought final presentation has to be foreseen, for any operation that concerns the integration of the stucco missing portions ("lacunae"/ losses)

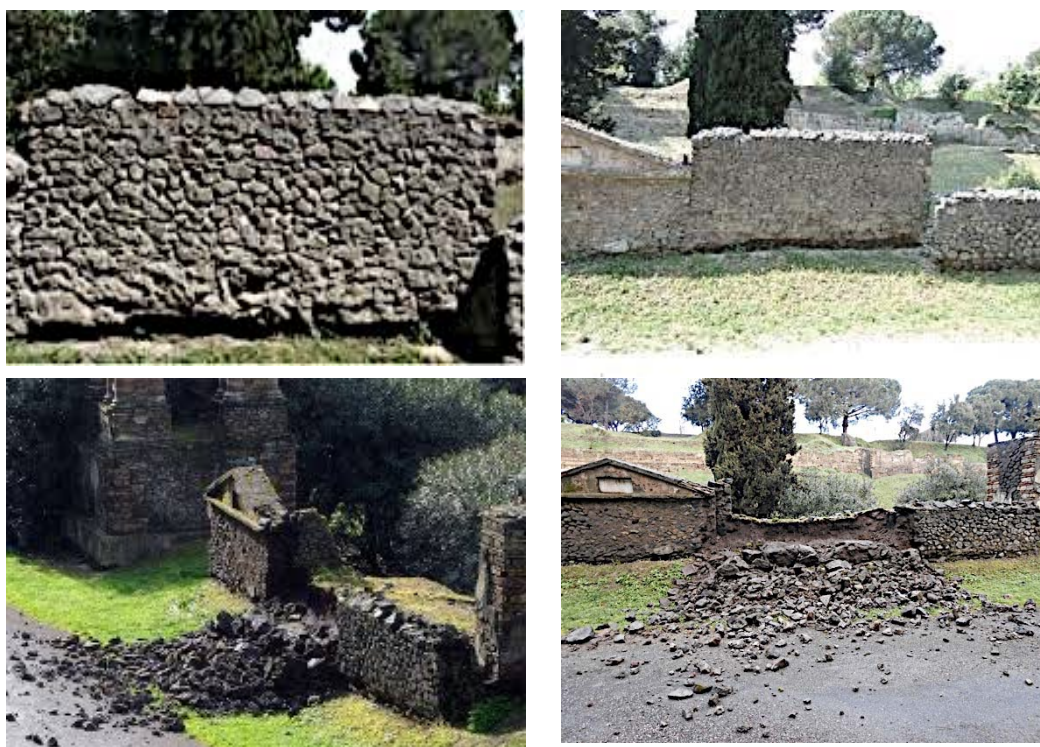
Fig 149- 150- 151- 152 - Tomb 24EN, the wall before and just after falling down, in March 2014.  
It is probable that the foundations have been slowly eroded by the rising damp and the rain.

We have also found that some monuments (7 in the whole necropolis) present a problem of *foundations* now out of their original ground level and today *visible* and therefore exposed to the weathering agents. This is not good as these masonries were supposed to be protected by the ground. And this can have possibly been the cause of the recent collapse of the wall of *Tomb 24EN*.

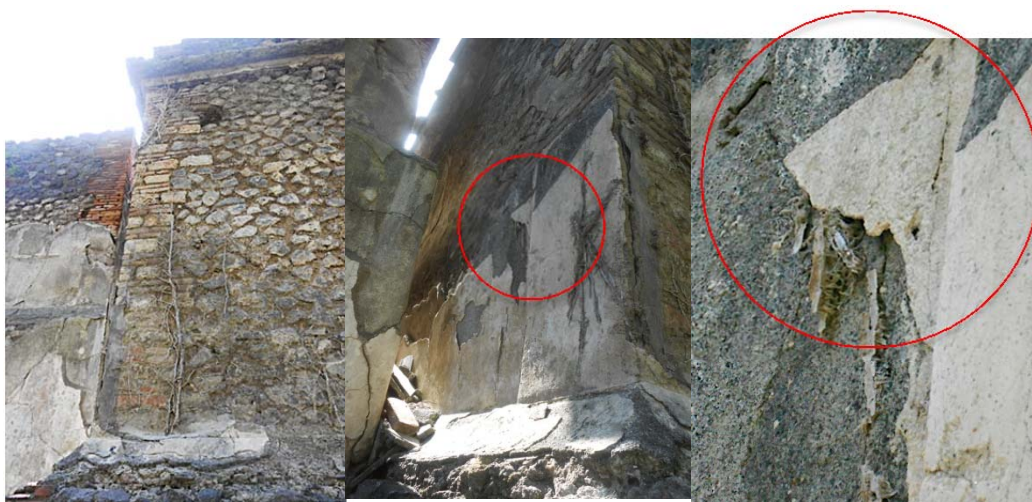
Fig 160 -161 - 162. - Back of Tomb 12EN. with long remains of climbing plants. In the detailed at the right, the roots are below a very unstable fragment of stucco, “pushing it out” from the surface.

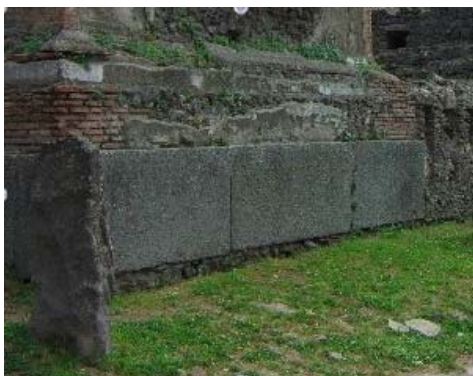
Fig 173 - Tomb 10S, part of the foundation are exposed

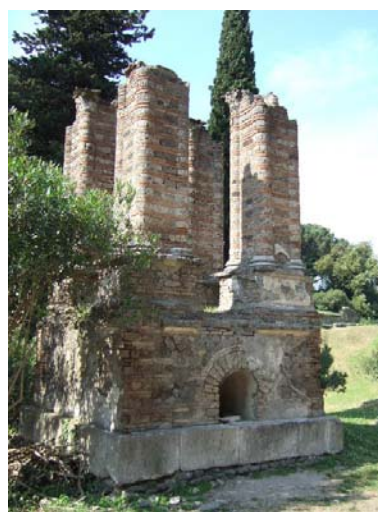
Fig 174 - Tomb 20EN, the foundations are exposed at the bottom of the front side.

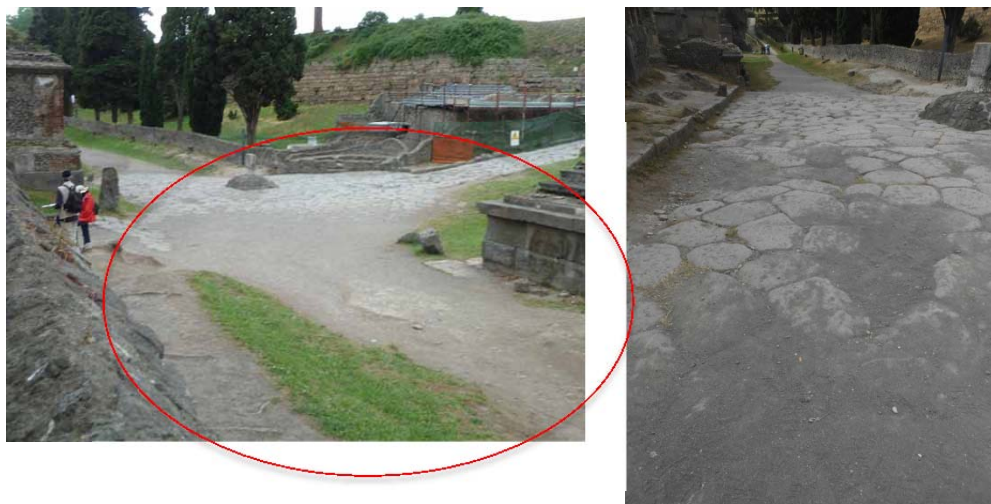
Fig 175 and 176 – view of the crossroad area with the debris and their detail at the left. This material comes from the very sloping Via di Nocera but also from the rain water erosion of the East part of the street of the necropolis (Via delle Tombe)

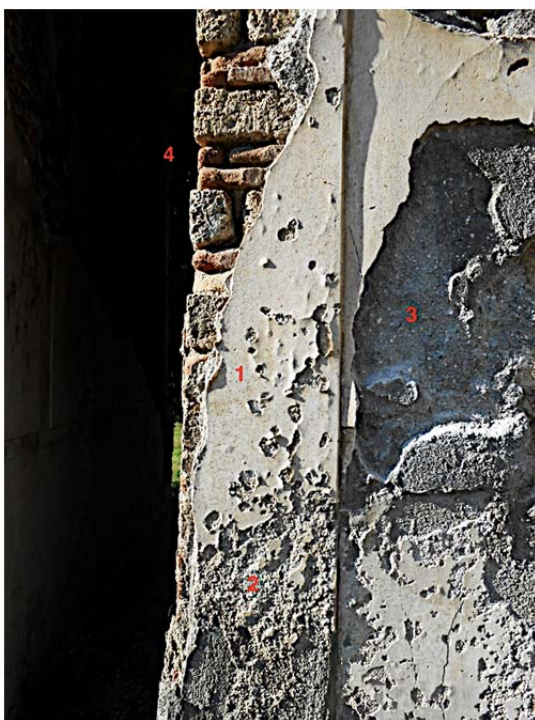
Fig 179 - Tomb 12EN, salt crystallization as:

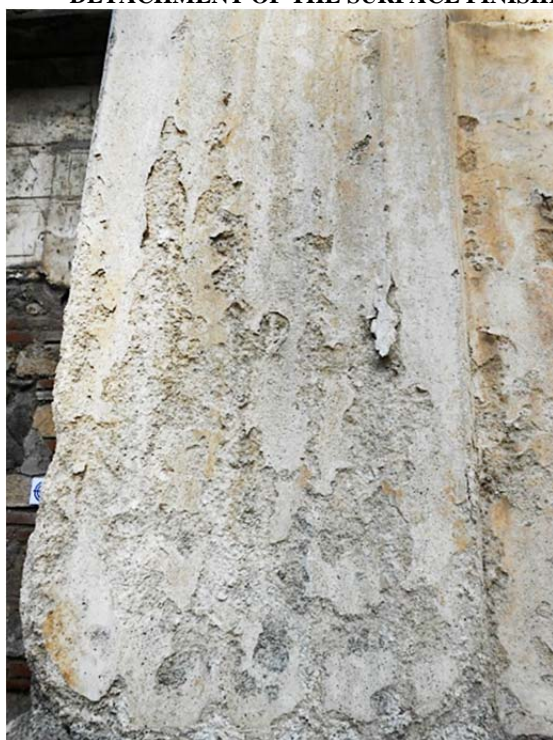
Fig 183 - Tomb 14EN surface of the "lesena" in stucco with a dramatic deterioration due to salts' efflorescences

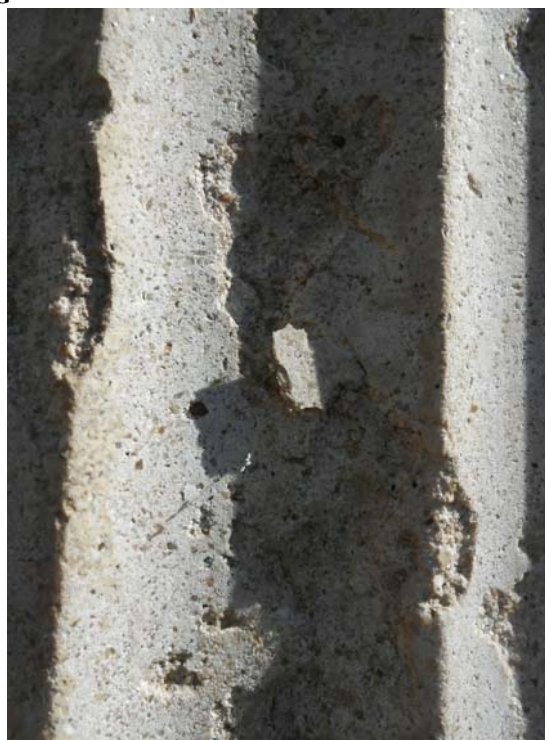
Fig 184 - Tomb 14EN detail of a detachment similar to those in the previous image.

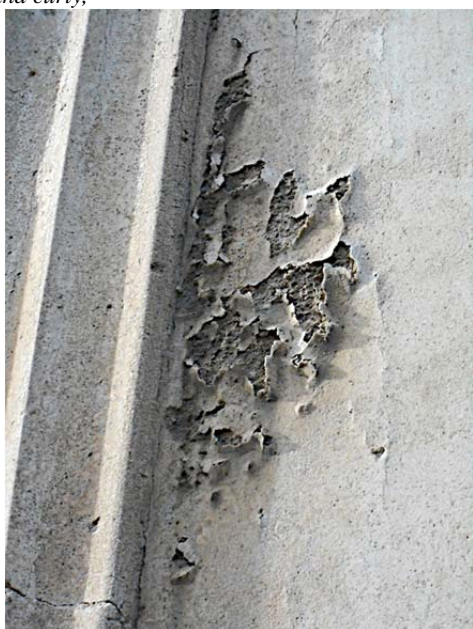
Fig 187a – 187b - Tomb 14EN, another area of the same surface. This kind of decay can happen when the surface has been treated with a protective coating, such as a wax or a resin, as visible in certain areas of the necropolis.

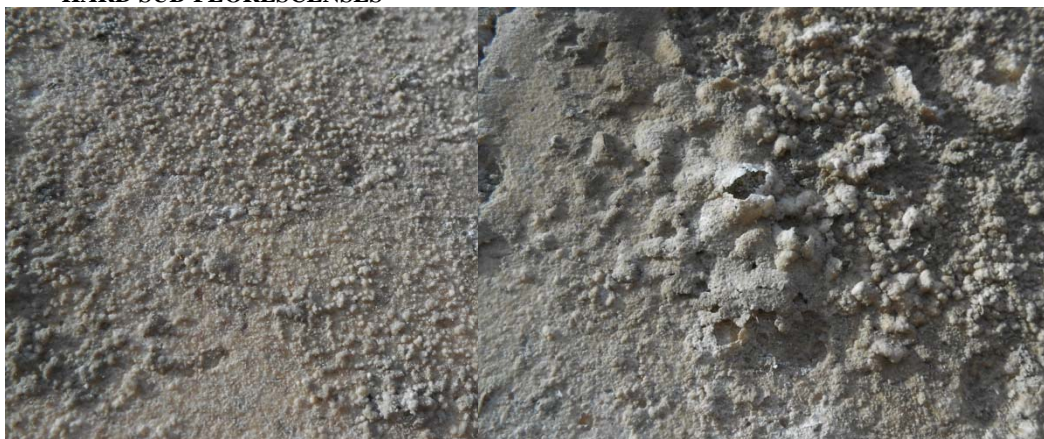
Fig 187c – 187d – a different typology of damage due to salts. The crystallization happens just below the external surface of the stucco and has a hard consistency, sometimes pushing out small portions of surface.

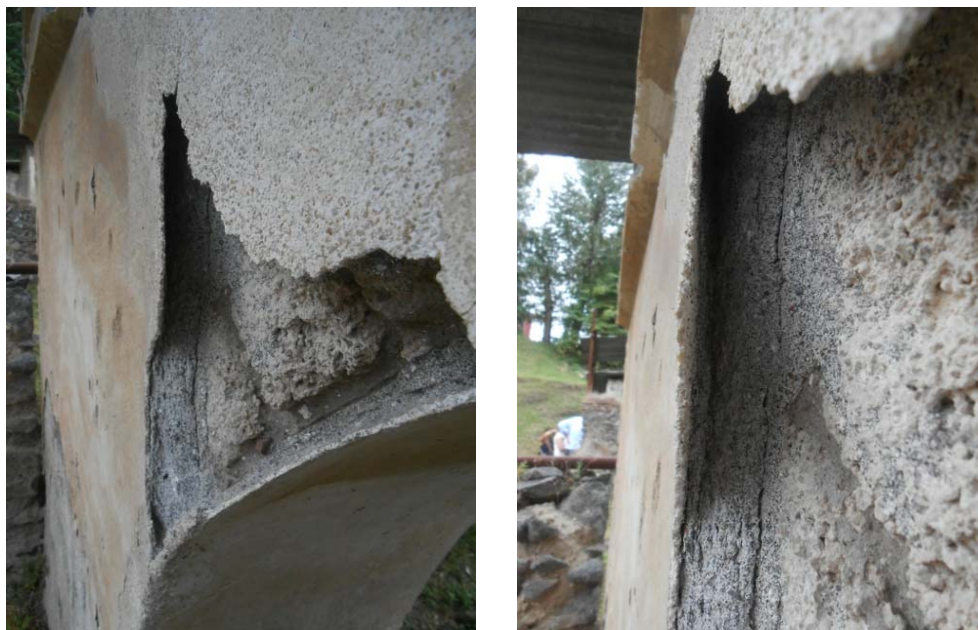
*Fig 187e – Fig 187f - Tomb FPN.... erosion and powdering of the internal preparatory mortars, leaving the external finishing layer (more compact) totally unprotected*

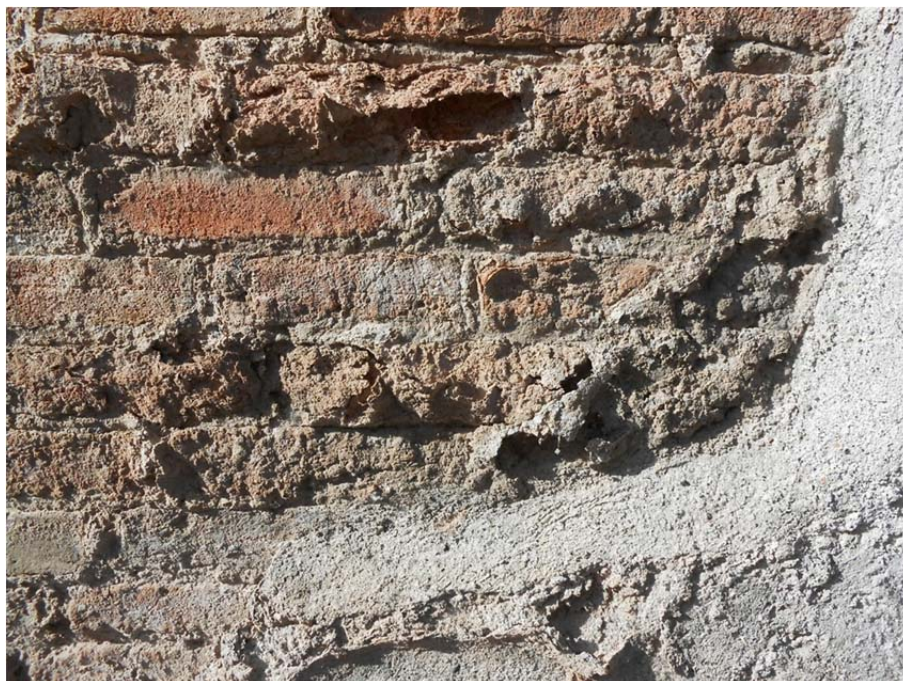
*Fig 188 - Tomb 10EN, “explosion” of the external surface of the bricks due to salts crystallization*

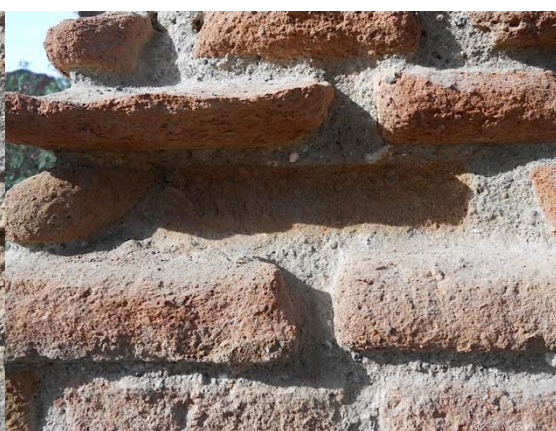
*Fig 192 - Tomb 10EN, same situation in a more advanced decay*

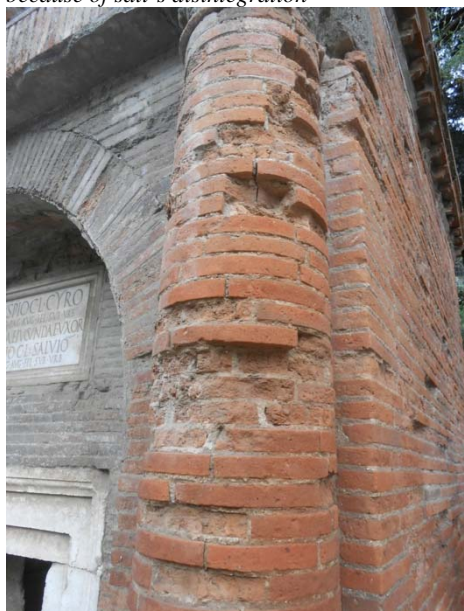
*Fig 193 - Tomb 17ES, the decay slowly leads to the loss of the brick*

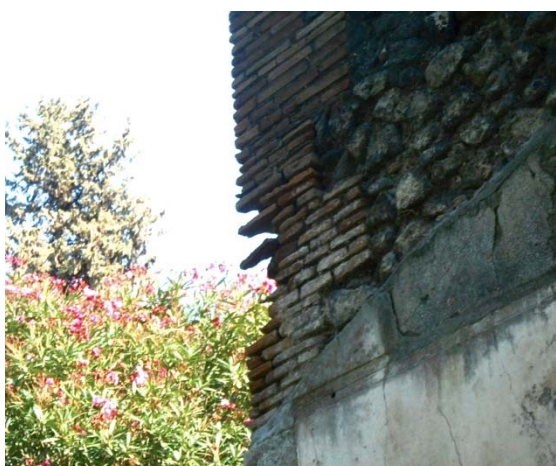
*Fig 194 - Tomb 14EN., the loss of the single bricks can lead furtherly to structural problems, especially in the corners of the monuments*

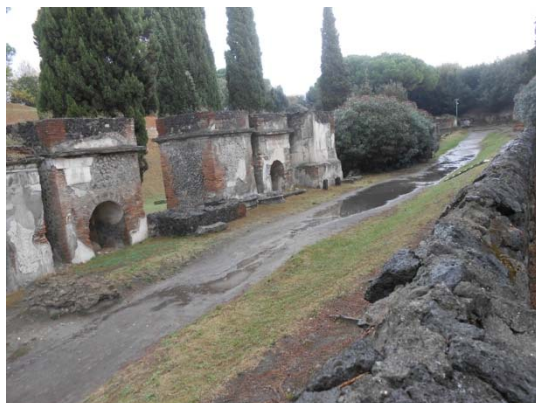
But we have found the possible reason for the very heavy salt decay of the surface of Tomb 14EN, when we saw a photo of the South surface after a heavy rain<sup>9</sup>. The road in front of the tomb appears completely filled with water. This water will of course penetrate into the structure, and re-emerge from the surfaces bringing a great amount of salts which will remain on the surfaces.

Fig 195 - Tomb 14EN, ponds due to water stagnation
