IBP REPORT

539

ASSESSING THE LONG-TERM PERFORMANCE OF APPLIED EXTERNAL THERMAL INSULATION COMPOSITE SYSTEMS (ETICS)

Fraunhofer Institute for Building Physics IBP

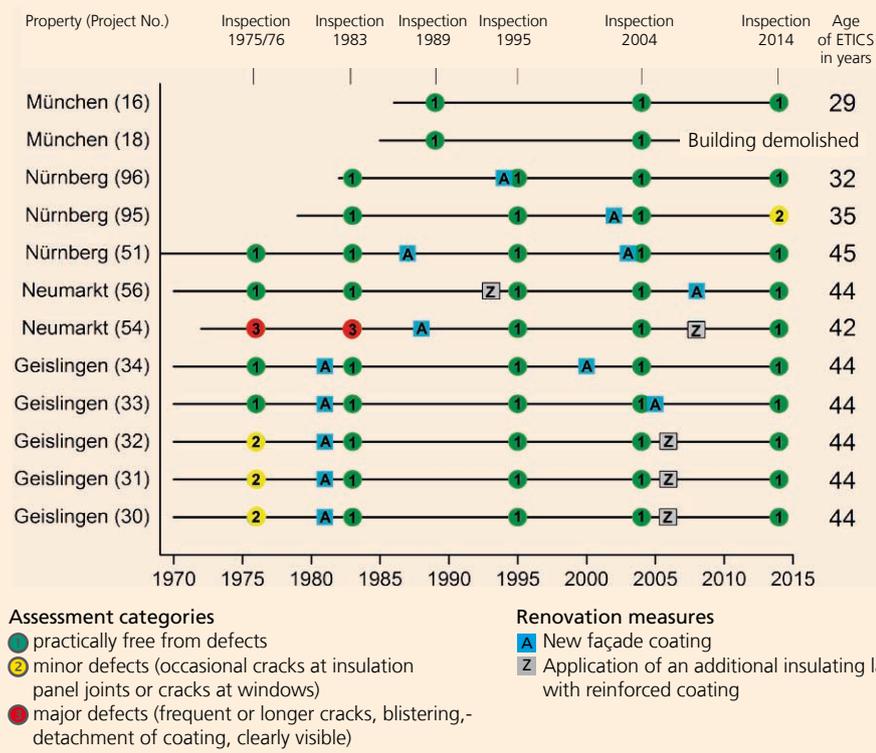
Diagram 1 Time schedule of application, on-site inspection and renovation of ETICS – including indication of the façade condition

The age of the examined ETIC systems ranges from 29 to 45 years. Within the last ten years, five buildings did not undergo any renovation. Four buildings were renovated by the installation of an additional insulation layer on their ETICS, but for no other reason than for energy retrofit. Two buildings were repainted. Following the 2014 on-site inspection, the condition of the façades of ten out of eleven buildings can be classified in category 1 “practically free from defects”. Only one façade, which had been repainted, is locally affected by minor or major defects (category 2).
