# **POMPEII SUSTAINABLE PRESERVATION PROJECT**

**Documentation of the funerary monuments  
14\_EN and 07\_ES**

**Christina Elsässer**

Munioch, February 25<sup>th</sup>, 2015

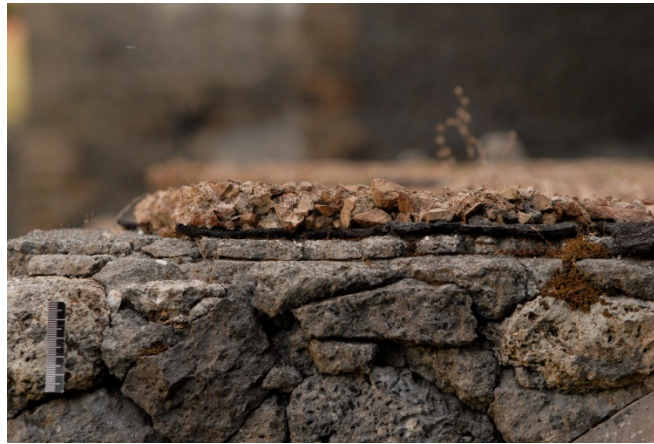
The reconstruction of masonry gives not only more stabilization to the ancient structure, but is also used to give some kind of water impermeability. On top of the reconstructed masonry, there are different layers of cement, bitumen and “cocciopesto” to give water impermeability (Figure 4). Even though the top of funerary monument was hardly visible, it supposed to have such kind of water impermeability. 14\_EN has also a rain drain visible at the north wall half up the reconstructed wall.

Figure 4: “modern waterproofing of original structure” at funerary monument 25\_OS. Visible are layers of cement over an reconstructed masonry. Over the cement a layer of bitum and on top “cocciopesto”.

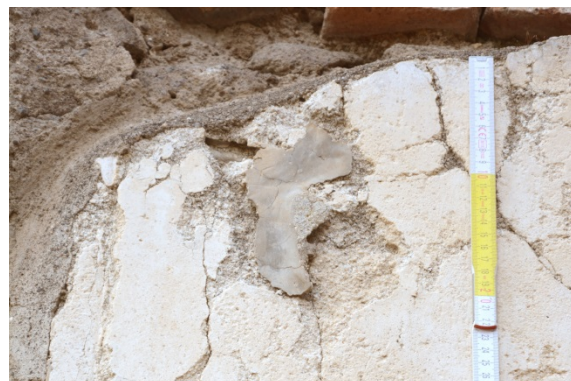
Two possible different filling materials could be observed at the walls. One, which seemed to be very hard but having a rather good connection to the original surfaces, and the other, which has a very smooth surface, a rather dark gray color and a bad connection to the original surface. The first described filling material is a hard mortar maybe containing cement (Figure 120 – Figure 121). The other described filling mortar could presumably contain plasticizer (Figure 120 – Figure 121). The filling mortar presumably containing plasticizer is very tense and the filling material itself has a lot of fine cracks. The connection to the original material is badly bonded and the filling material scales off. Therefore, most of these fillings have to be renewed.

Figure 6: fillings mortar contains presumably plasticizer.

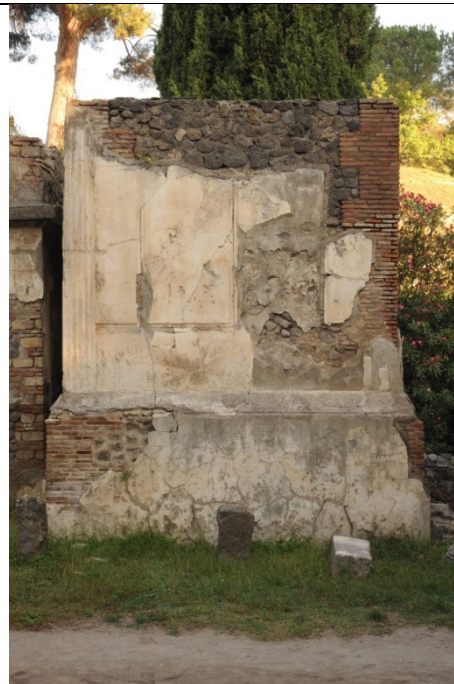
Figure 16: 14\_EN\_S October 2014.

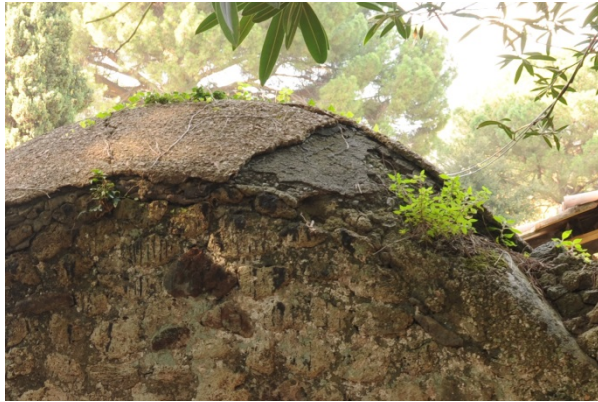
07\_ES has no protecting roof but a reconstructed roof. At the east corner of southern wall, original roofing is preserved. The water impermeability was gained by a layer of cement, bitumen and "cocciopesto" (Figure 28). At some parts, new "cocciopesto" layers are mounted over the original ones (Figure 29).

Figure 28: reconstructed roof with layers of cement, bitumen and “cocciopesto”.

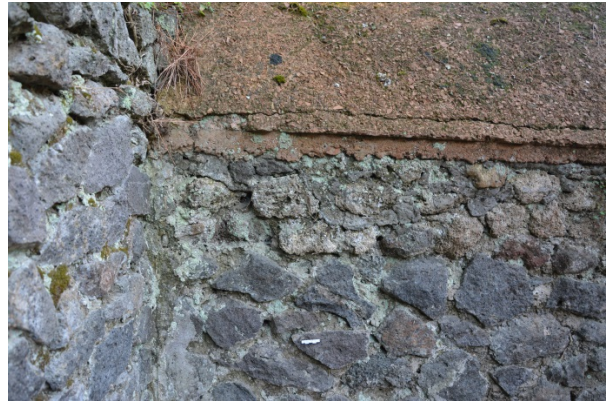
Figure 29: Fragments of original “cocciopesto” layers under a mounted reconstruction of “cocciopesto” roofing.

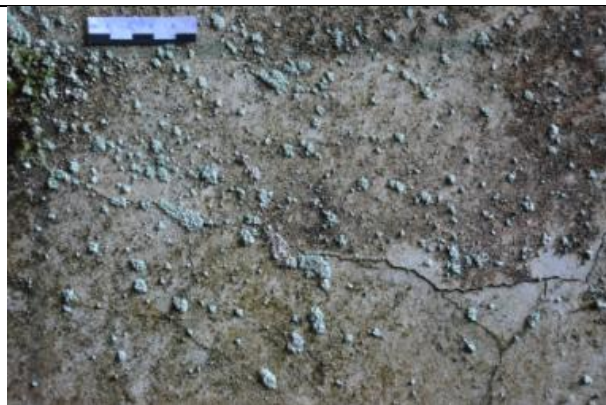
Figure 32: white turquoise lichens (picture number: 07\_ES\_W\_I\_BO\_DSC\_3147).

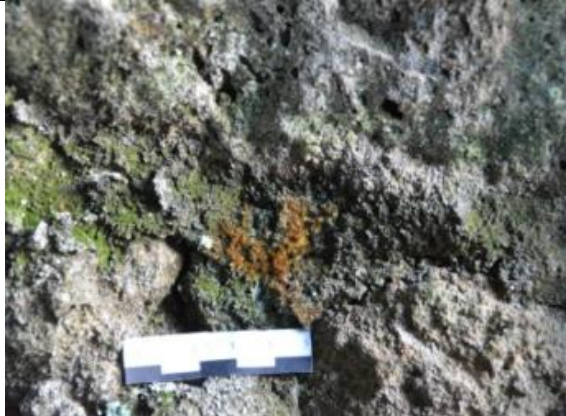
Figure 36: reddish brown moss (picture number: 07\_ES\_W\_I\_BO\_DSC\_3153).

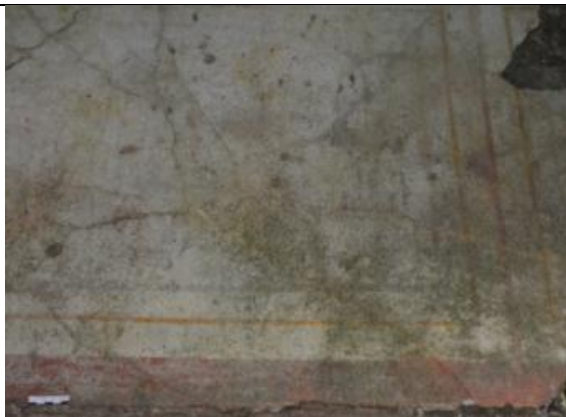
Figure 38: green-brown algae (picture number: 07\_ES\_W\_I\_BO\_DSC\_3155).

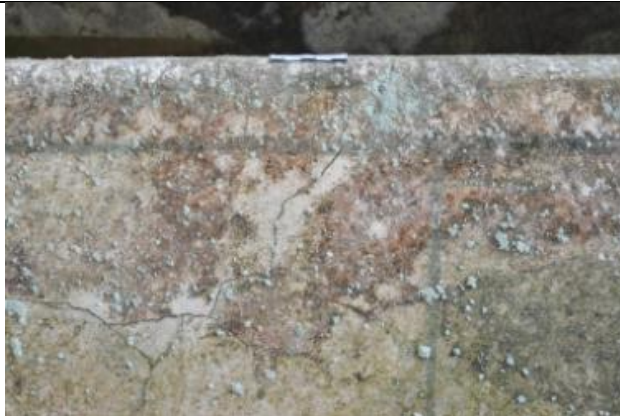
Figure 40: red-brown algae (picture number: 07\_ES\_W\_I\_BO\_DSC\_3158).

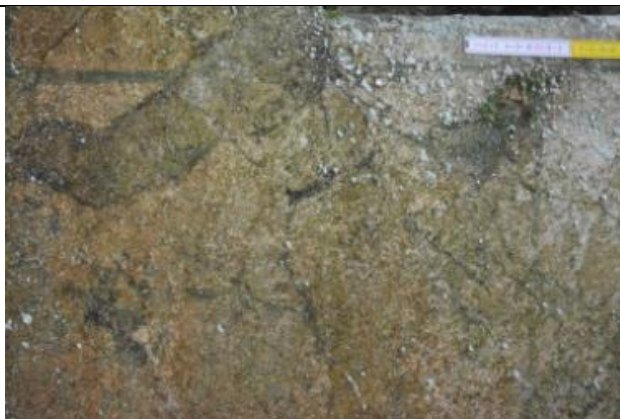
Grave overgrowth of green and red algae? at the south west corner of the western wall up to a height of 1,6 m. Developing clusters in cracks and gaps of plaster (could be as well something else?).

Figure 42: green and red algae (picture number: 07\_ES\_W\_I\_BO\_DSC\_3159).

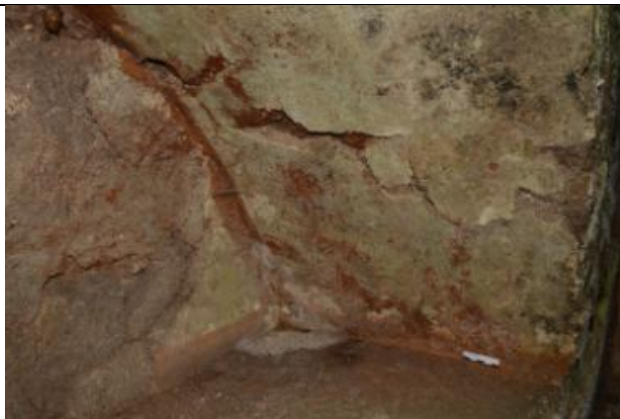
Figure 45: algae/moss/bacteria??? (picture number: 07\_ES\_W\_I\_BO\_DSC\_3166).

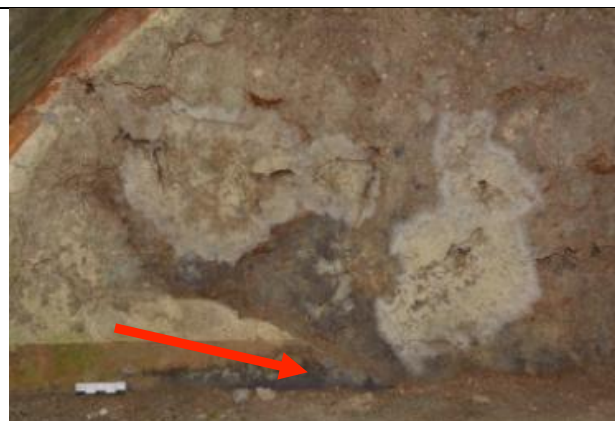
Apparently a mould formation, which has the color grey up to black. It is found on the lower edge of the niche and it grows laminar on plaster and masonry.

Figure 49: black fungi (picture number: 07\_ES\_W\_I\_BO\_DSC\_3168).

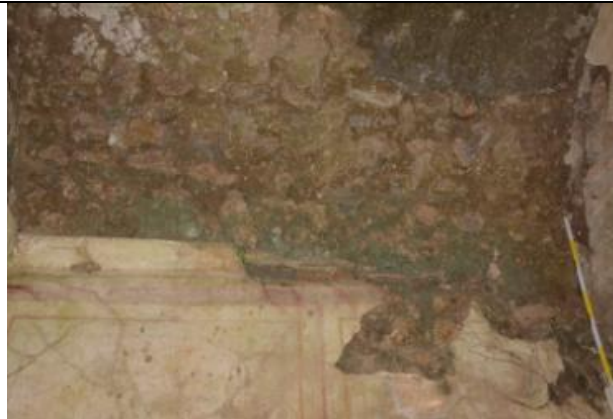
Figure 51: turquoise fungi (picture number: 07\_ES\_W\_I\_BO\_DSC\_3174).

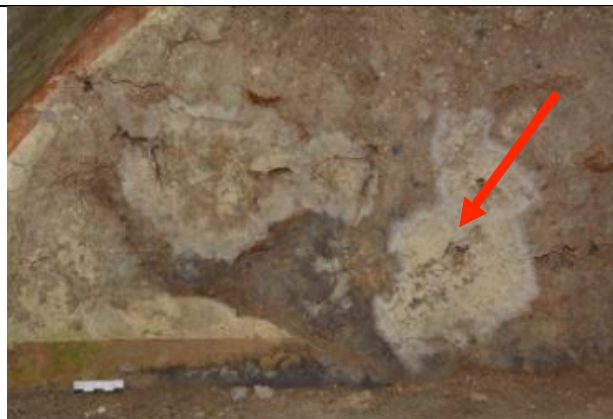
Figure 53: 07\_ES\_W\_I\_BO\_DSC\_3168

two oval shaped spots of the size of ca. 15 x 25 cm, located at the niche back wall, which could be mould (07\_ES\_W\_I\_BO\_DSC\_3168). To be found as well at the north west corner of the niche (07\_ES\_W\_I\_BO\_DSC\_3169). The appearance is like a fluffy cluster with a well-defined shape.

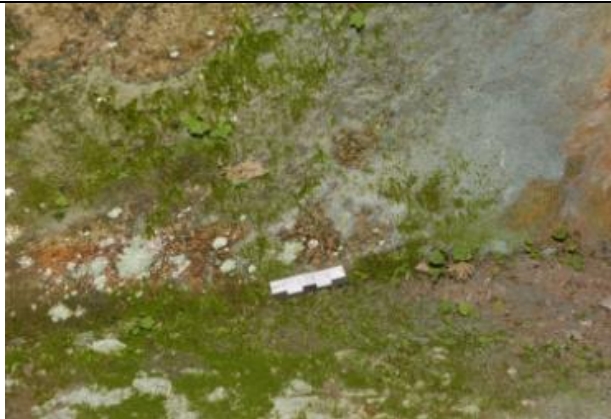
Figure 55: 07\_ES\_W\_I\_BO\_DSC\_3171

Growing of Plants in the niche, especially in the south west corner of the niche (sunlight). It is growing on the horizontal bottom of the niche as well at the vertical vault. It reaches a height up to 4 cm.

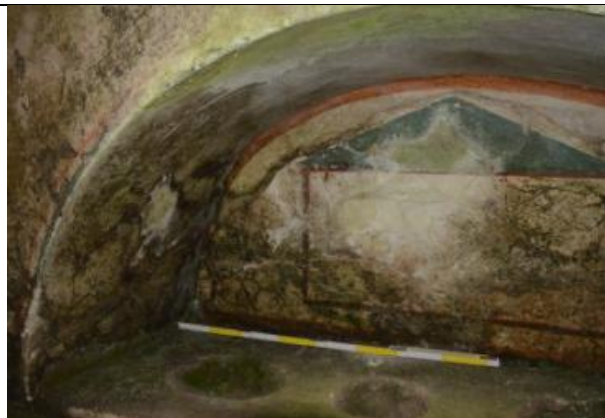
Figure 66: 07\_ES\_S\_I\_BO\_DSC\_3194

- green, brown laminar algae
- building dark clusters at gaps and cracks
- south-east corner at the dado (07\_ES\_S\_I\_BO\_DSC\_3193)
- south-east corner at the niche (07\_ES\_S\_I\_BO\_DSC\_3194)
- south-west corner at the niche (07\_ES\_S\_I\_BO\_DSC\_3195)

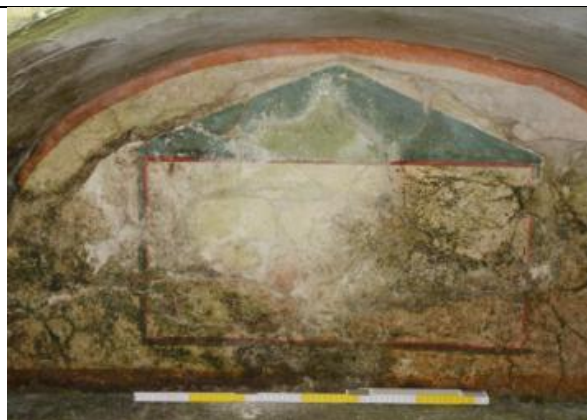
Figure 70: 07\_ES\_S\_I\_BO\_DSC\_3209

- selective white mould, round shaped
- centered at the lower edge of the niche (07\_ES\_S\_I\_BO\_DSC\_3208)
- centered at the back wall of the niche (07\_ES\_S\_I\_BO\_DSC\_3209)
- eastern part of the niche, vault and bottom (07\_ES\_S\_I\_BO\_DSC\_3210)
- centered over above the niche (07\_ES\_S\_I\_BO\_DSC\_3211)

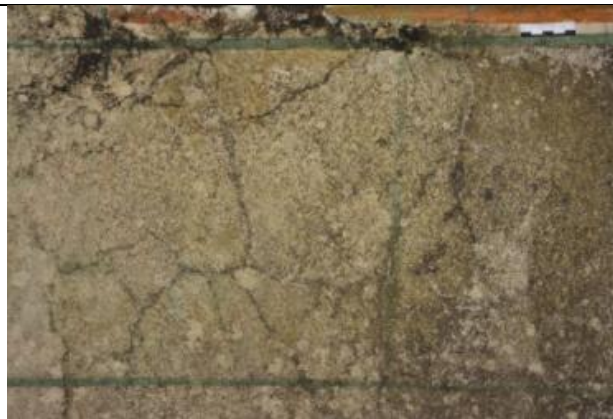
Figure 71: 07\_ES\_E\_I\_BO\_DSC\_3221

- greenish brown algae, growing laminar
- all over the dado up to a height of 1,6 m
- building dark clusters in gaps and cracks
- growing on plaster and masonry

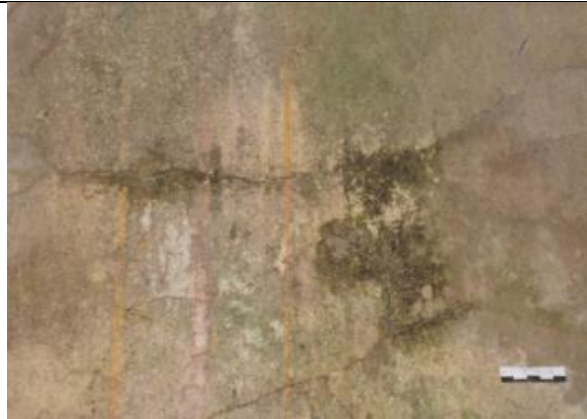
Figure 91: 07\_ES\_E\_I\_BO\_DSC\_3254

- green, black Algae
- grows in cluster along plaster losses and cracks
- centered underneath the hole in the vault, size 20 - 15 cm

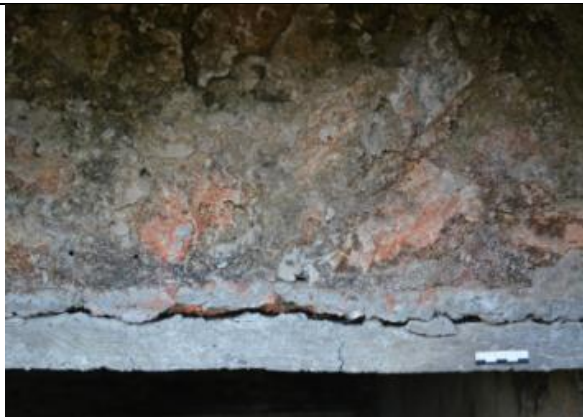
Figure 109: 07\_ES\_N\_BO\_DSC\_3285

- flamy red infestation, maybe kind of corrosion (minium?/core iron)
- growing in the crack of the beam and over the masonry above the beam at the entrance (needing much light?)

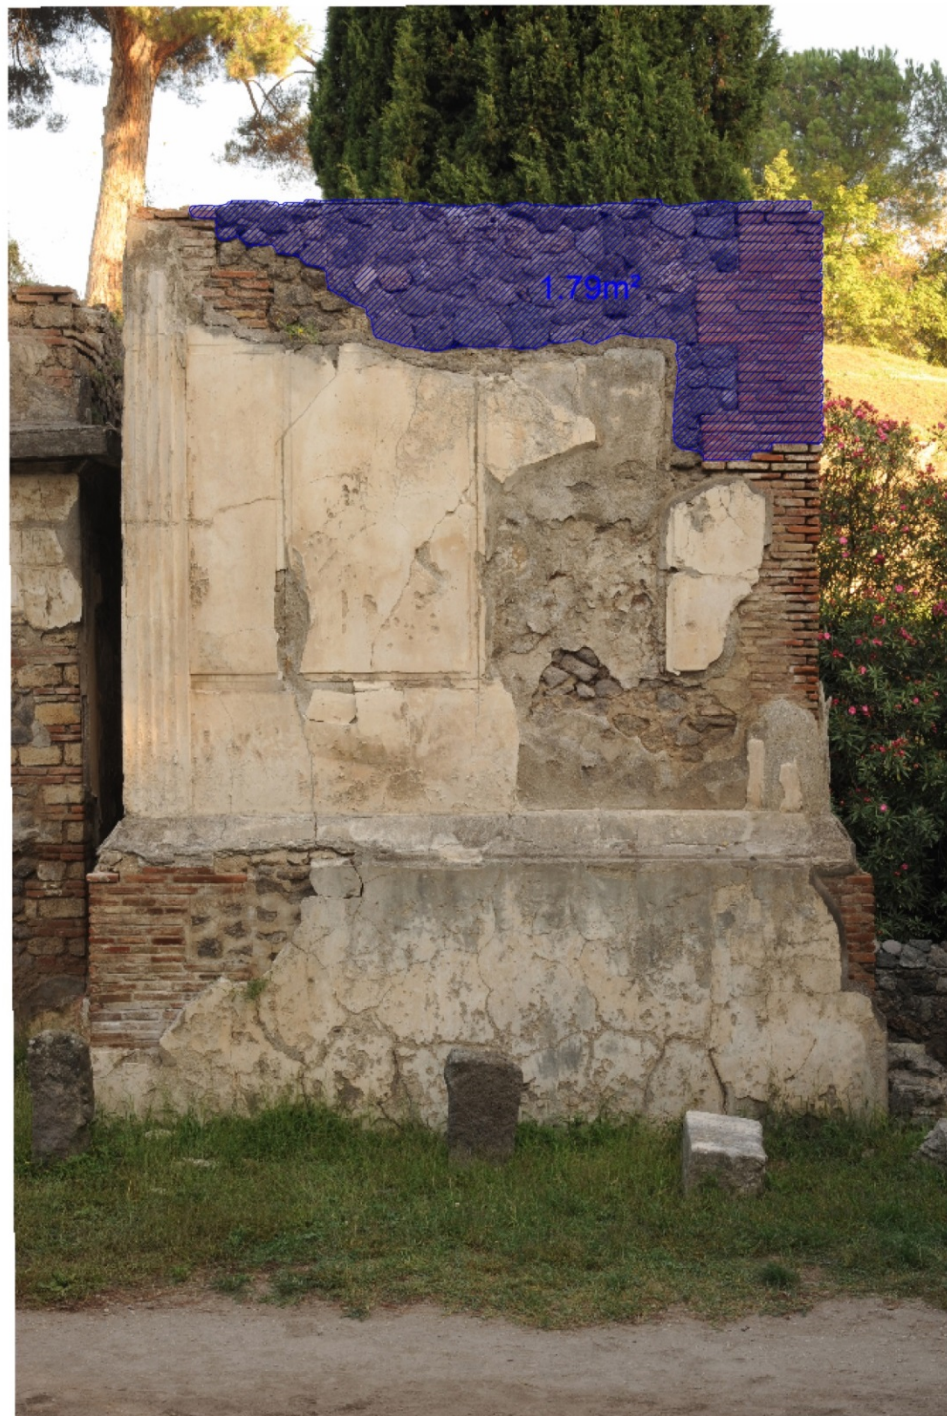
Figure 116: map of reconstruction of 14\_EN\_S.

Maps Figure 116 – Figure 119 show the amount of reconstruction, which is in average 13,5 % percent of the total amount (Table 2).

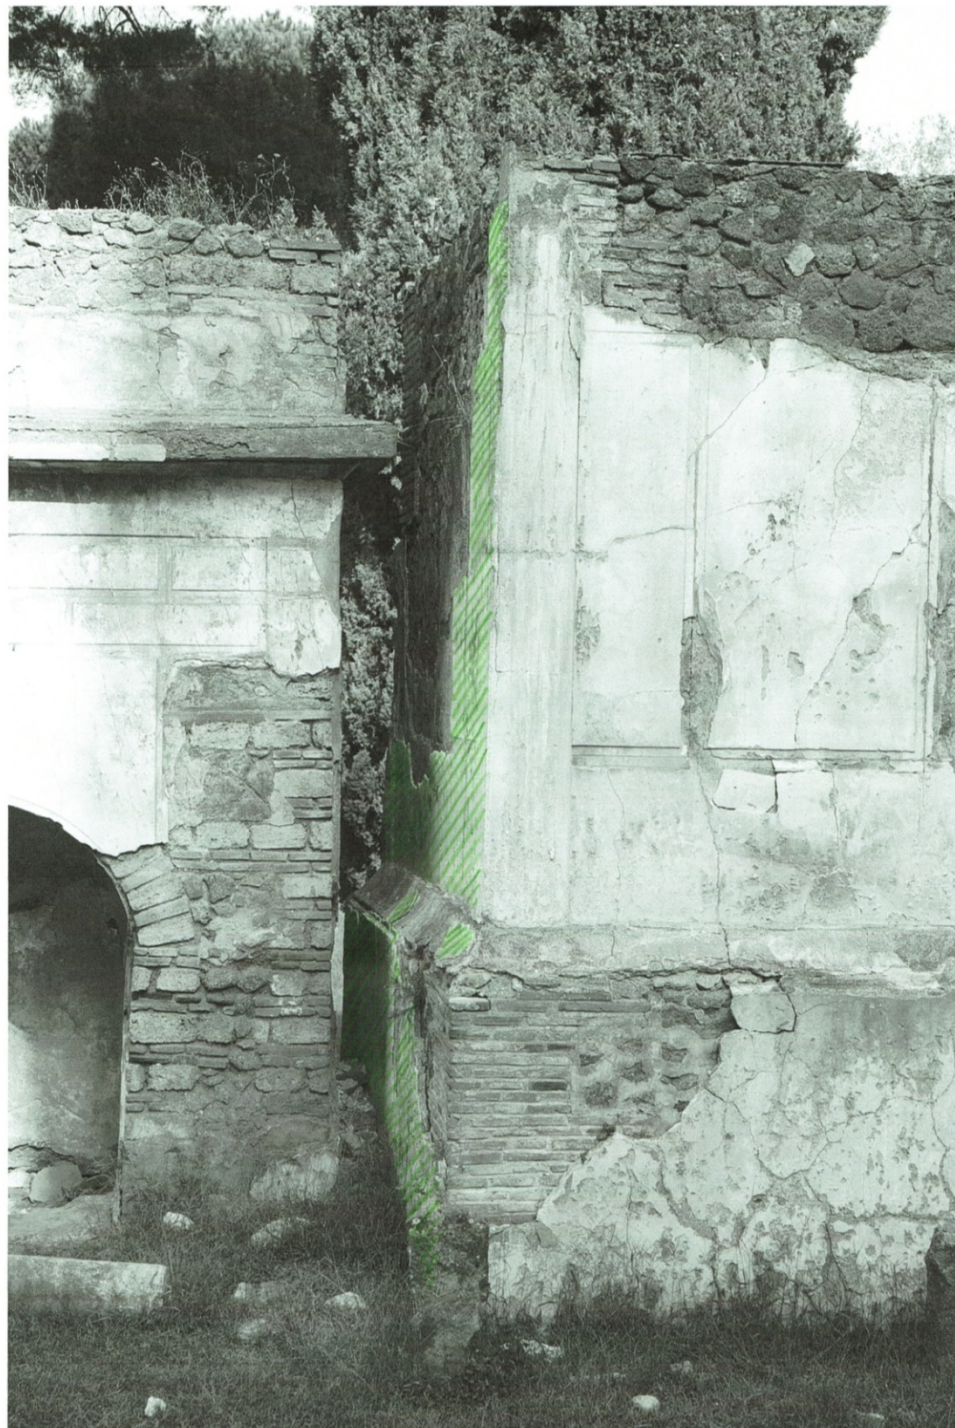
Figure 131 map 14\_EN\_W delamination (detachment) Intonaco from preparatory layers.

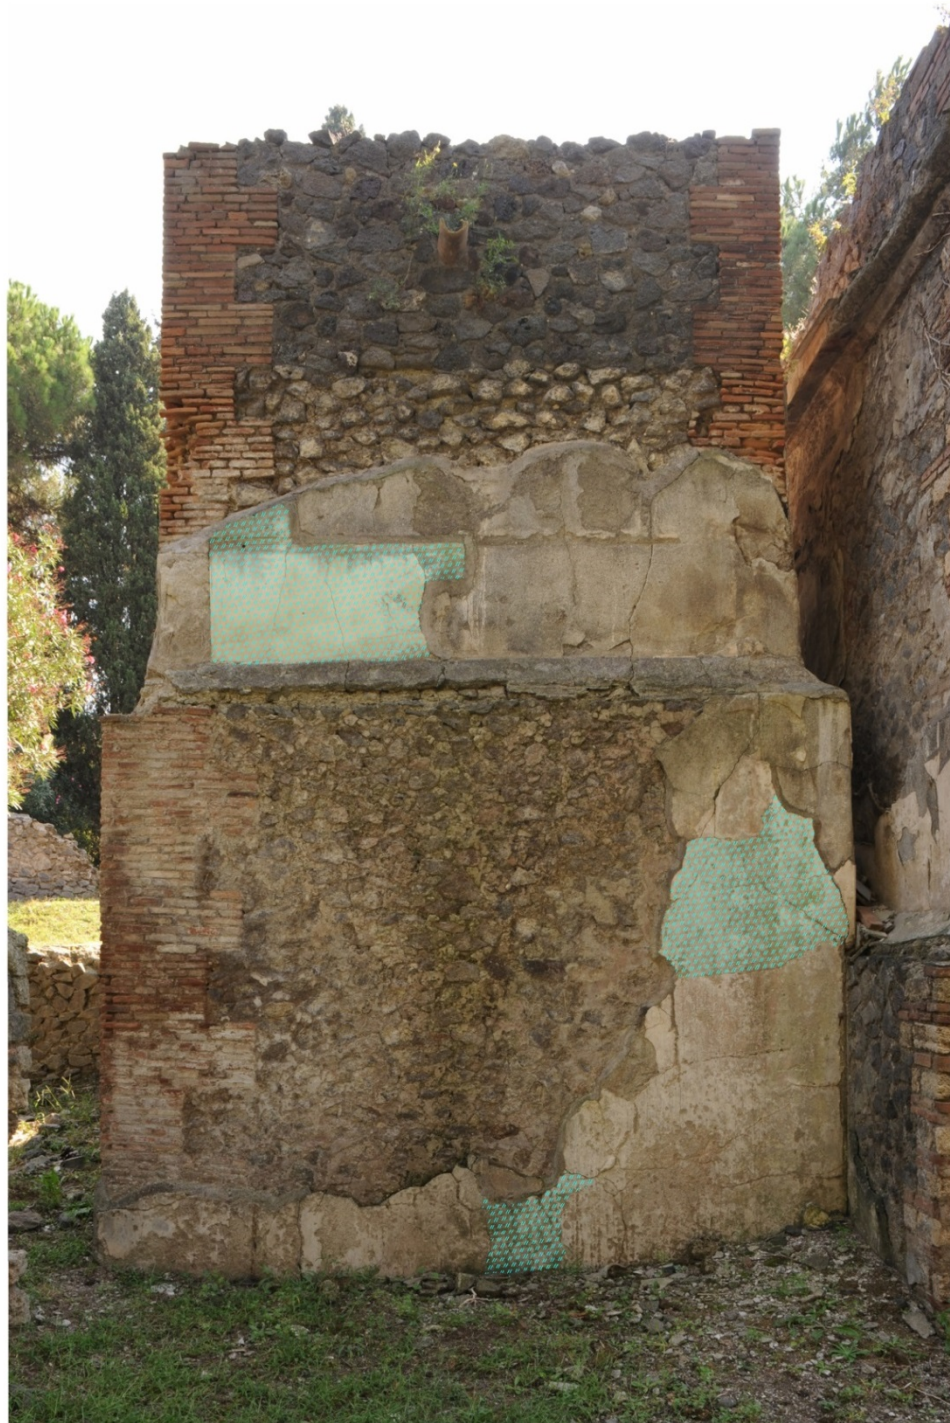
Figure 132: map 14\_EN\_N delamination (detachment) Intonaco from preparatory layers.

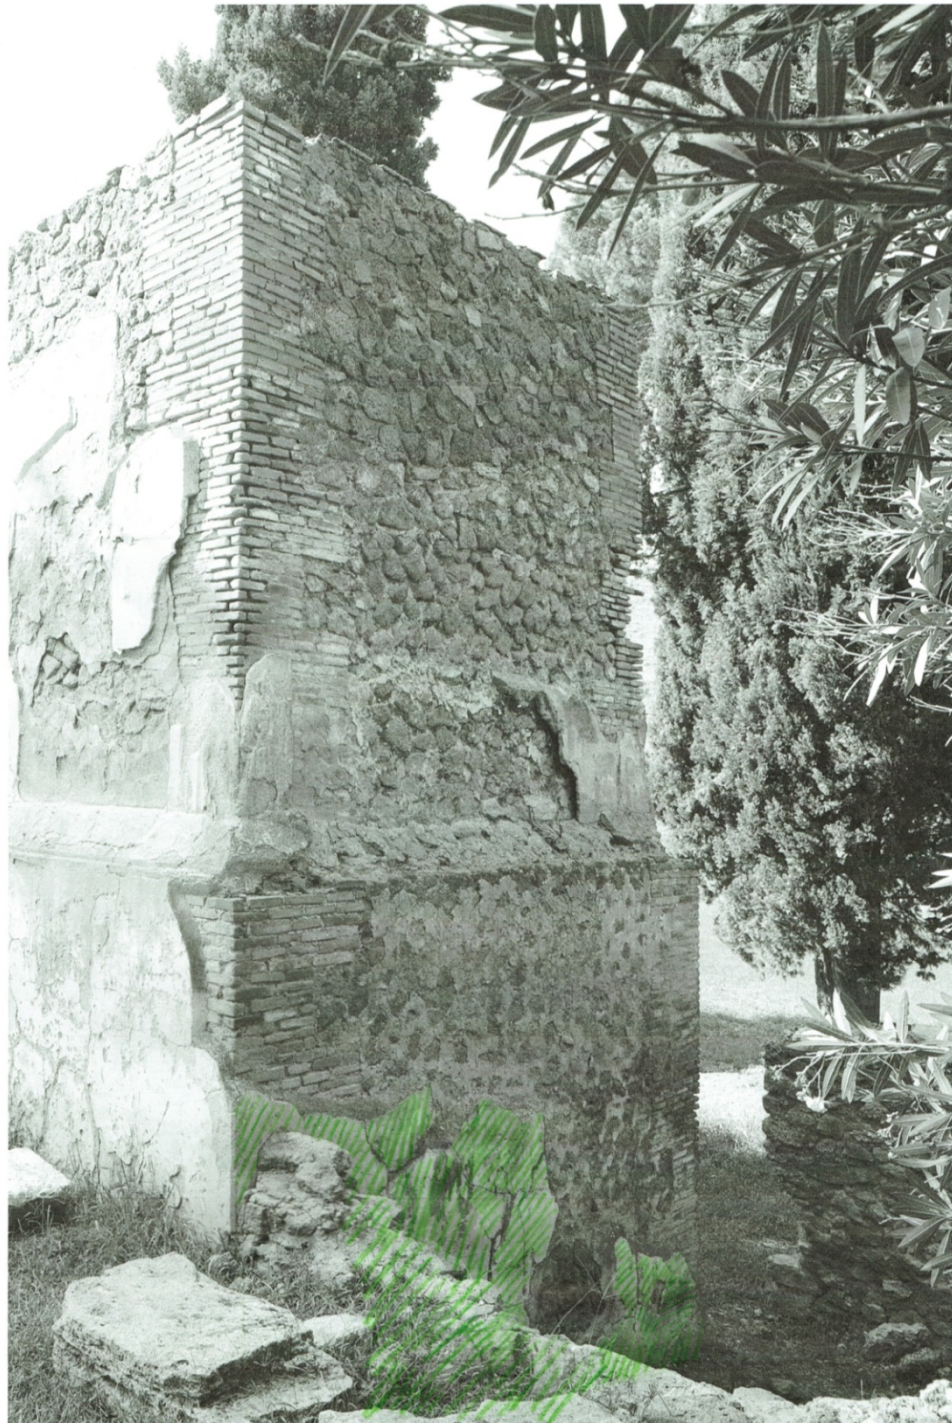
Figure 133: map 14\_EN\_E delamination (detachment) Intonaco from preparatory layers.

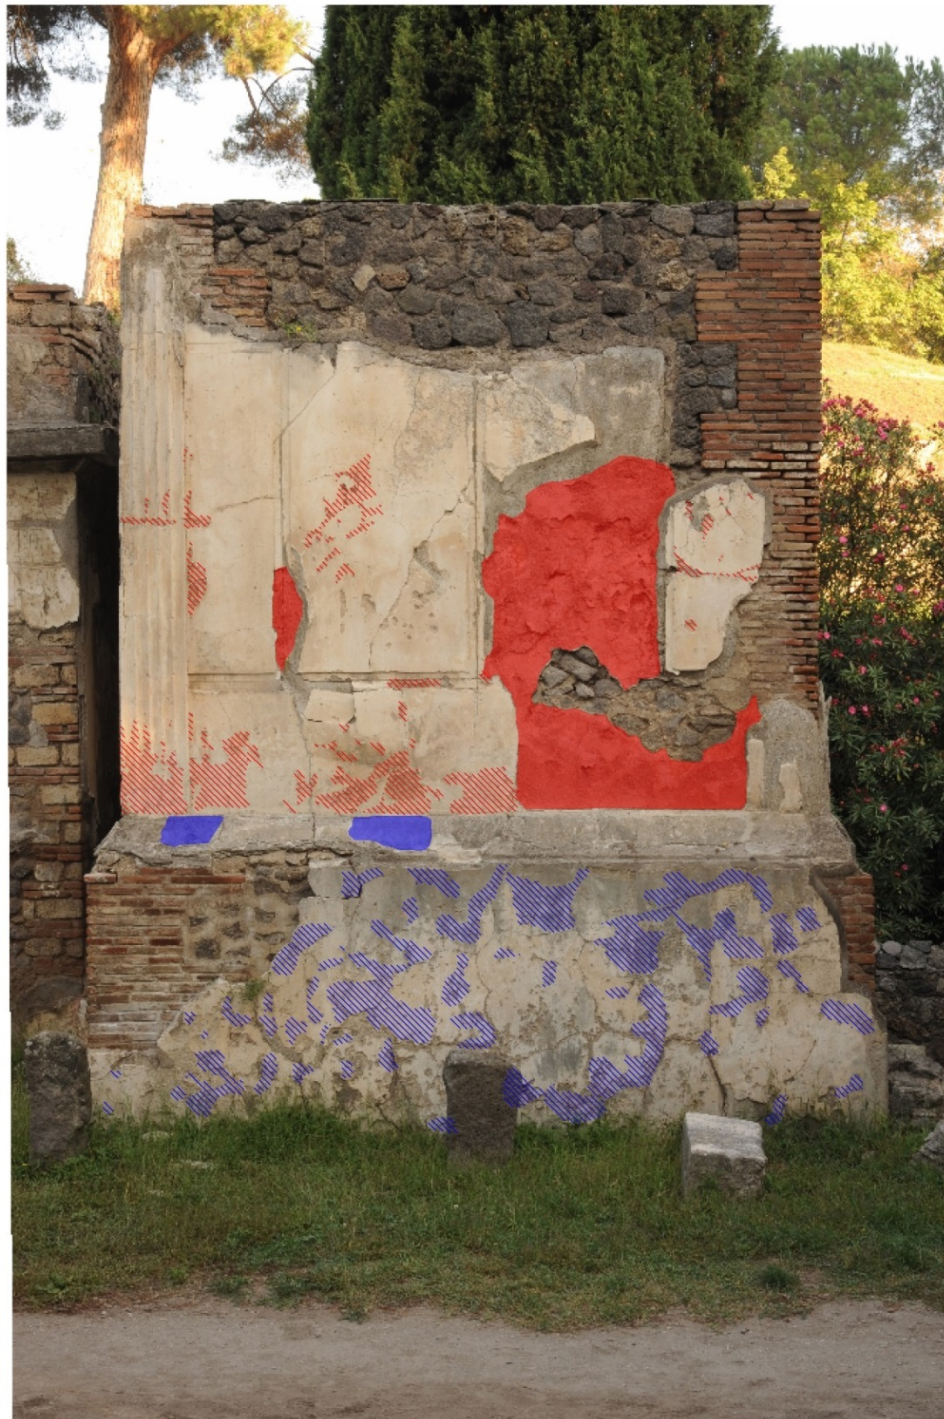
Figure 134: map 14\_EN\_S preparatory layers scaling, Intonaco scaling, preparatory layers flaking and Intonaco flaking.

Flaking and scaling layers (Figure 134 – Figure 137) should be consolidated by e.g. microinjections (e.g. hydraulic mortar) and micro-fillings (e.g. very fine lime/sand mortar). Powdering layers should be consolidated (e.g. brushing and spraying).

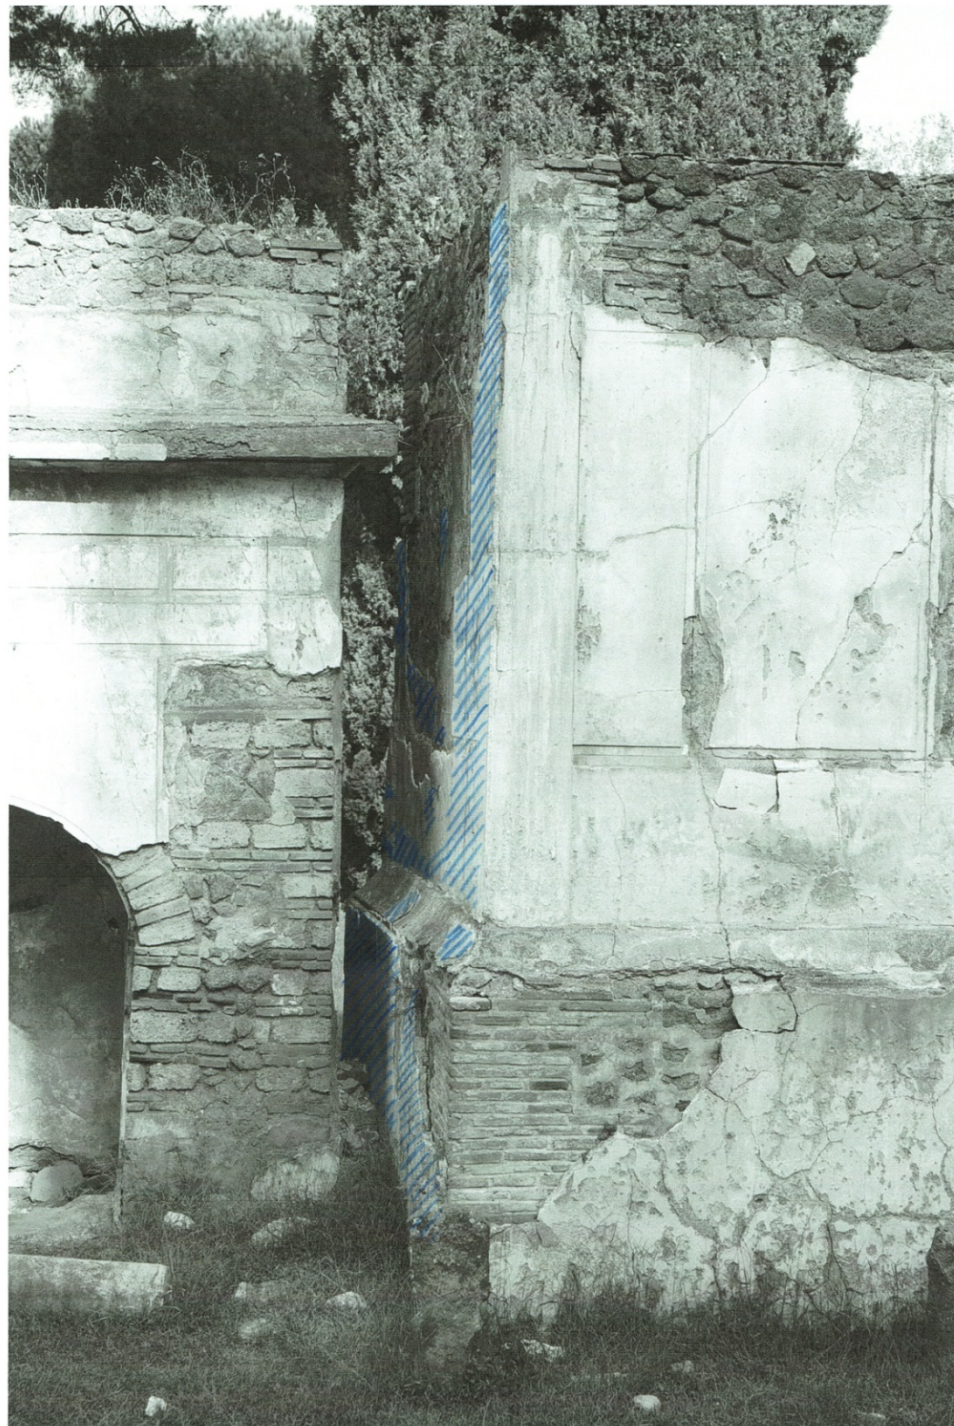
Figure 135: map 14\_EN\_W scaling and flaking of plaster.

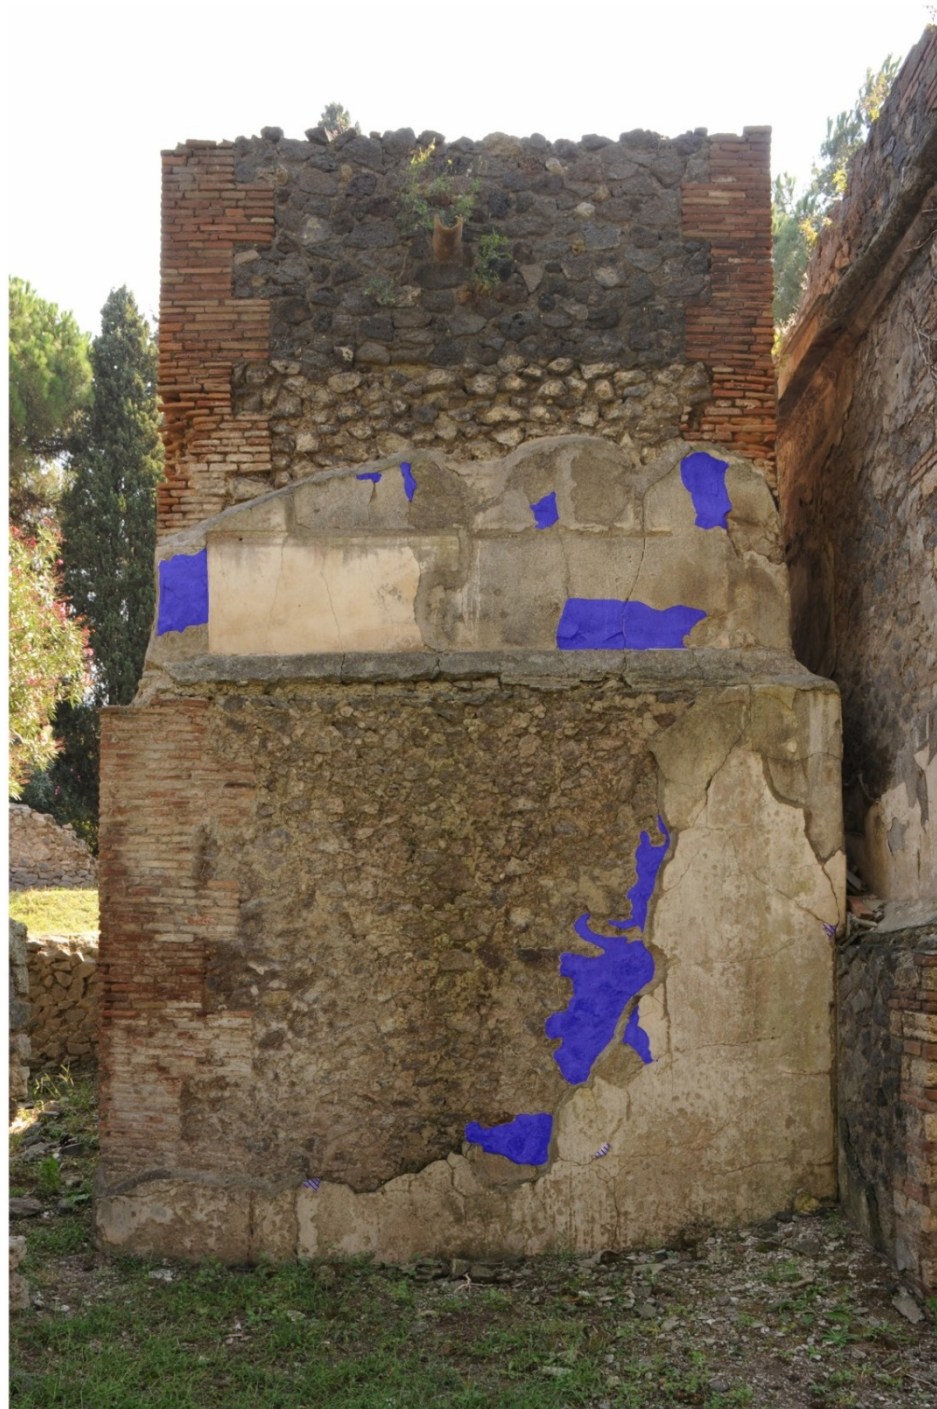
Figure 136: map 14\_EN\_N preparatory layers scaling, Intonaco scaling, preparatory layers flaking and Intonaco flaking.

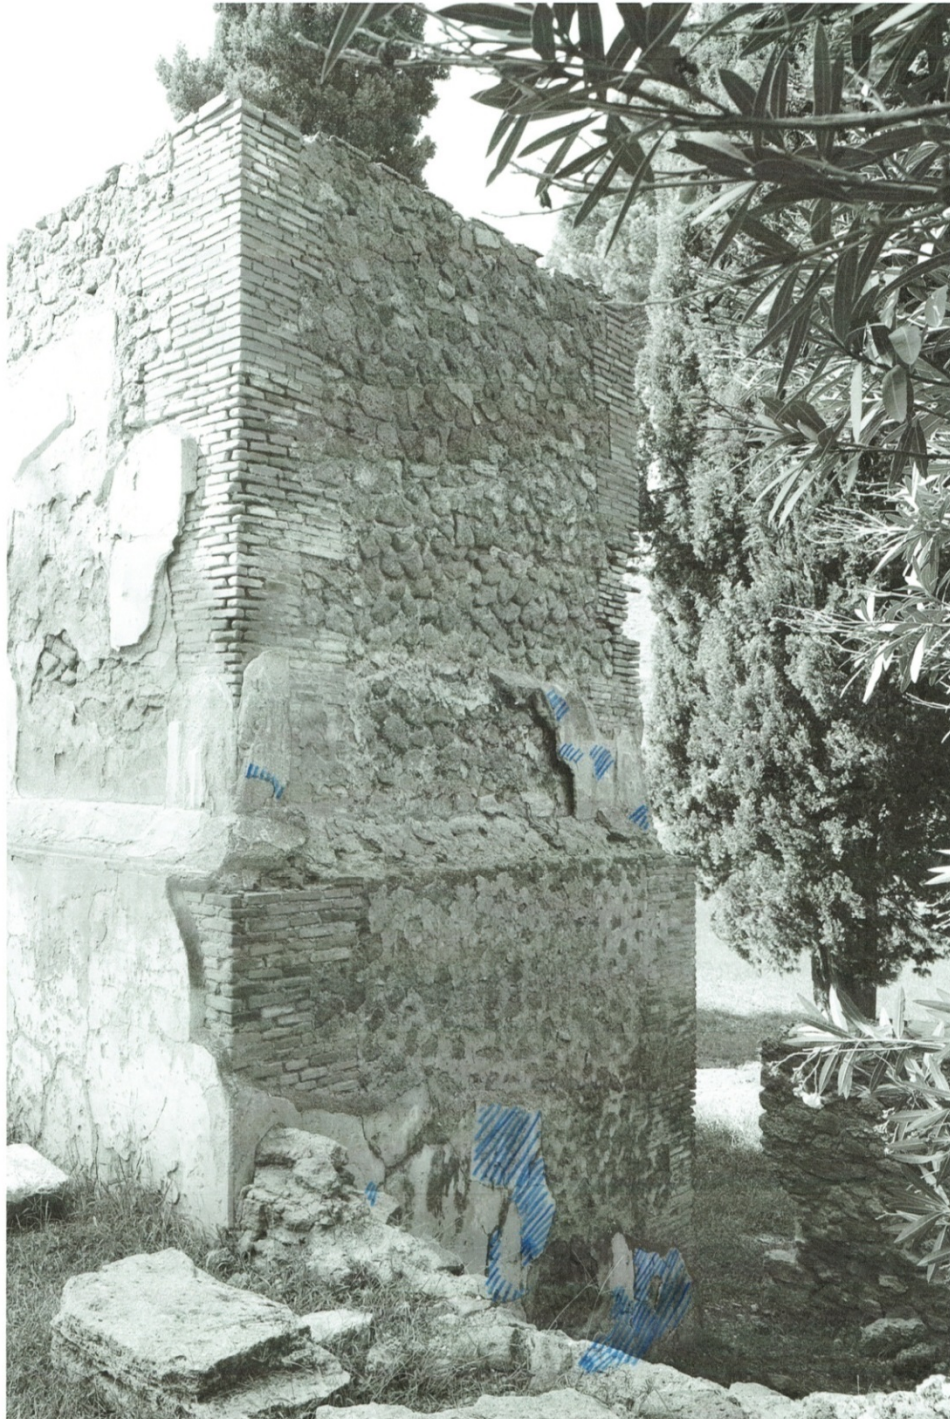
Figure 137: map 14\_EN\_E scaling and flaking of plaster.

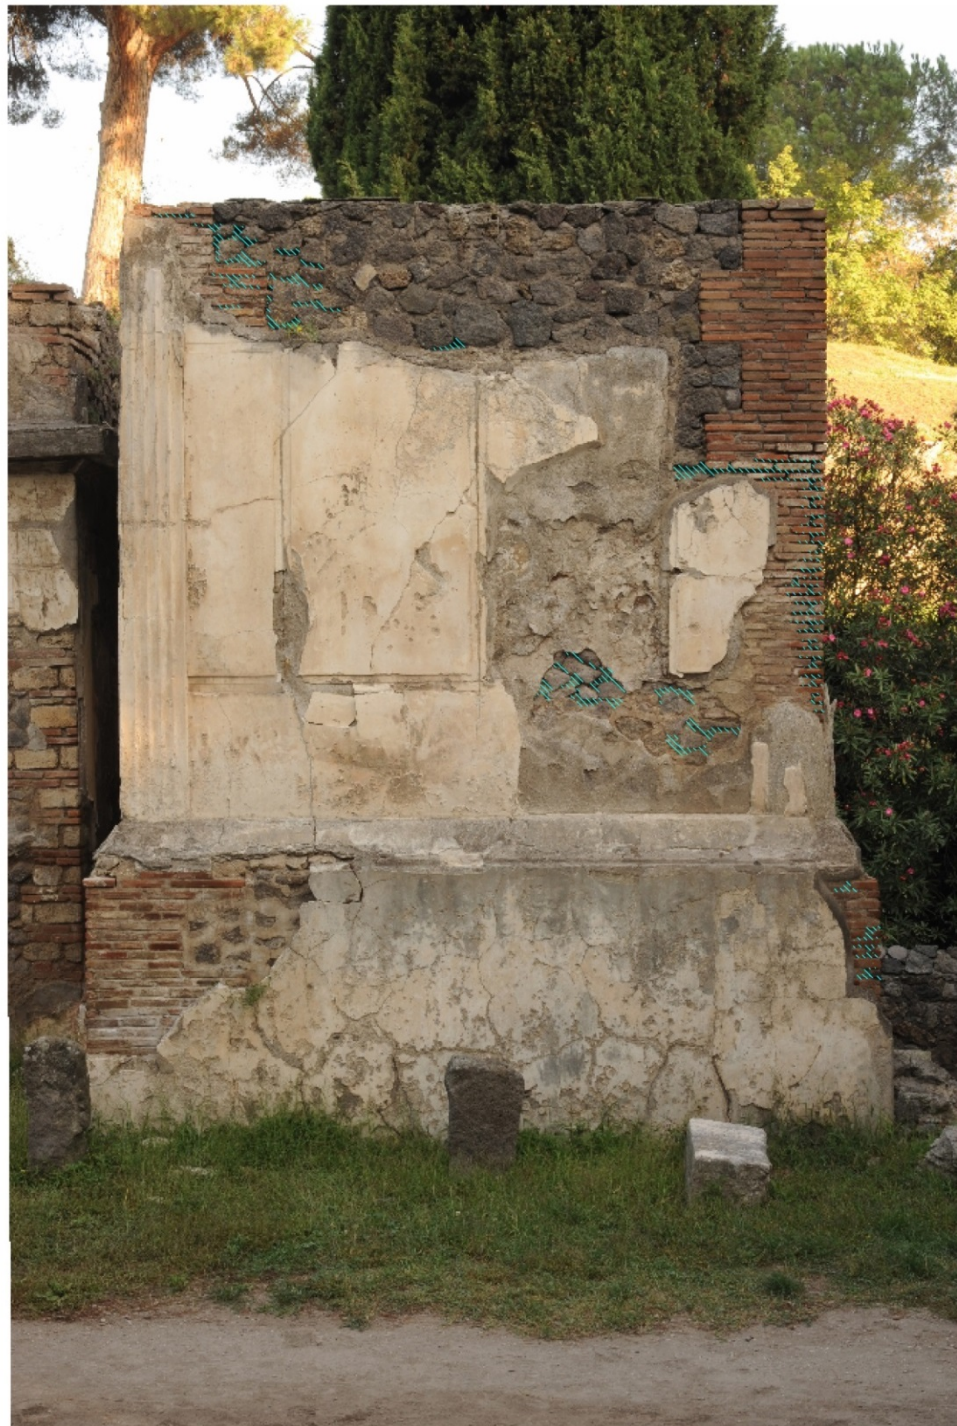
Figure 138: Map 14\_EN\_S of missing mortar.

Missing mortar (Figure 138 – Figure 141) between the bricks and lava should be refilled (e.g. with lime/sand mortar). The estimated amount is listed at Table 4.

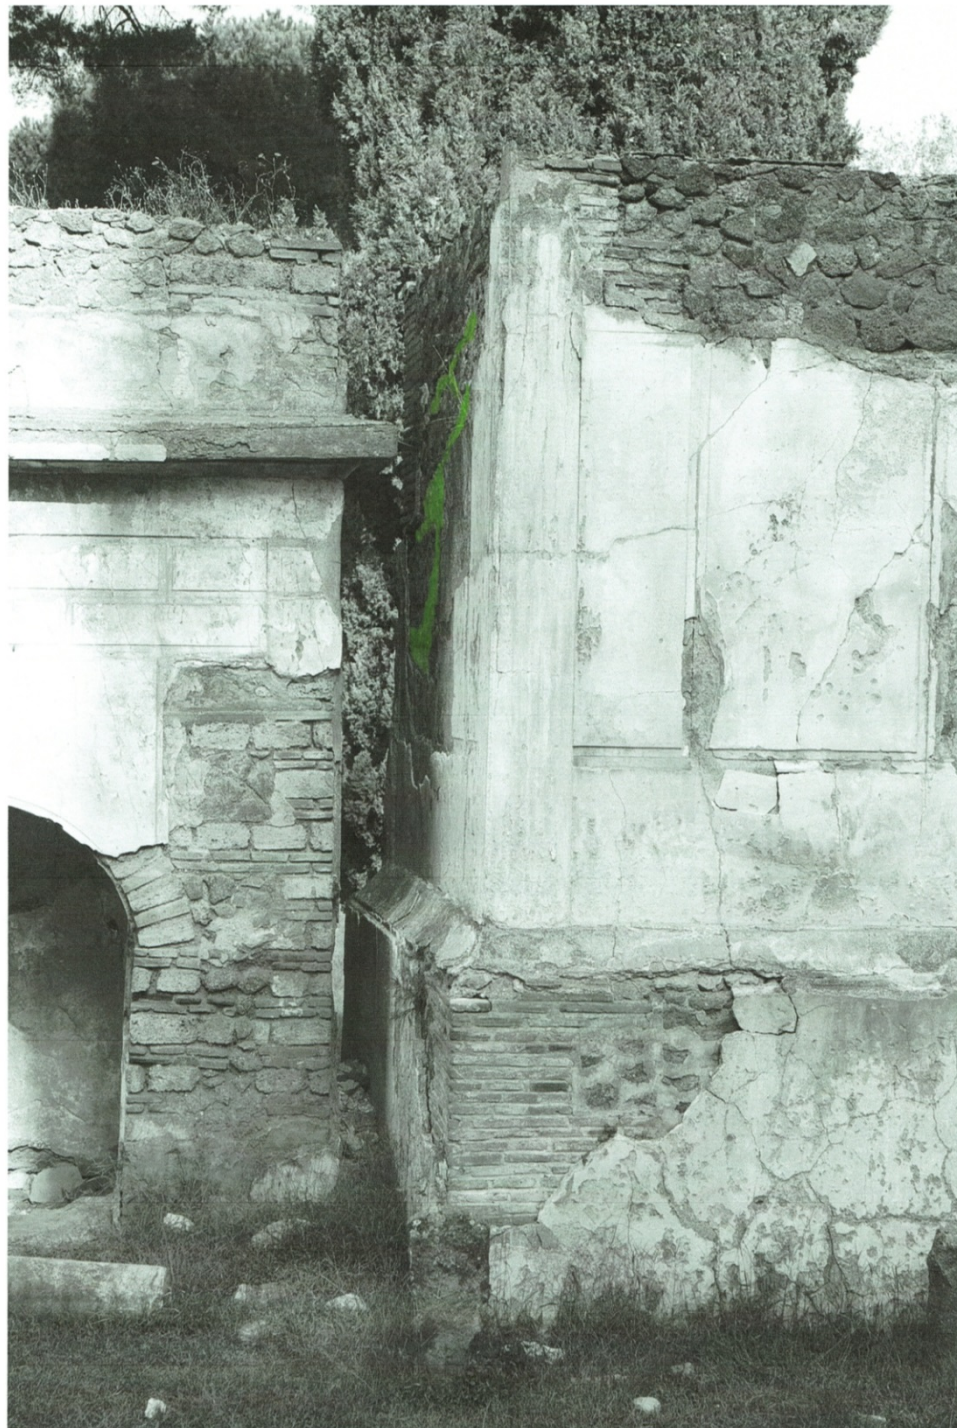
Figure 143: map 14\_EN\_W of powdering and presumably powdering mortar.

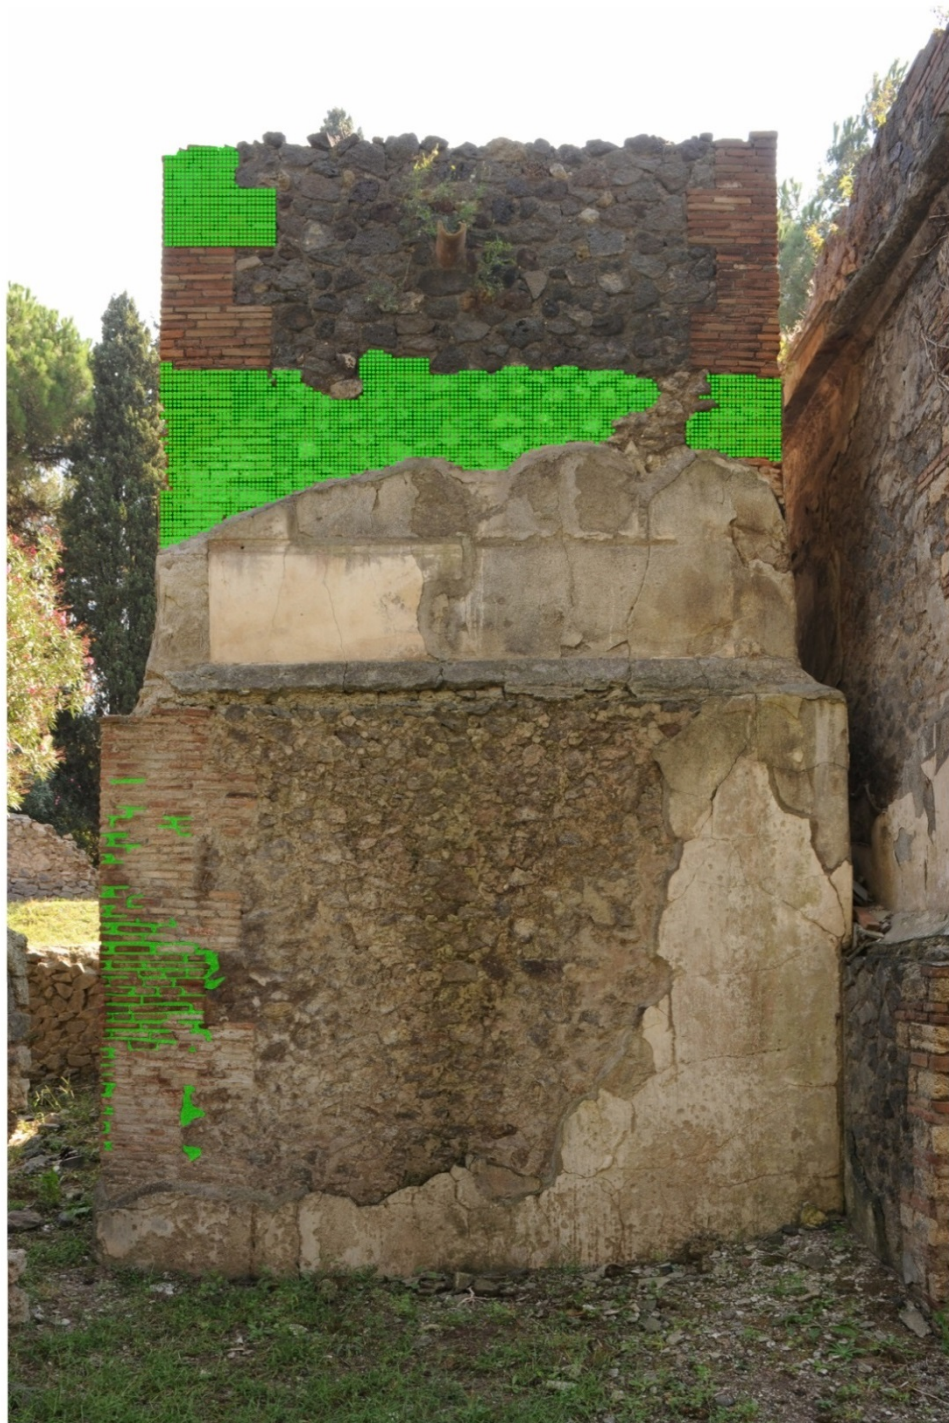
Figure 144: map 14\_EN\_N of powdering and presumably powdering mortar.

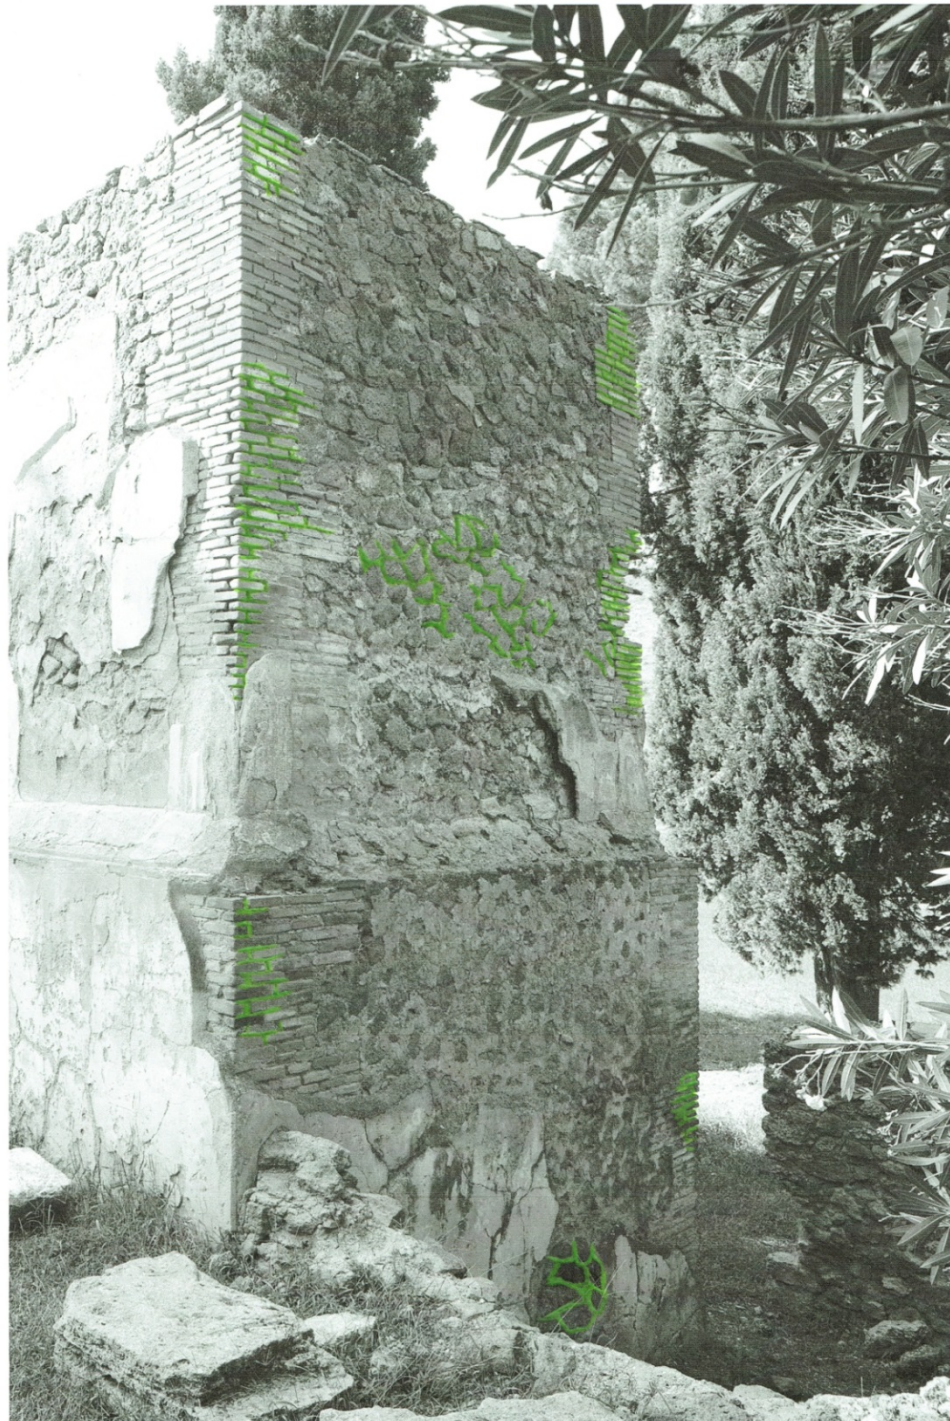
Figure 145: map 14\_EN\_E of powdering and presumably powdering mortar.
