# **POMPEII SUSTAINABLE PRESERVATION PROJECT**

**Documentation of the funerary monuments  
14\_EN and 07\_ES**

**Christina Elsässer**

Munioch, February 25<sup>th</sup>, 2015

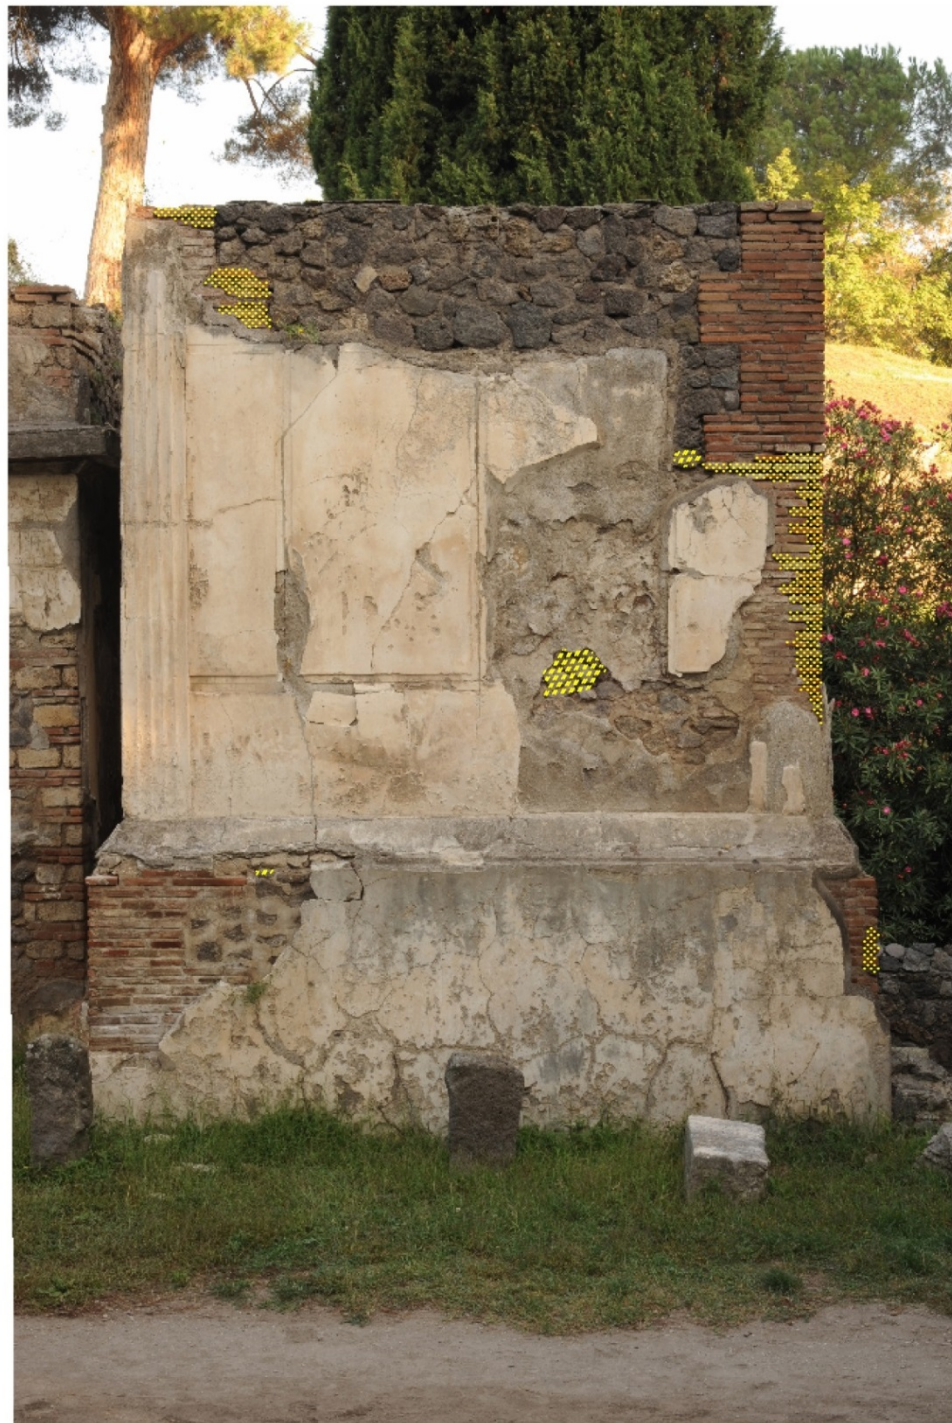
Figure 146: map 14\_EN\_S of eroded (round flushed out) brick and lava.

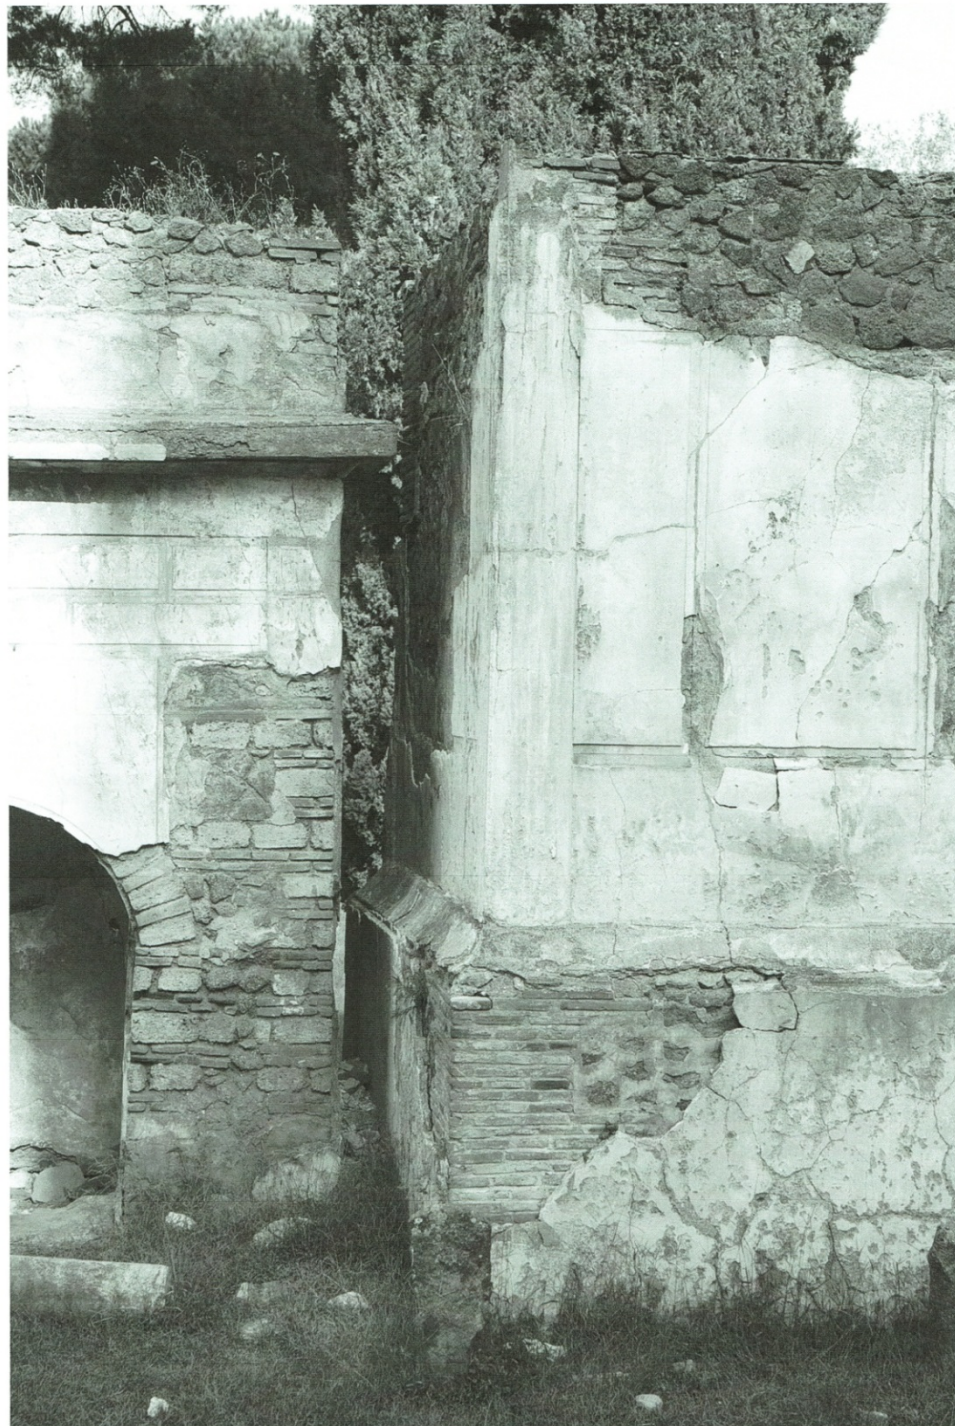
Figure 147: map 14\_EN\_W of eroded (round flushed out) brick and lava.

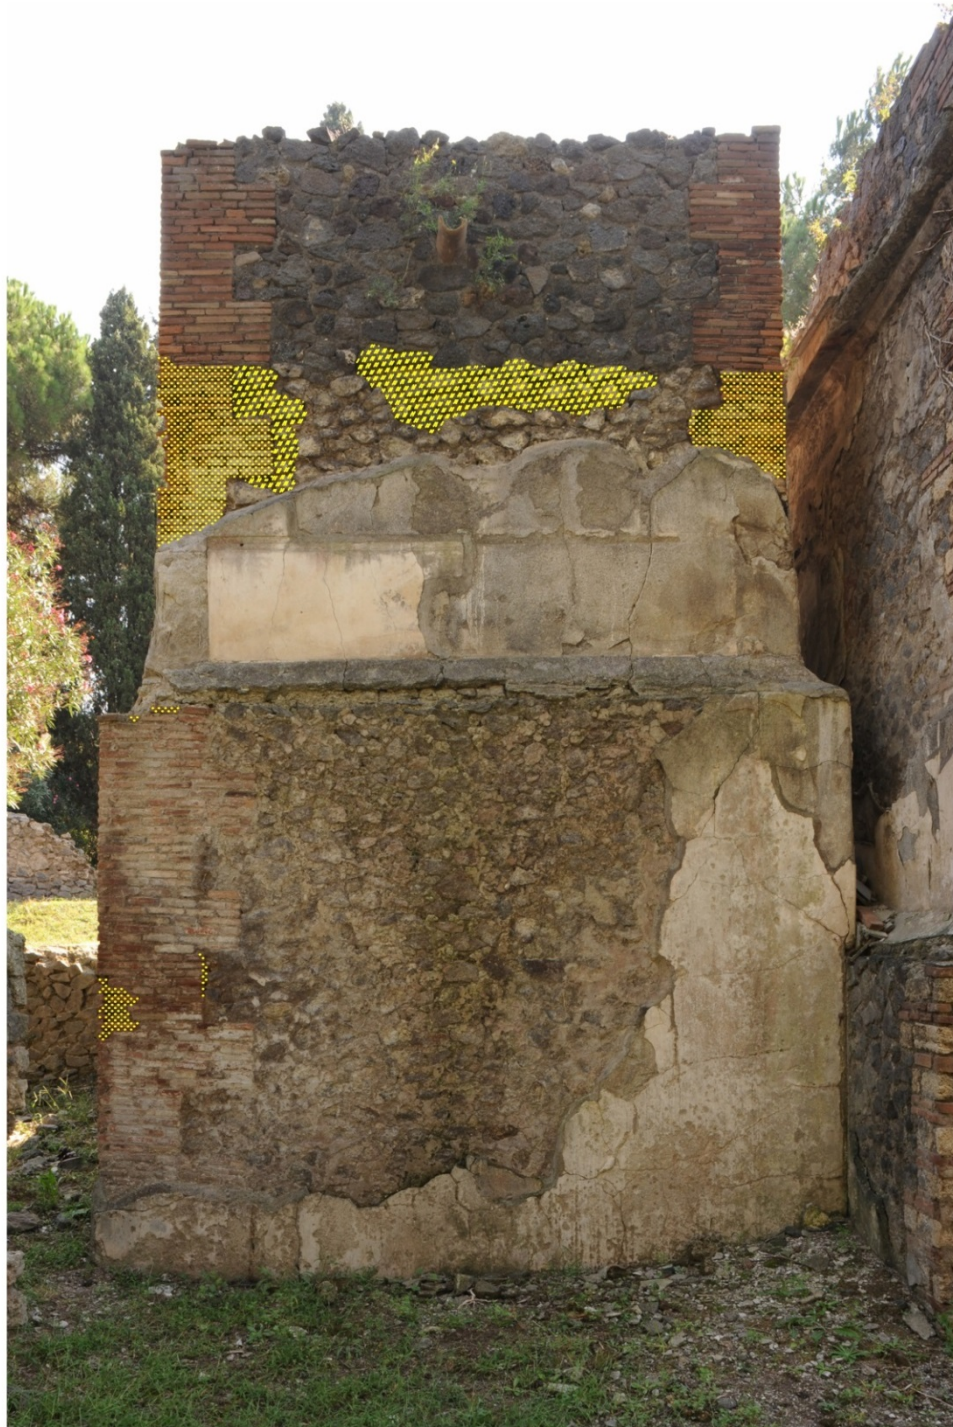
Figure 148: map 14\_EN\_N of eroded (round flushed out) brick and lava.

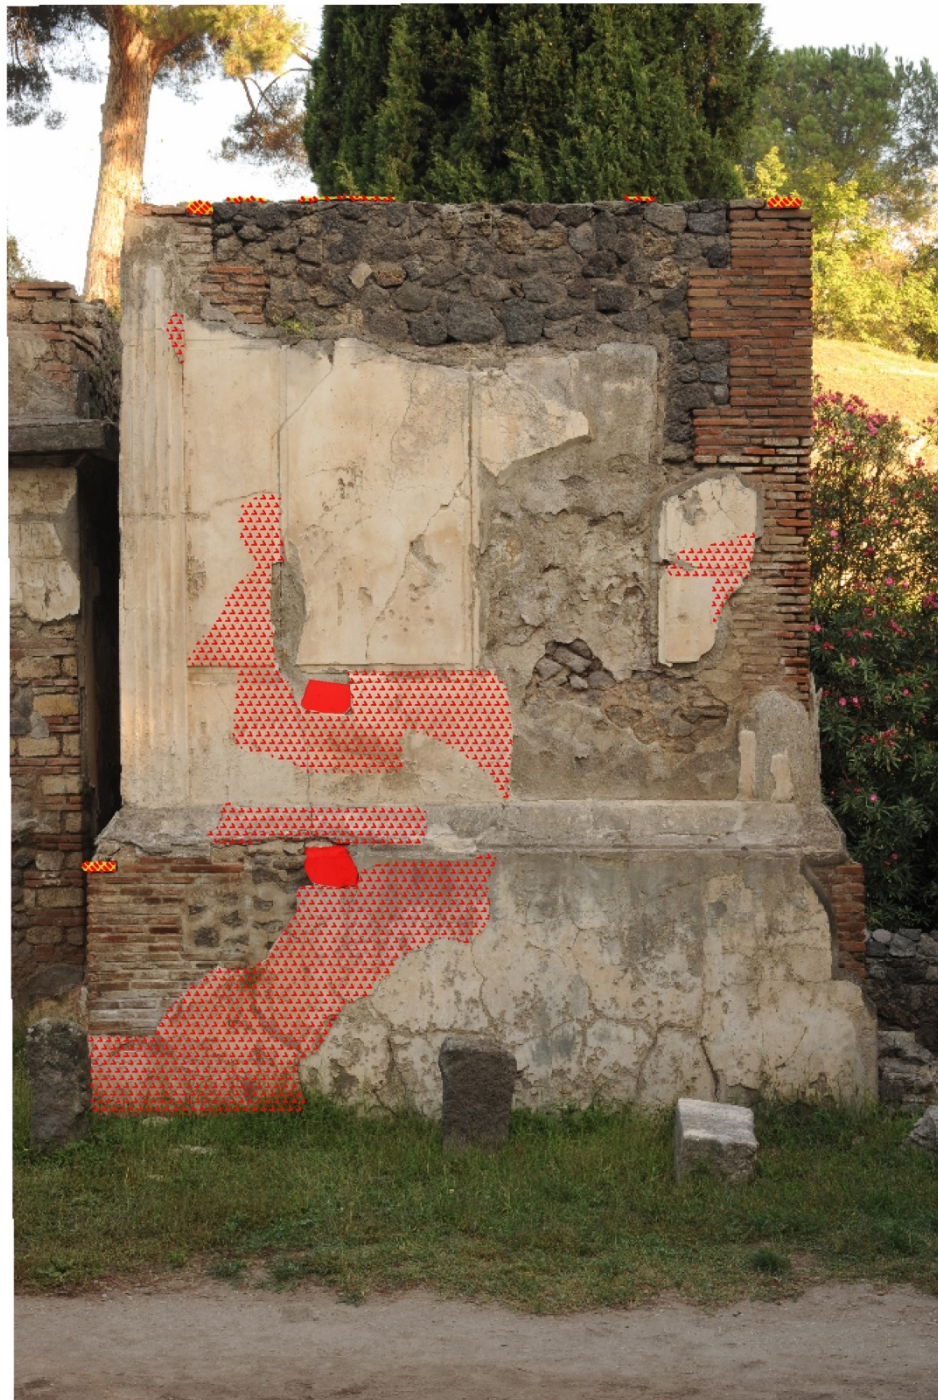
Figure 150: map 14\_EN\_S of collapsing areas.

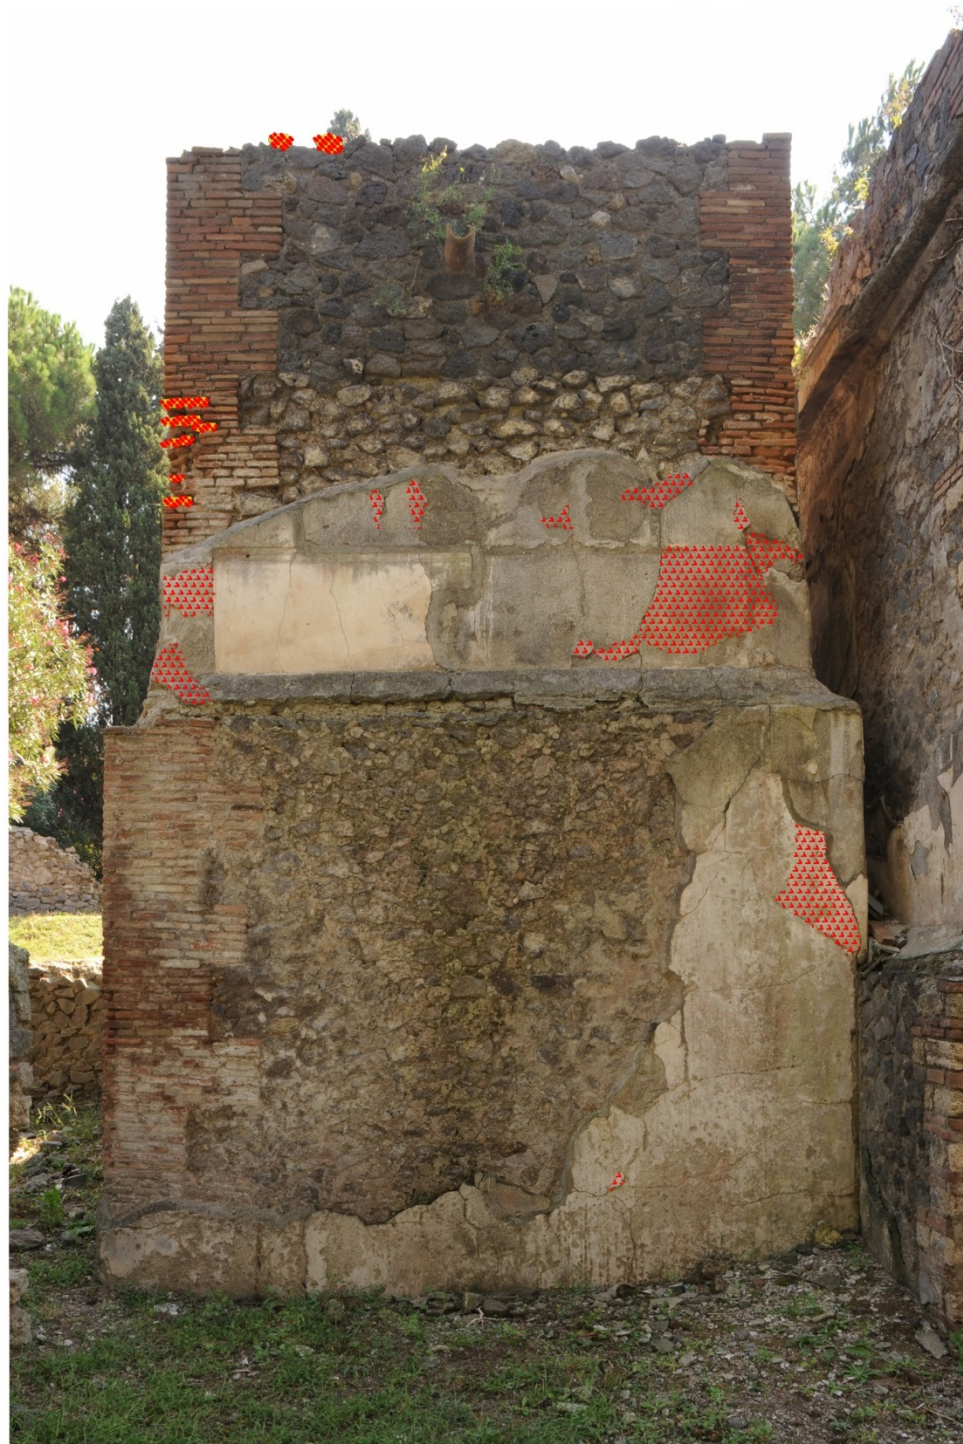
Figure 151: map 14\_EN\_N of collapsing areas.

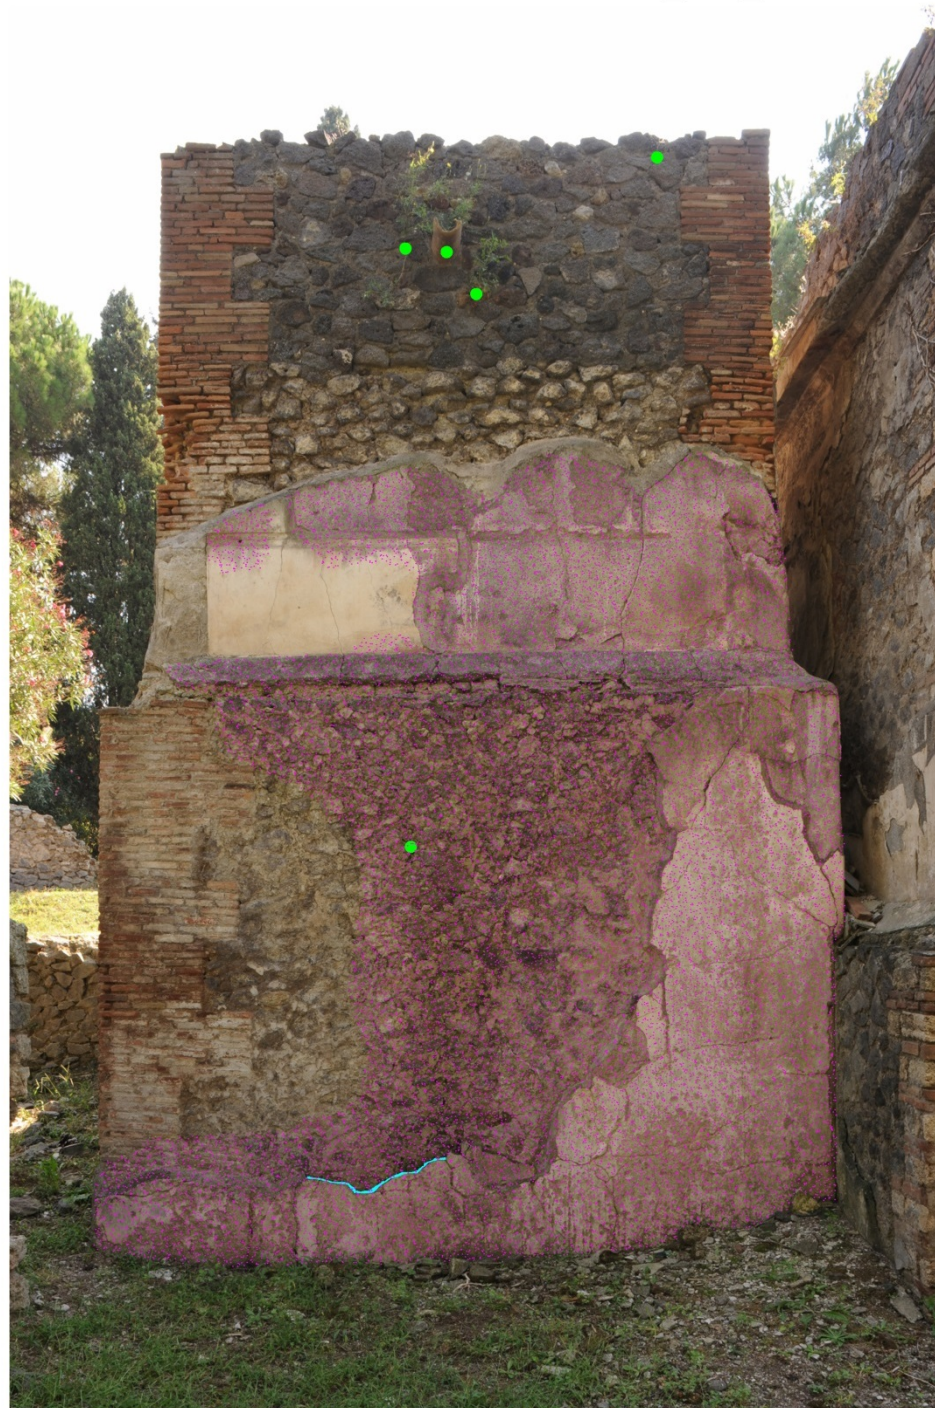
Figure 156: map 14\_EN\_N of biological overgrowth.

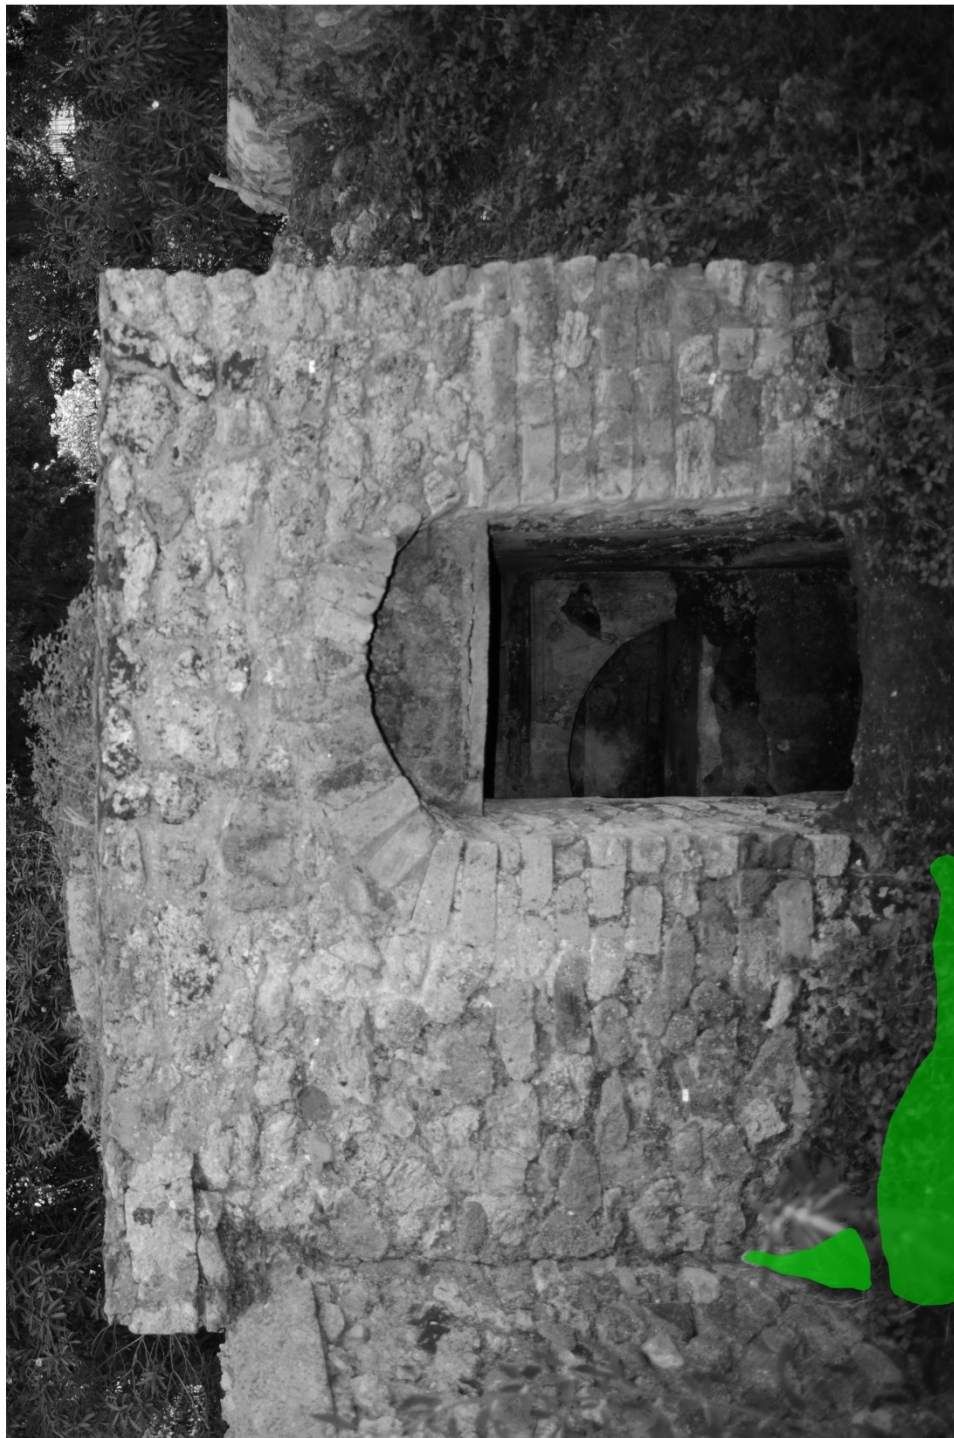
07\_ES\_N

D'AMBROSIO<sup>7</sup> described original plaster fragments at external walls of 07\_ES. But the exact position and amount of original plaster fragments was not named. Therefore the original plaster fragments were documented and mapped in the present state of November 2014 (Figure 163 – Figure 165).

Figure 163: map 07\_ES\_N\_E of preserved original plaster fragments.

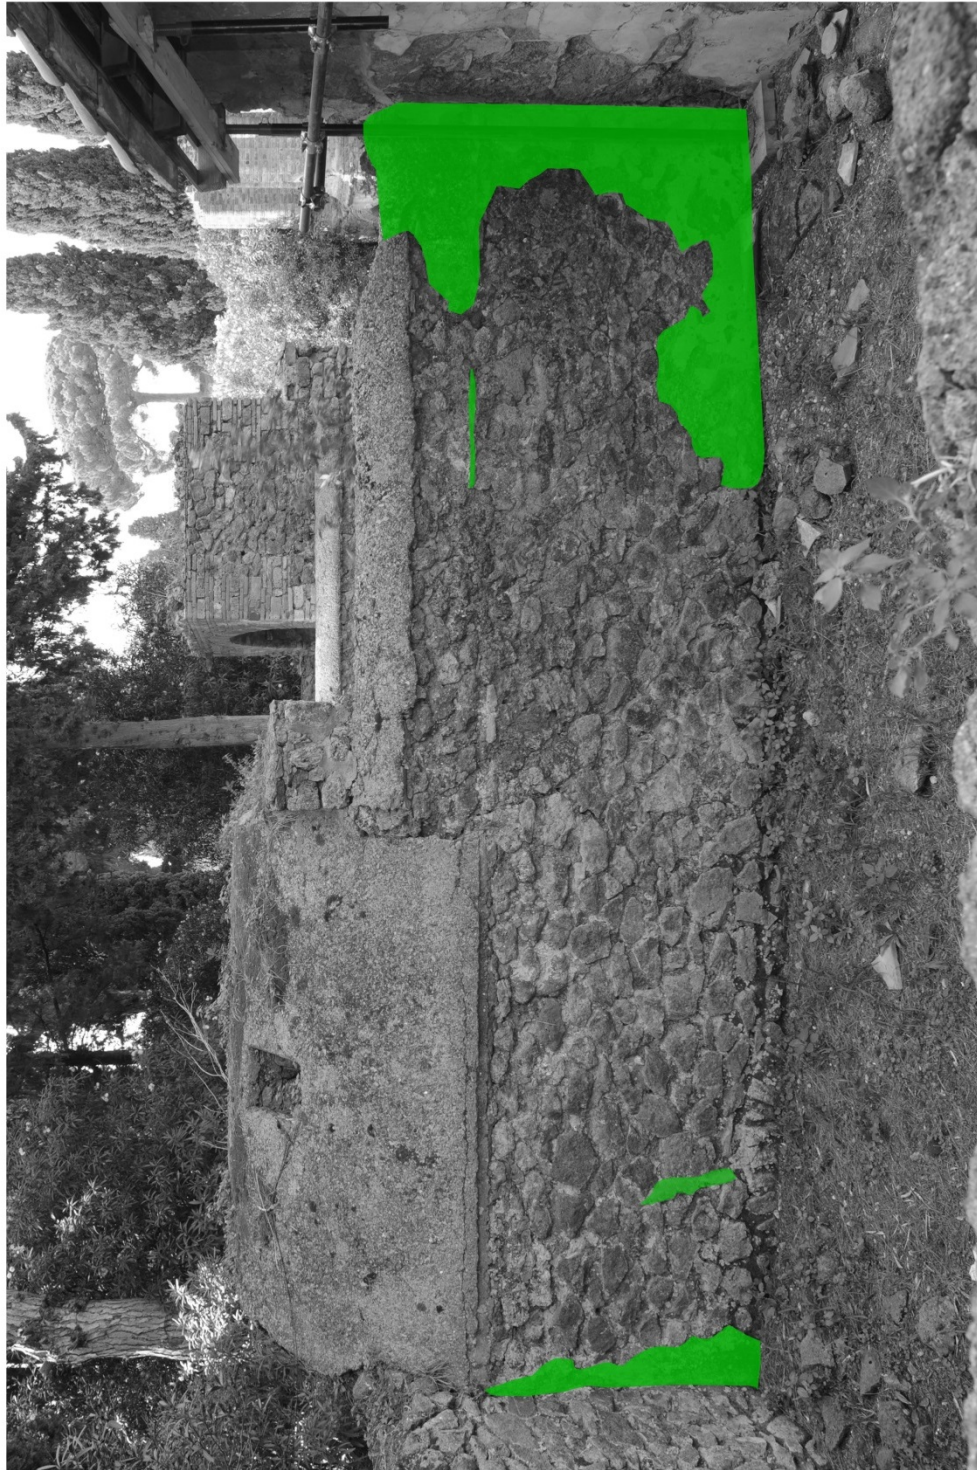
07\_ES\_E

Figure 164: map 07\_ES\_E\_E of preserved original plaster fragments.

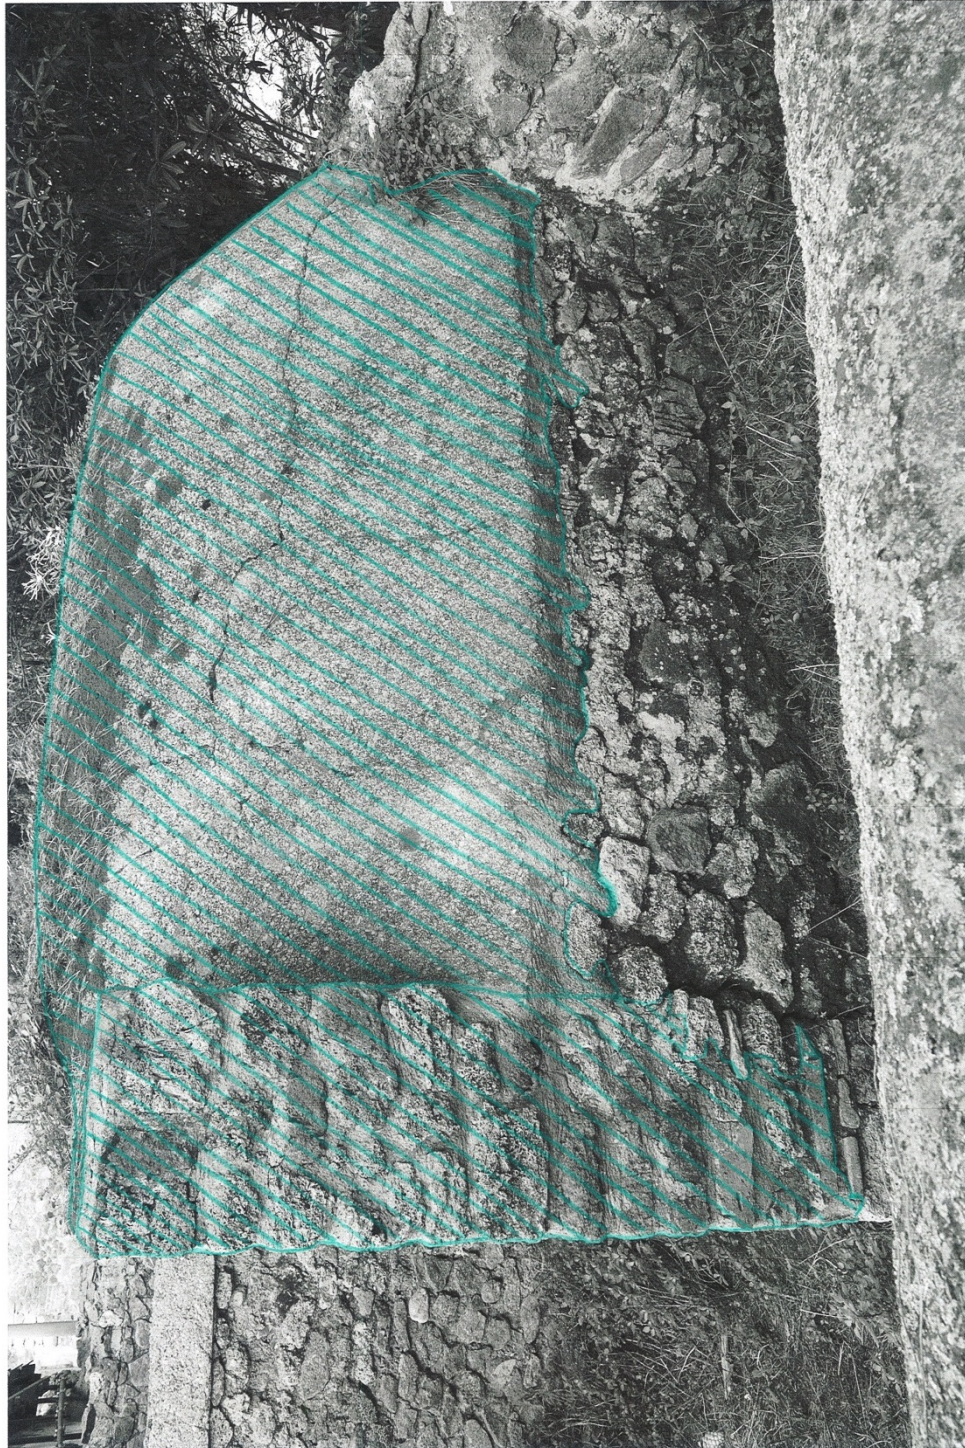
07\_ES\_W

As you can see on Figure 166 – Figure 170, especially the ceiling of the chamber has been reconstructed and the west corner of the northern external wall.

Figure 170: map 07\_ES\_W\_E of reconstruction.

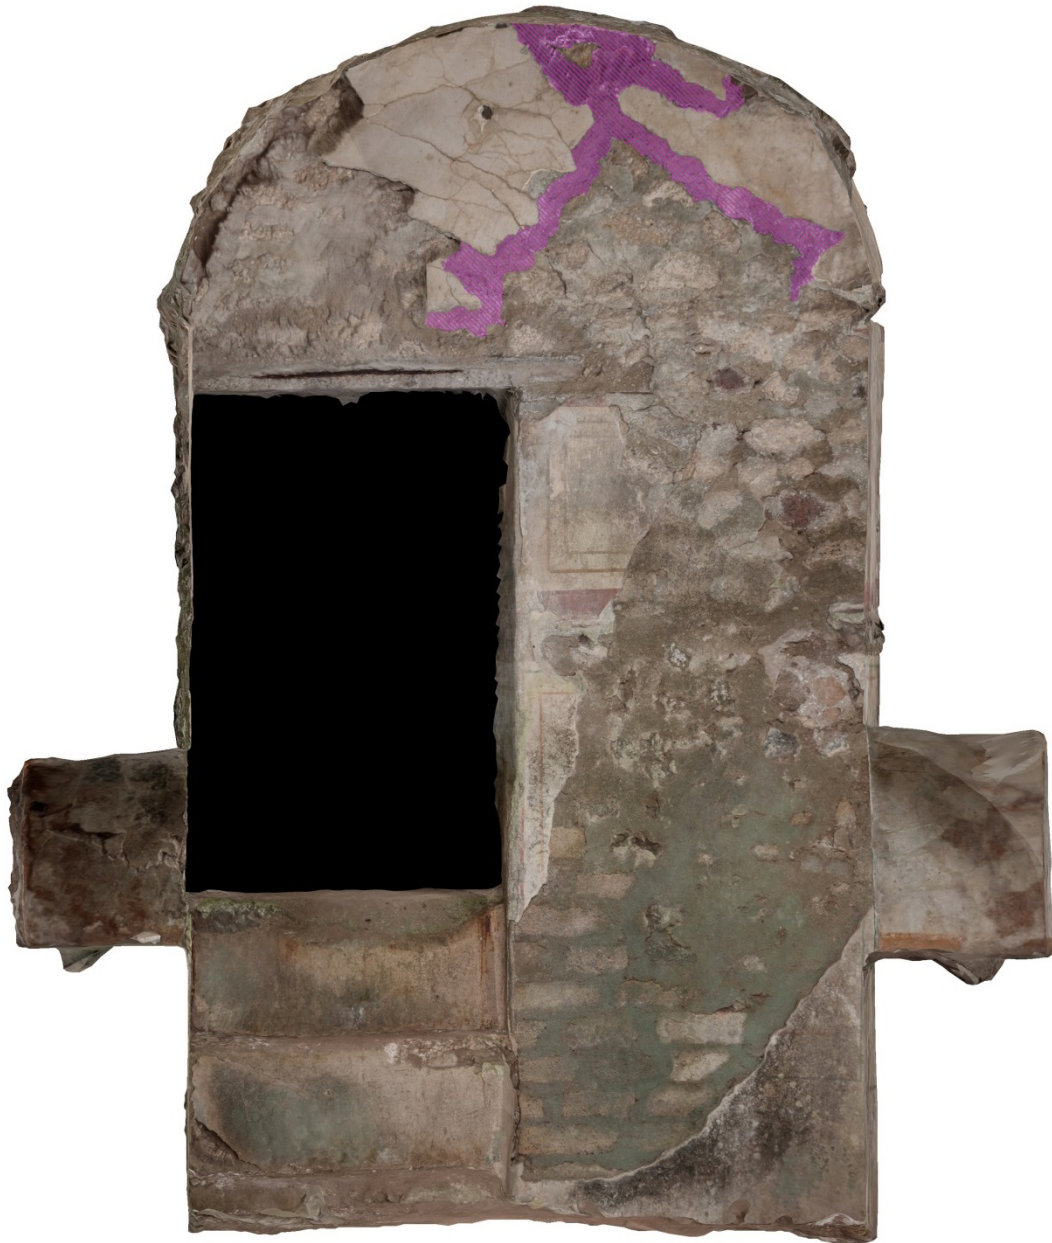
In the chamber a few fillings and edge protection (Figure 31) was used (Figure 171 – Figure 174). Obviously, they are all done with the same material at the same time. A division of different kind of edge protection and fillings was not possible (as done at 14\_EN).

Figure 171: map 07\_ES\_N\_I of fillings and protection of edges.

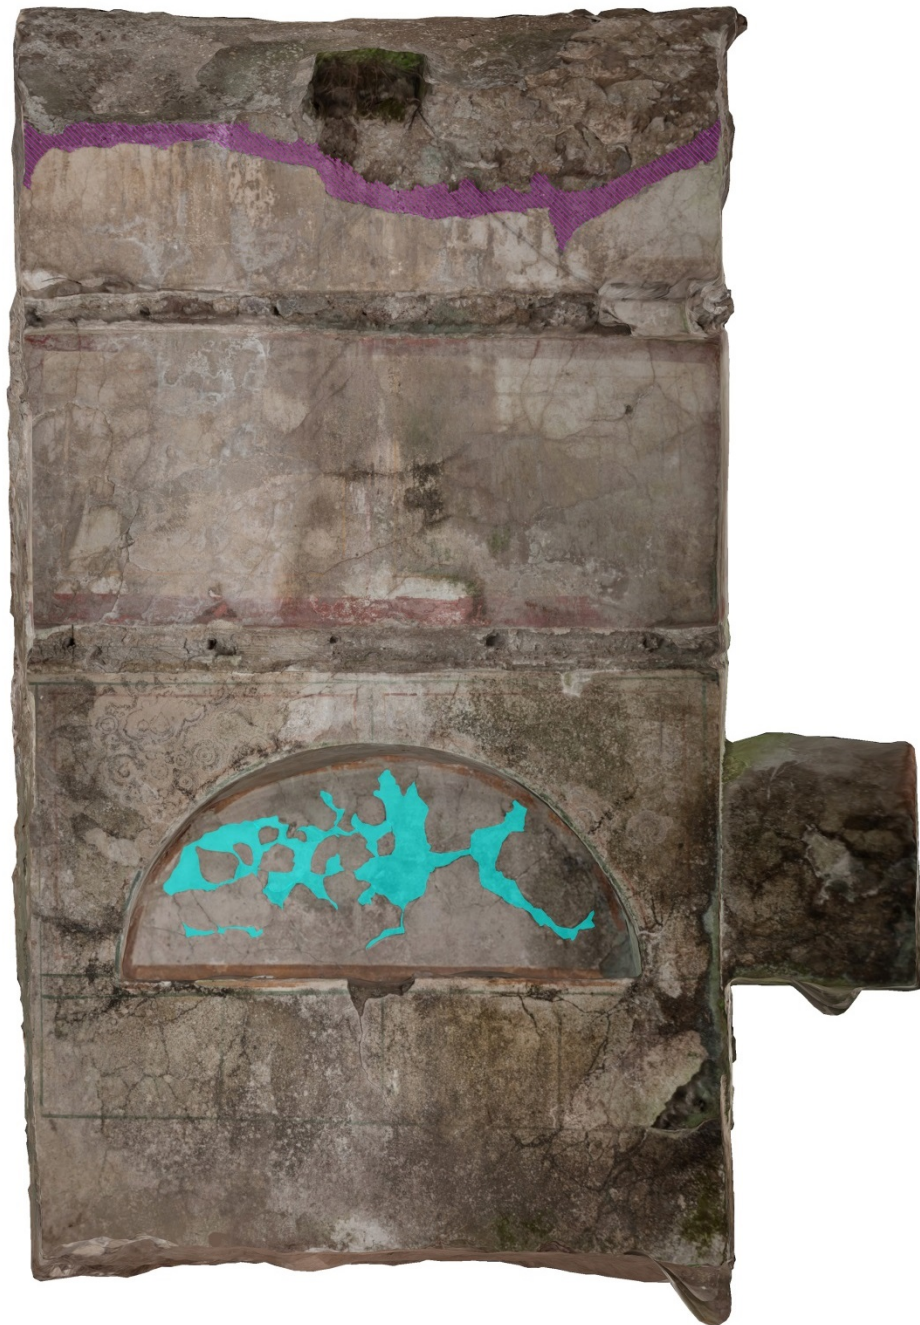
Figure 172: map 07\_ES\_E\_I of fillings and protection of edges.

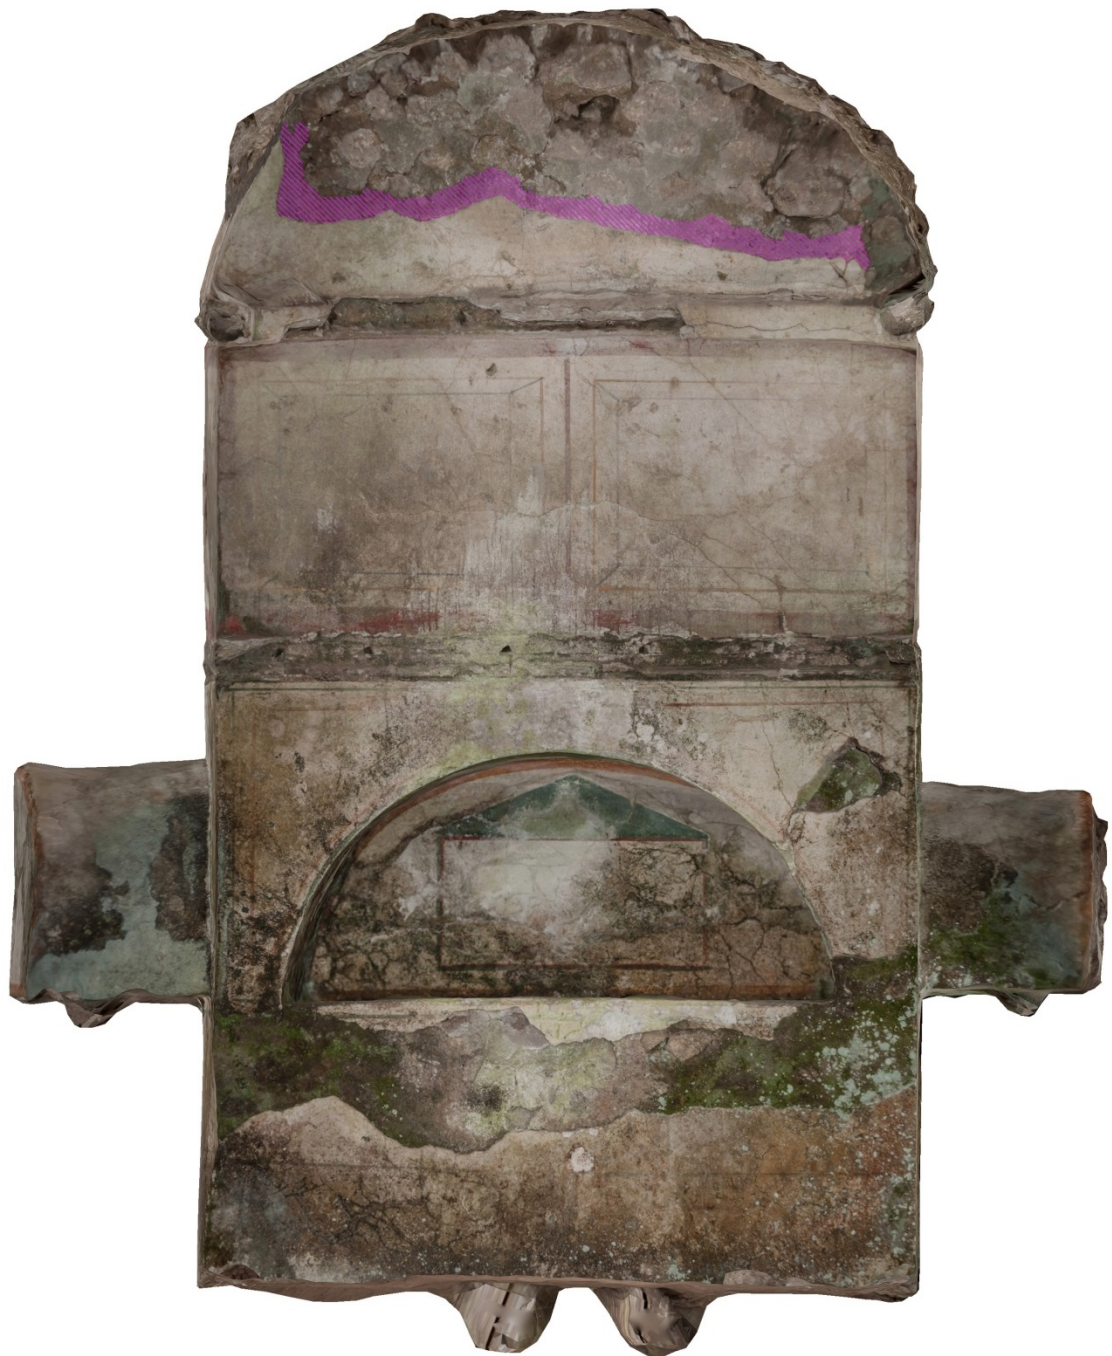
Figure 173: map 07\_ES\_S\_I of fillings and protection of edges.

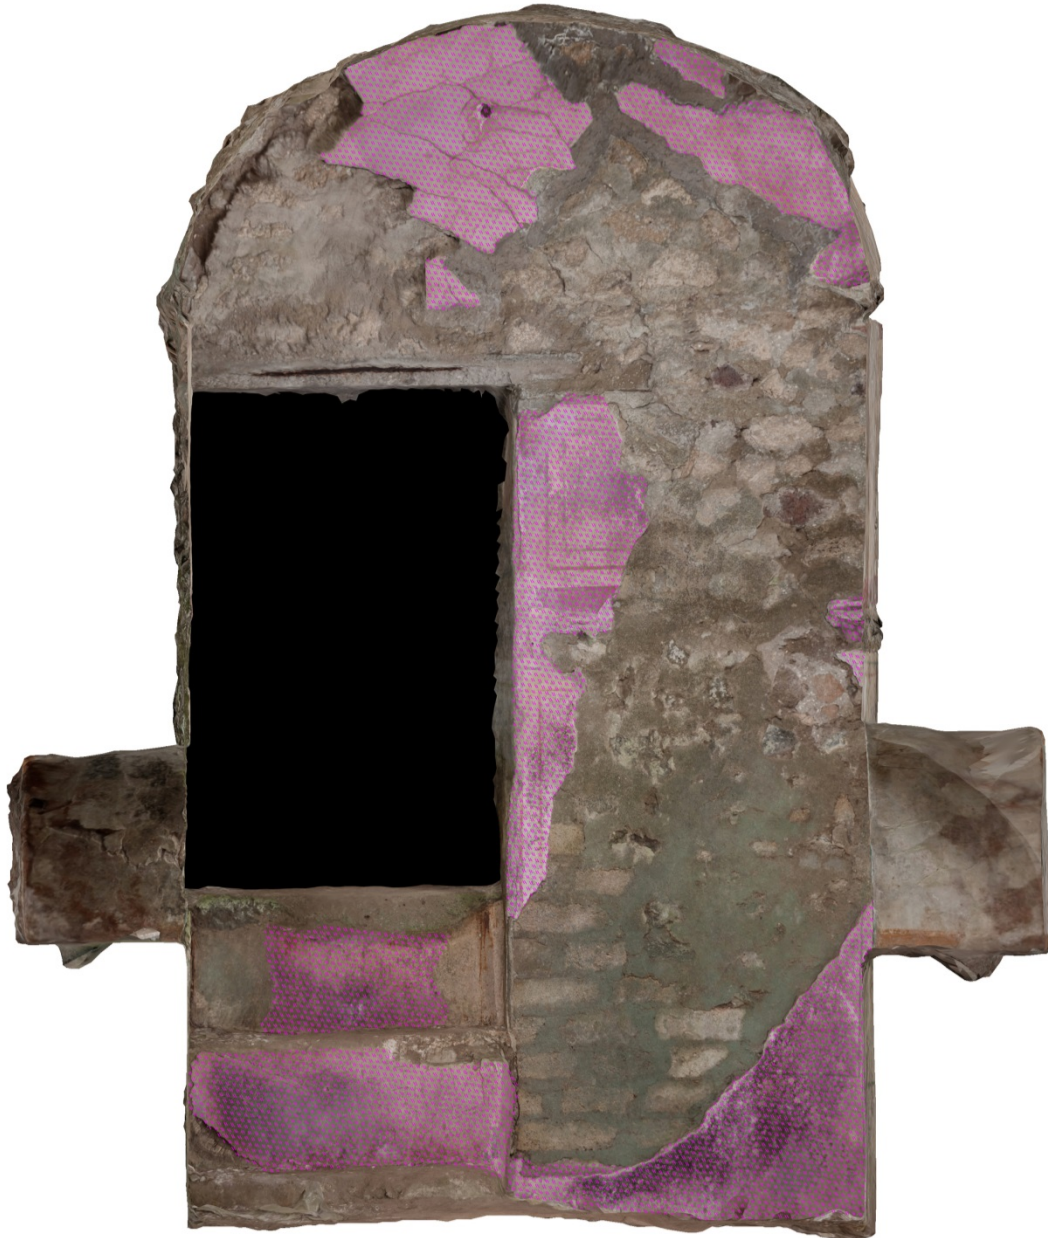
Figure 175: map 07\_ES\_N\_I of delamination (detachment) from structure.

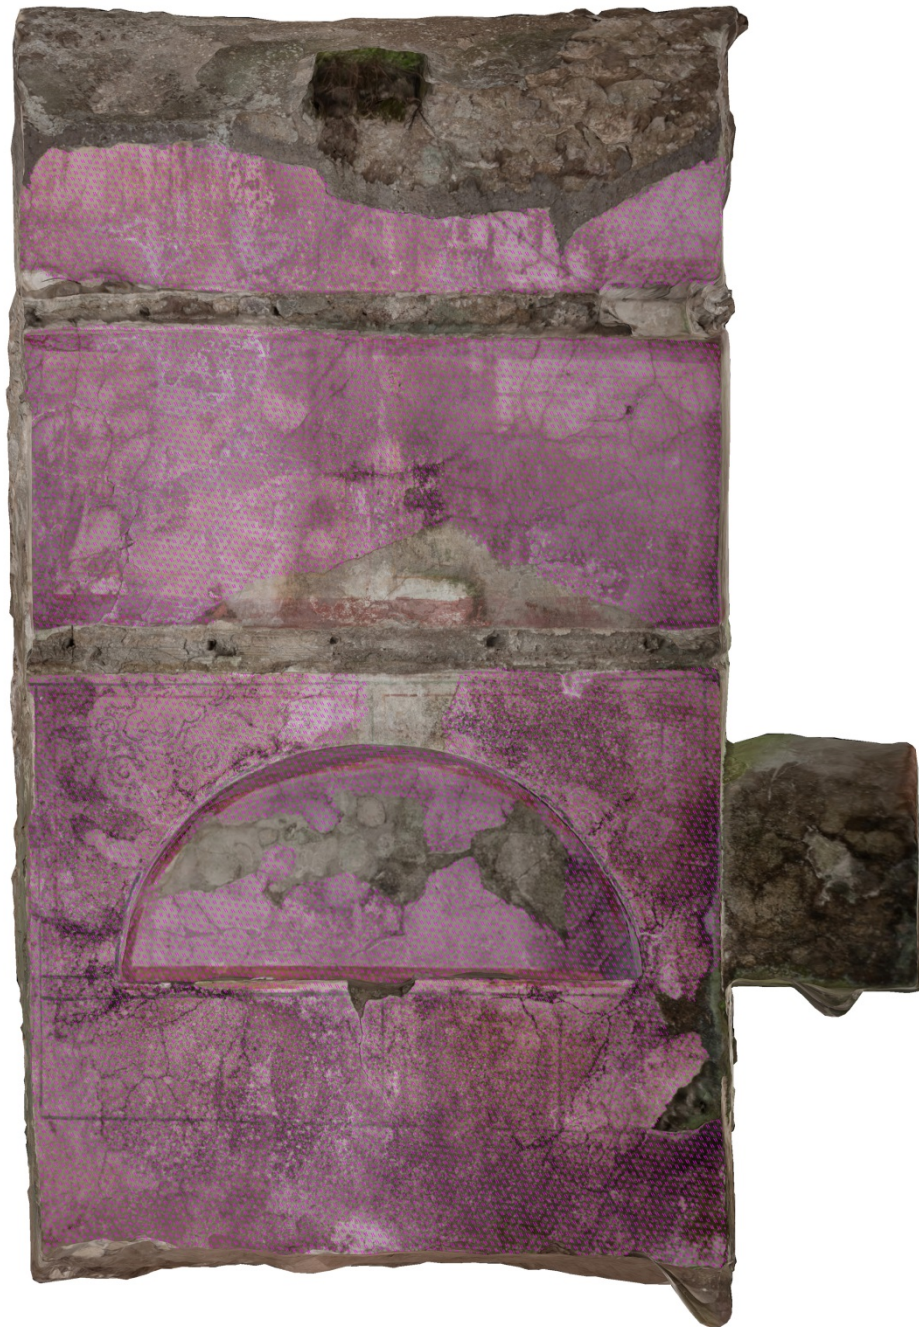
Figure 176: map 07\_ES\_E\_I of delamination (detachment) from structure.

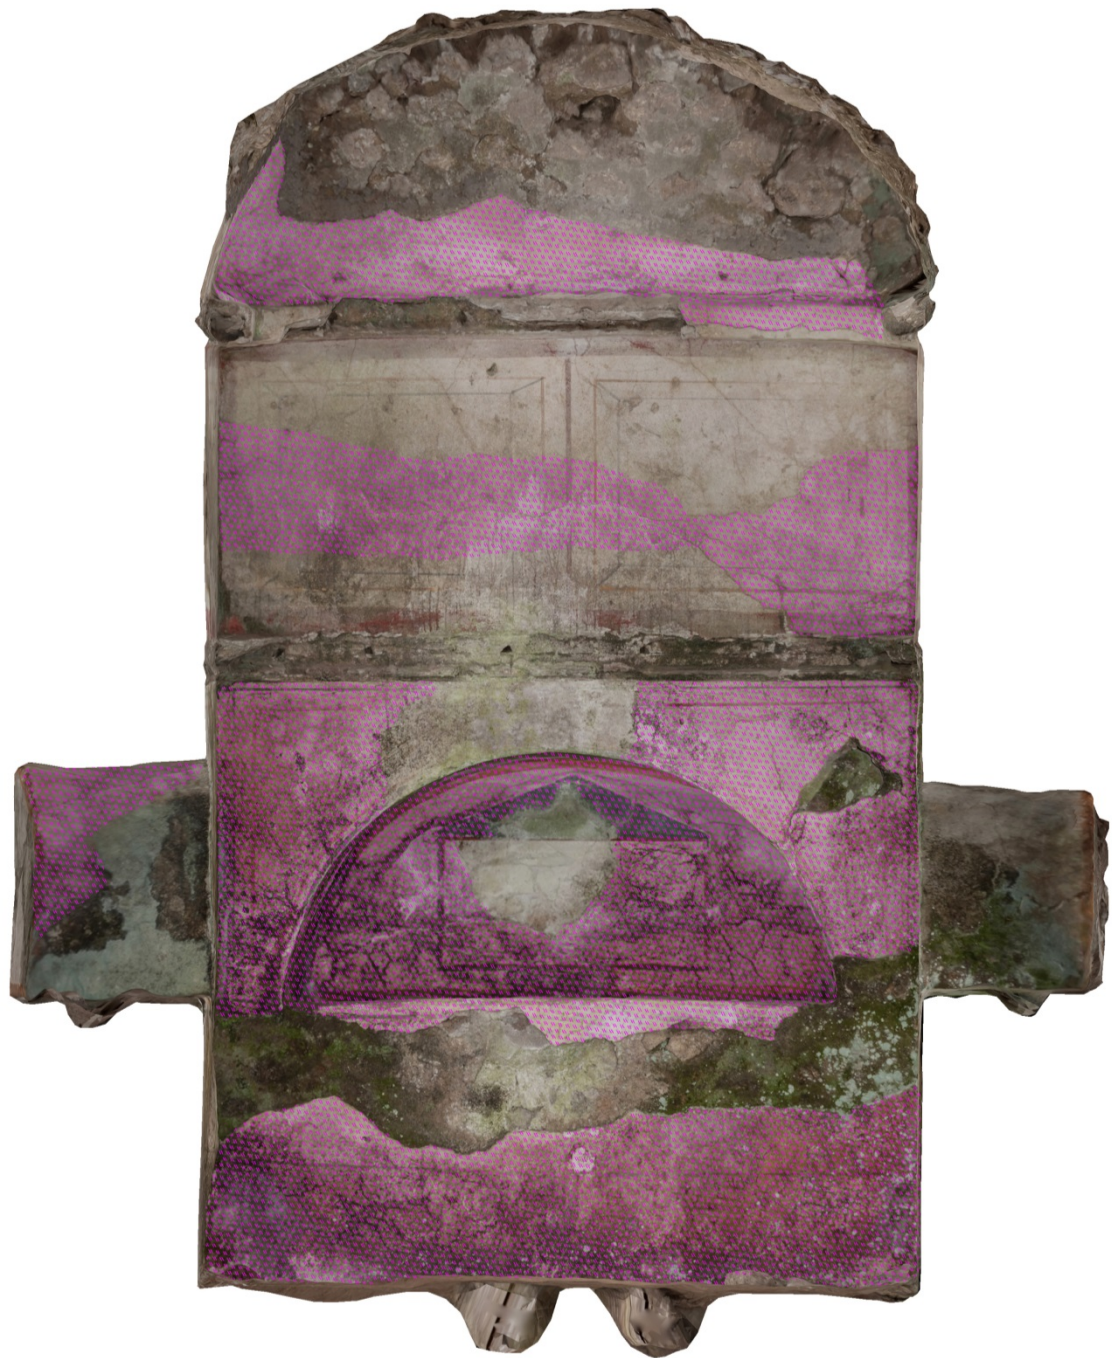
Figure 177: map 07\_ES\_S\_I of delamination (detachment) from structure.

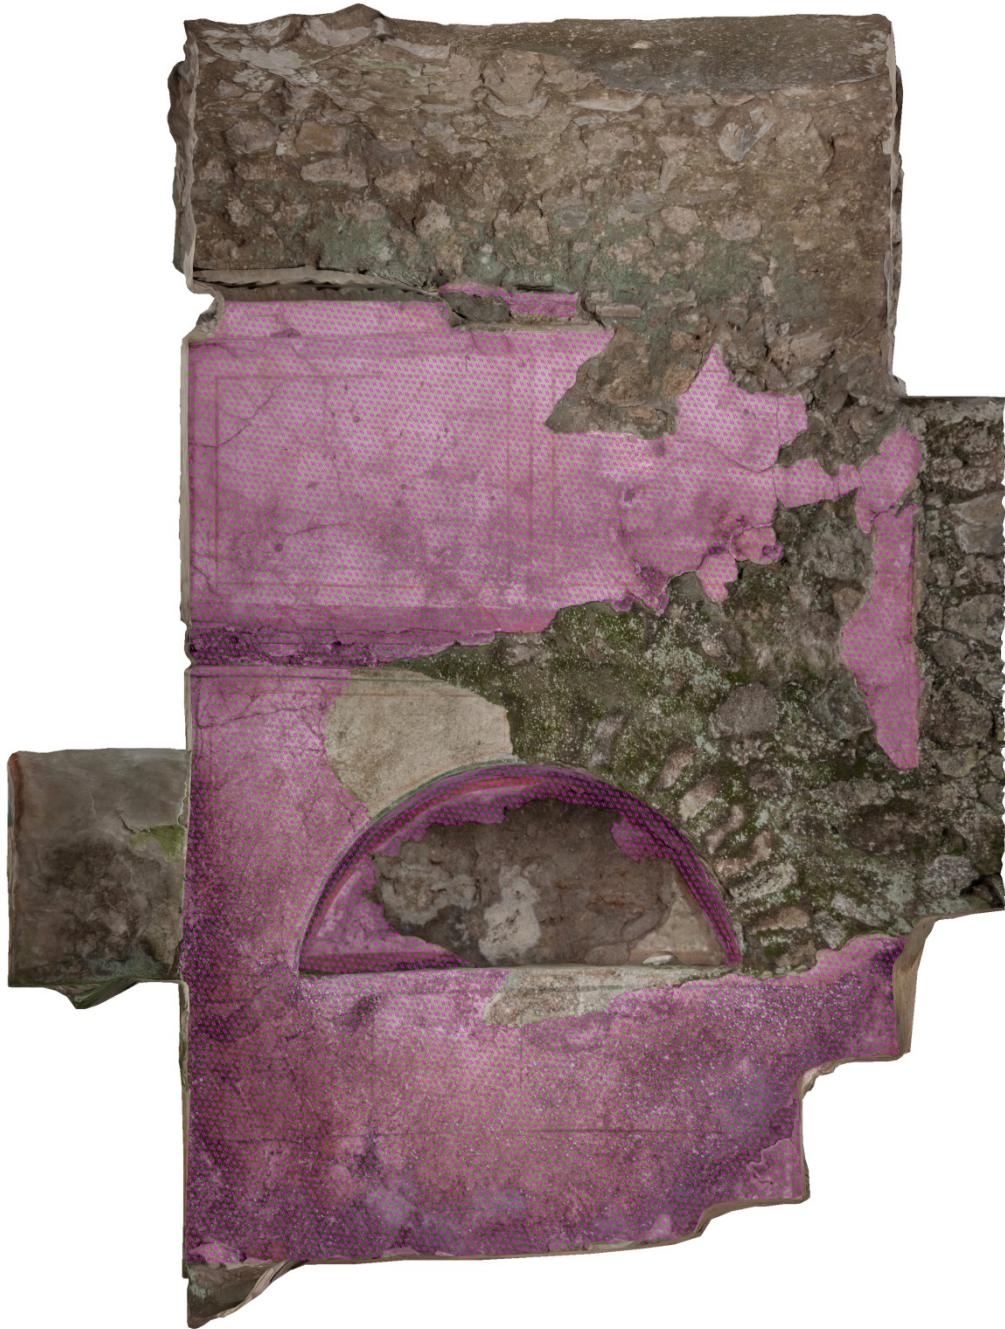
Figure 178: map 07\_ES\_W\_I of delamination (detachment) from structure.

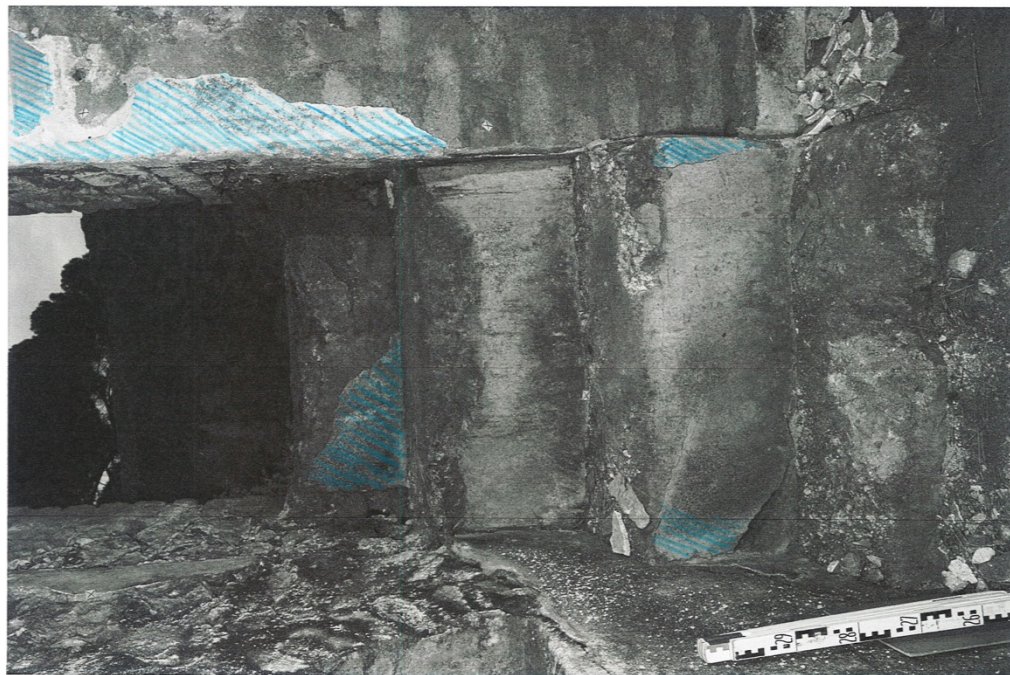
07\_ES\_N\_I

Figure 179: map 07\_ES\_N\_I\_1 of delamination (detachment) Intonaco from preparatory layers (blue) and delamination (detachment) preparatory layers from each other's (green).
