# **POMPEII SUSTAINABLE PRESERVATION PROJECT**

**Documentation of the funerary monuments  
14\_EN and 07\_ES**

**Christina Elsässer**

Munioch, February 25<sup>th</sup>, 2015

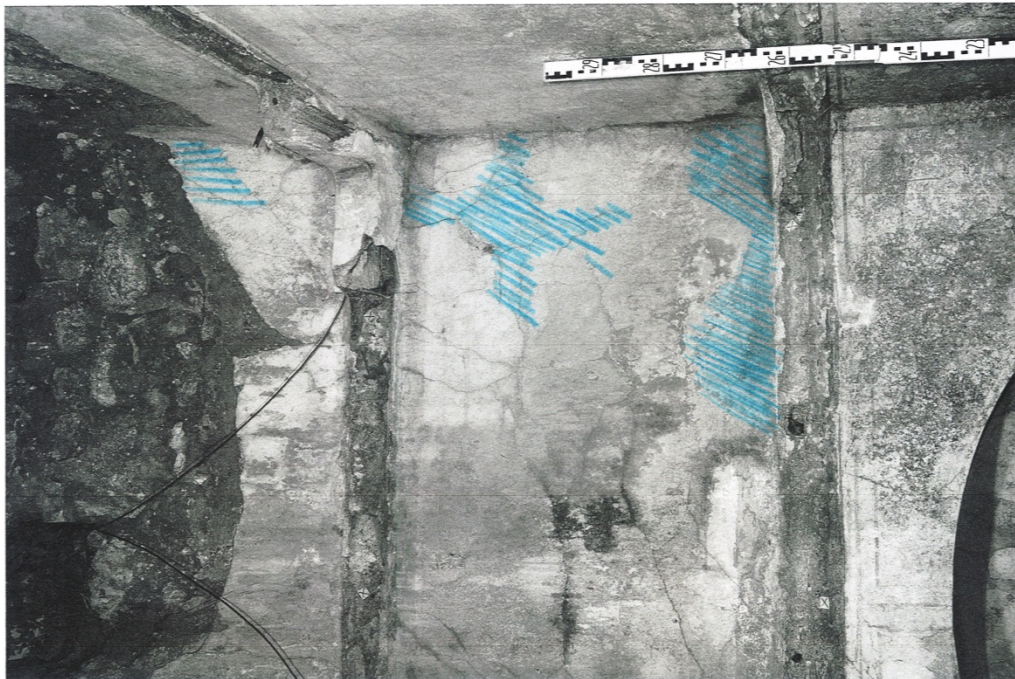
07\_ES\_E\_I

Figure 182: map 07\_ES\_E\_I\_2 of delamination (detachment) Intonaco from preparatory layers (blue) and delamination (detachment) preparatory layers from each other's (green).

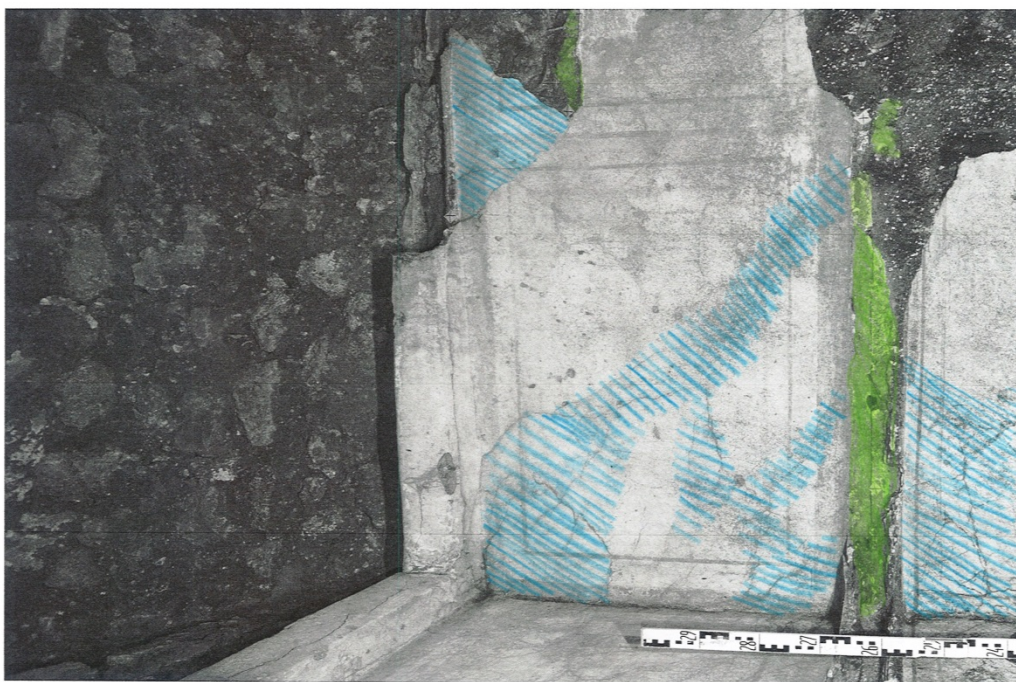
07\_ES\_W\_I

Figure 185: map 07\_ES\_W\_I\_2 of delamination (detachment) Intonaco from preparatory layers (blue) and delamination (detachment) preparatory layers from each other's (green).

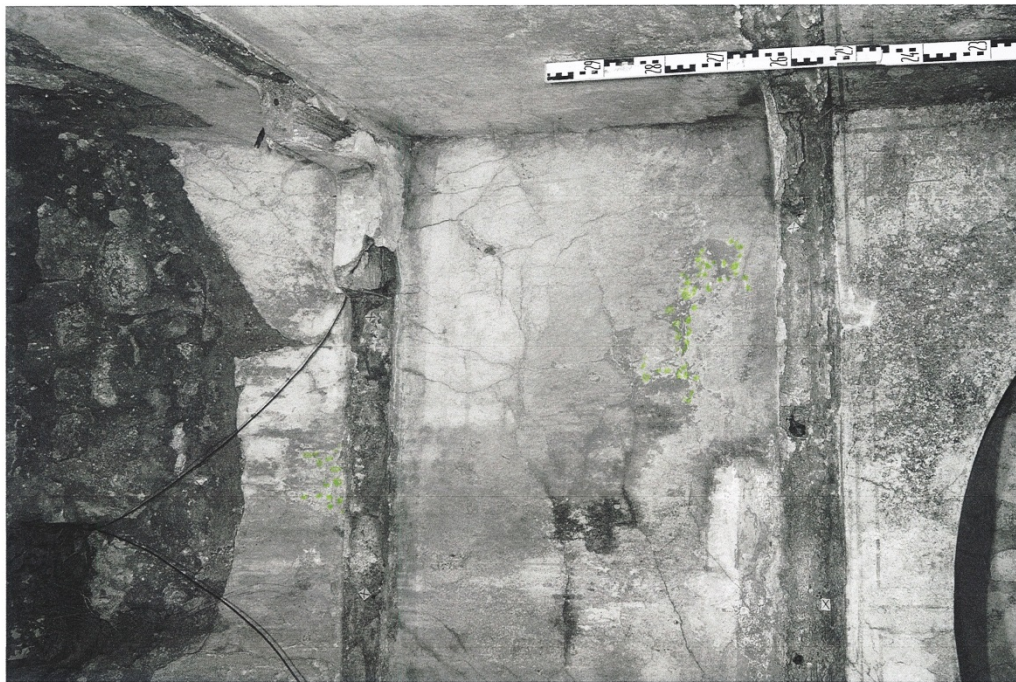
07\_ES\_E1

Figure 189: map 07\_ES\_E\_I\_2 of scaling (blue) and salt weathering layers (green).

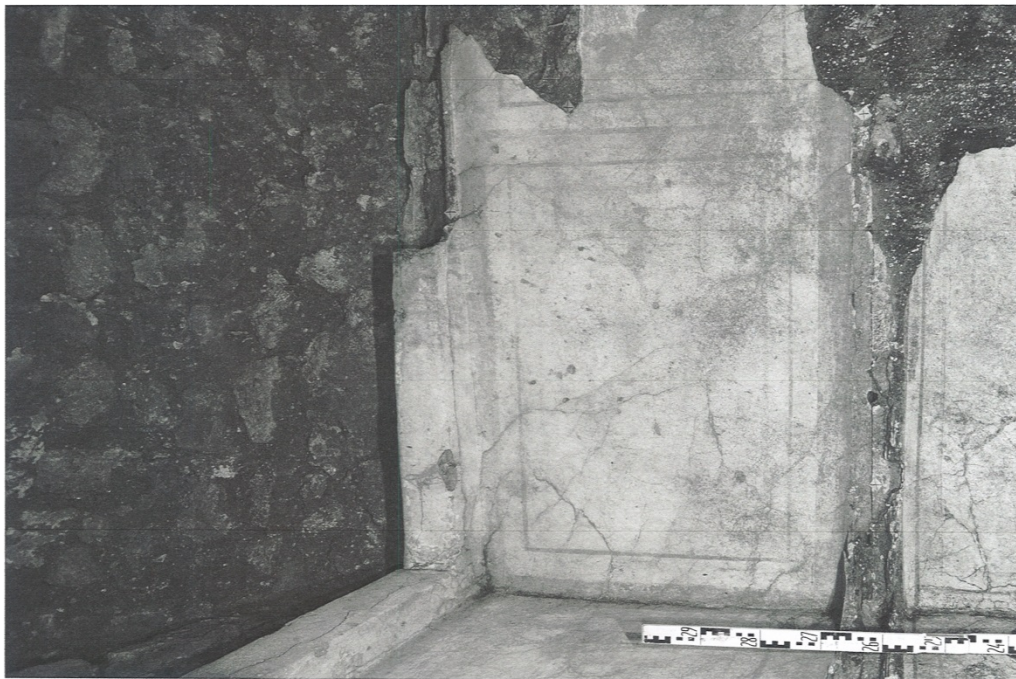
07\_ES\_W\_I

Figure 192: map 07\_ES\_W\_I\_2 of scaling (blue) and salt weathering layers (green).

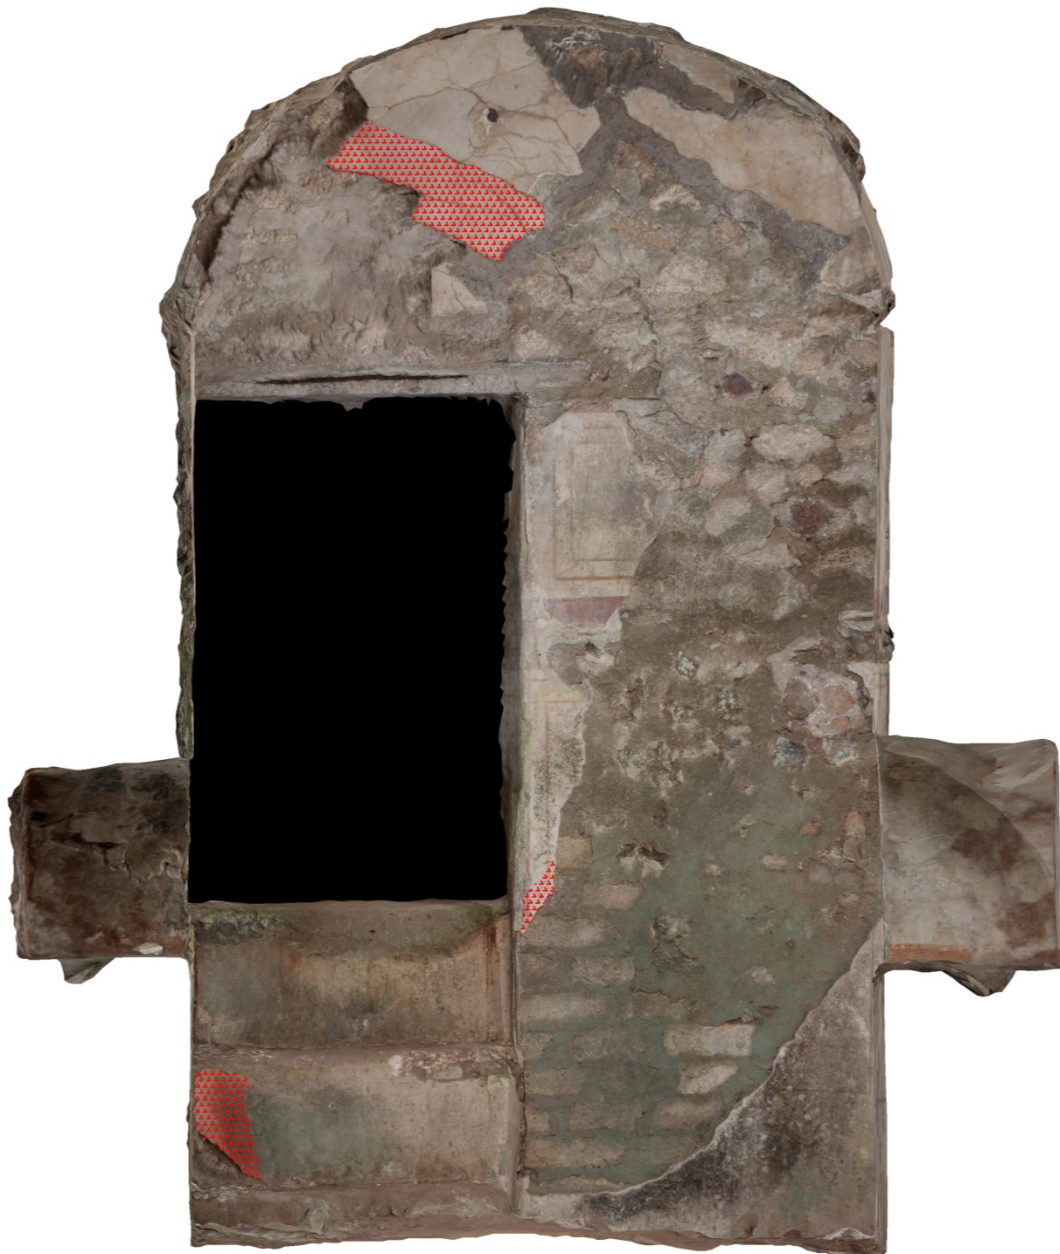
Figure 205: map 07\_ES\_N\_I collapsing areas.

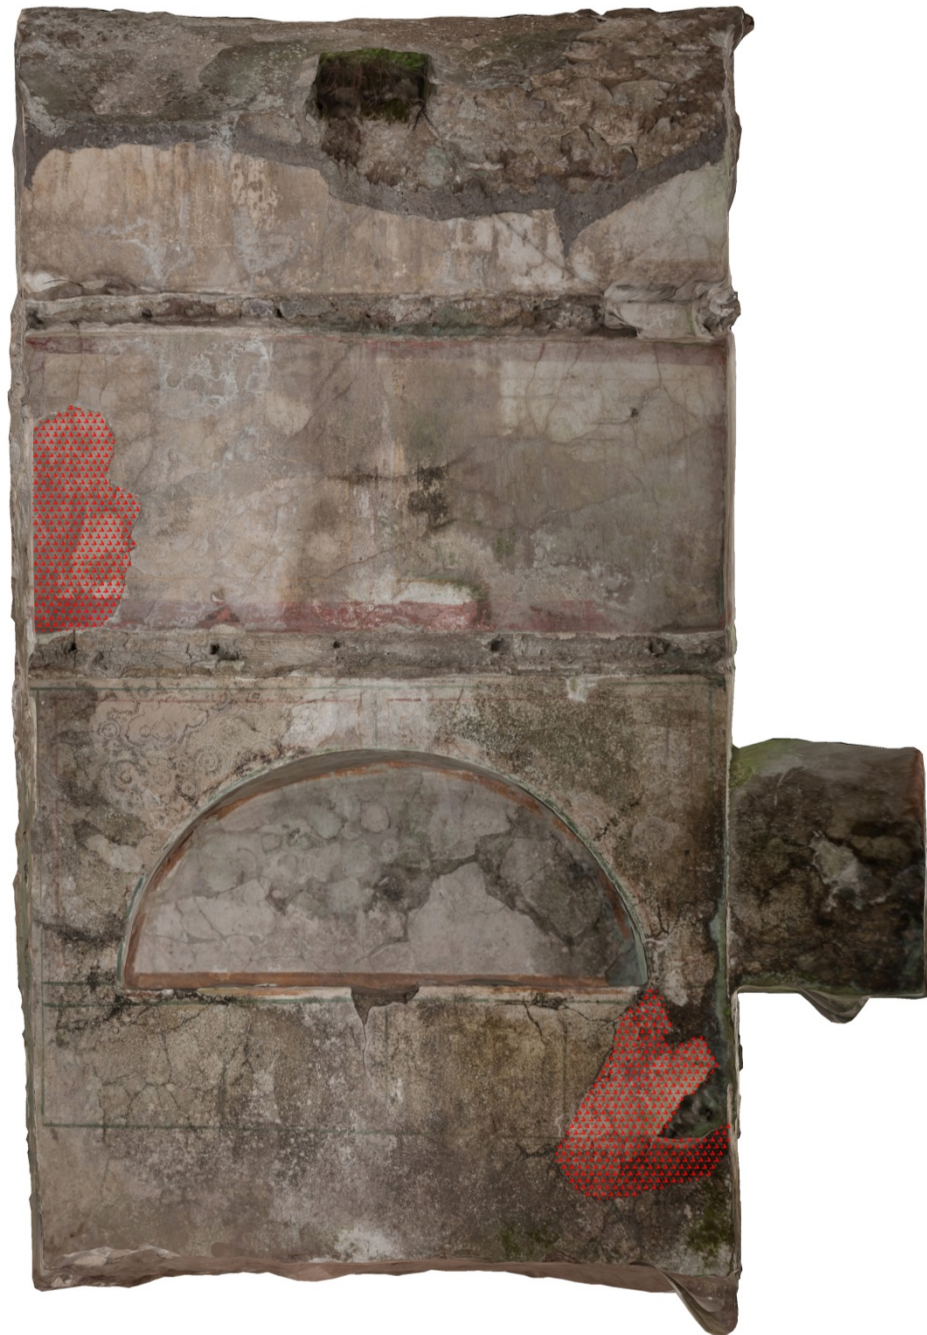
Figure 206: map 07\_ES\_E\_I collapsing areas.

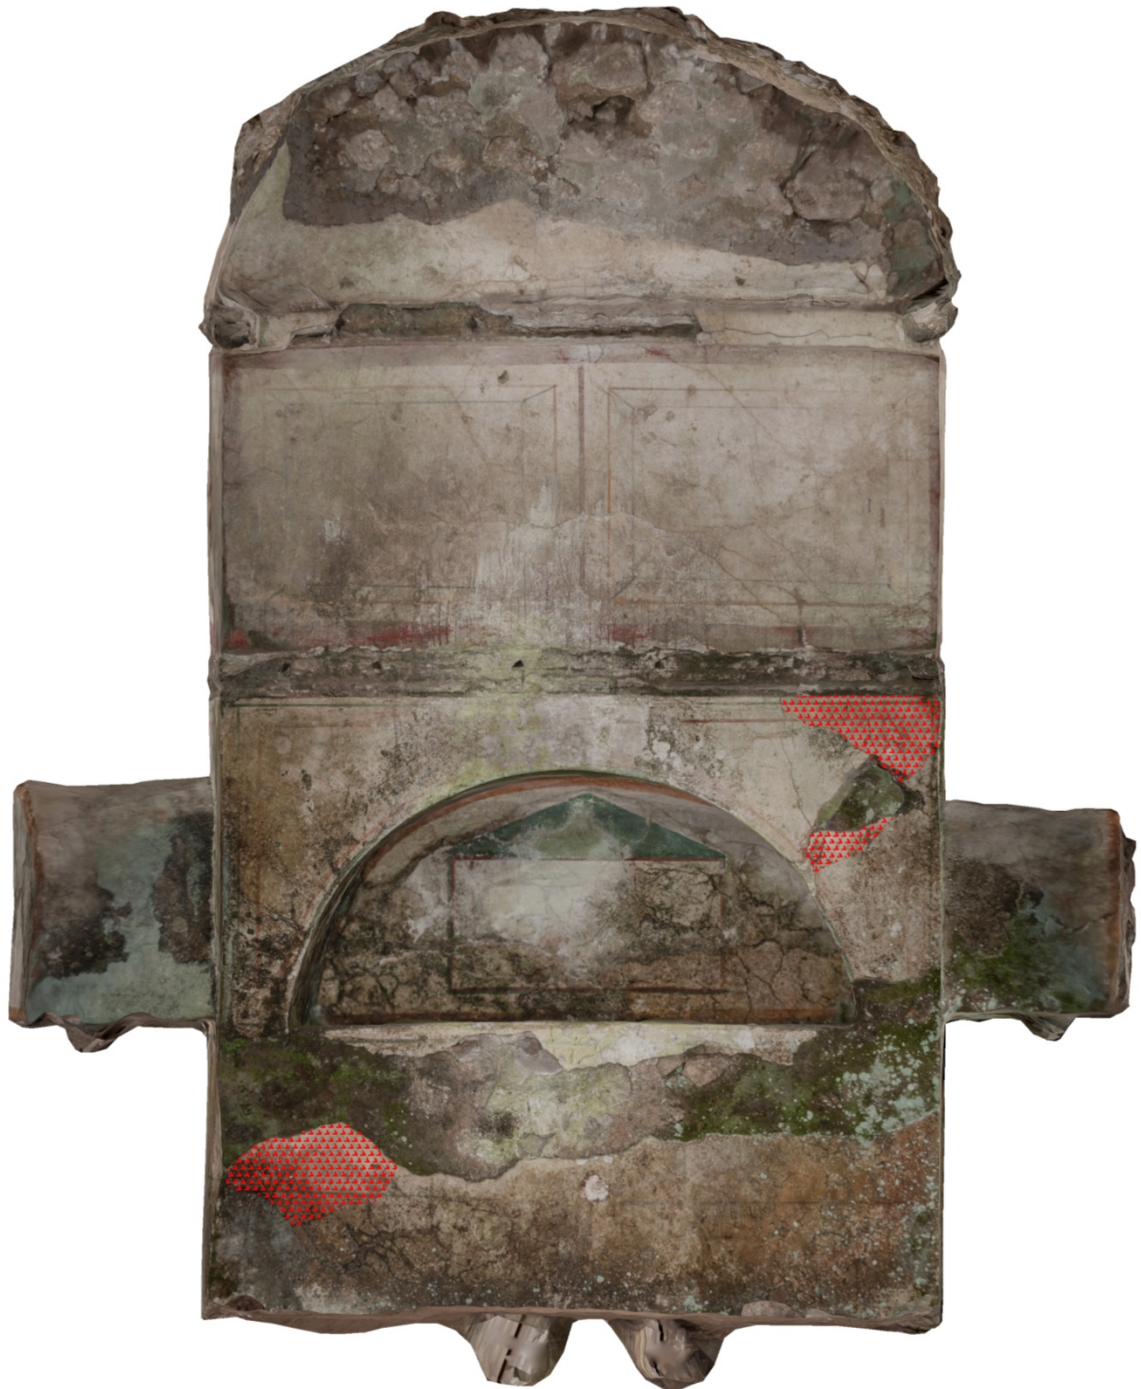
Figure 207: map 07\_ES\_S\_I collapsing areas.

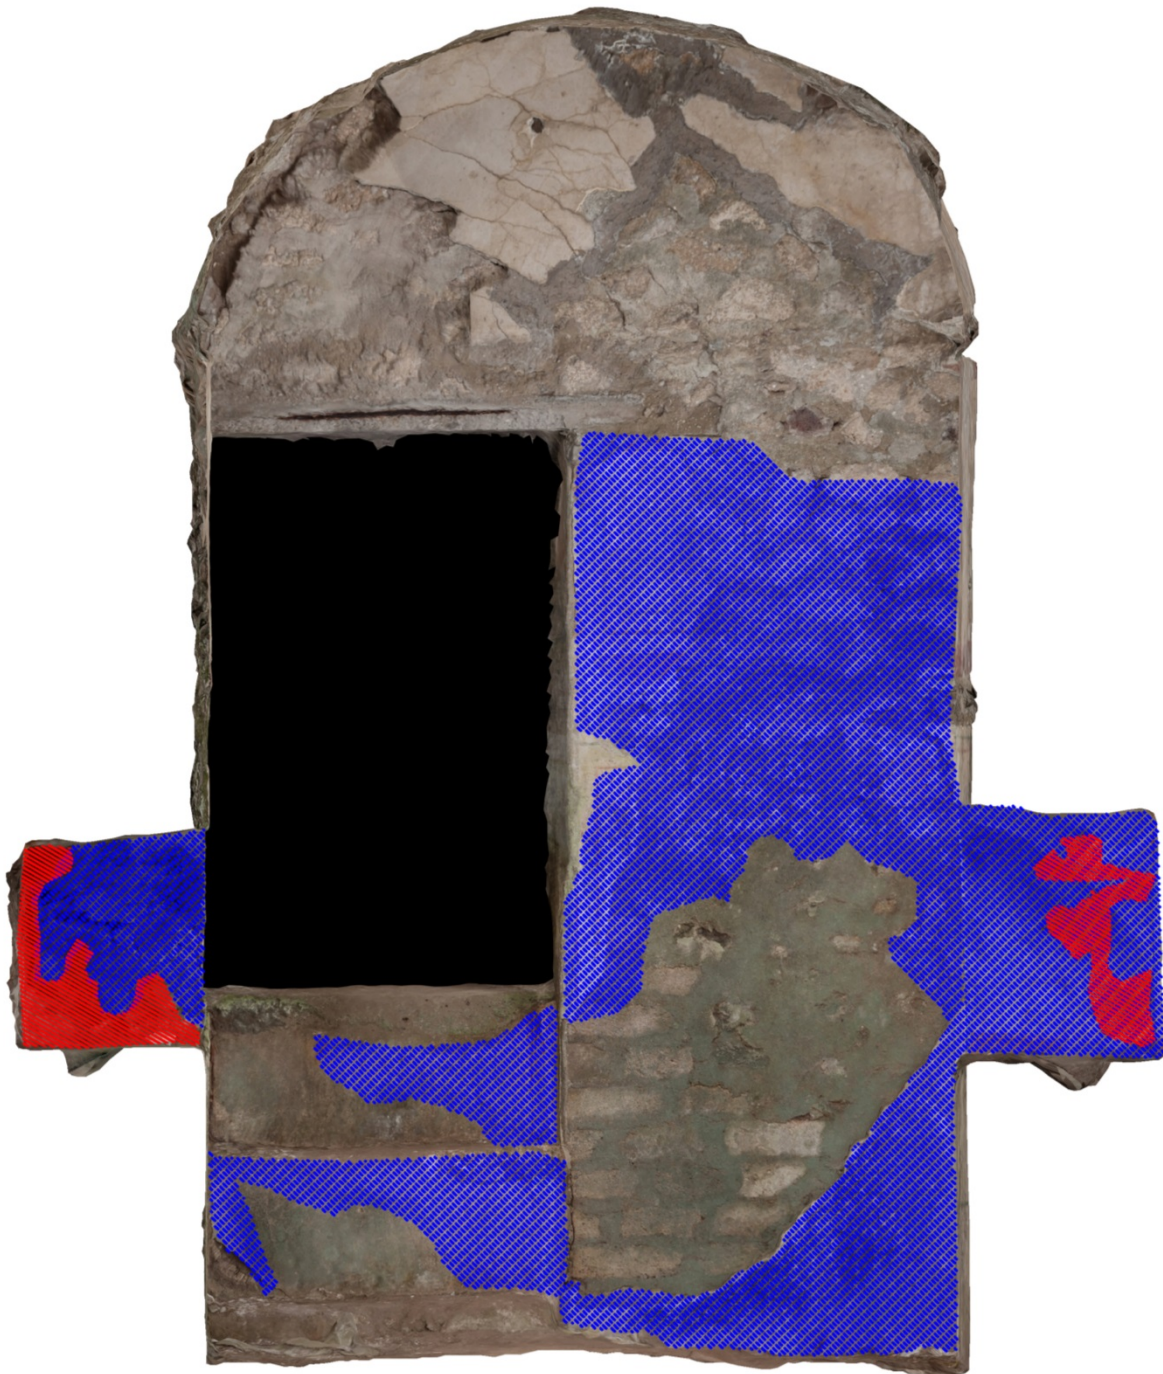
## NECROPOLIS OF PORTA NOCERA - 07\_ES\_N\_I

Figure 209: map 07\_ES\_N\_I of possible algae.

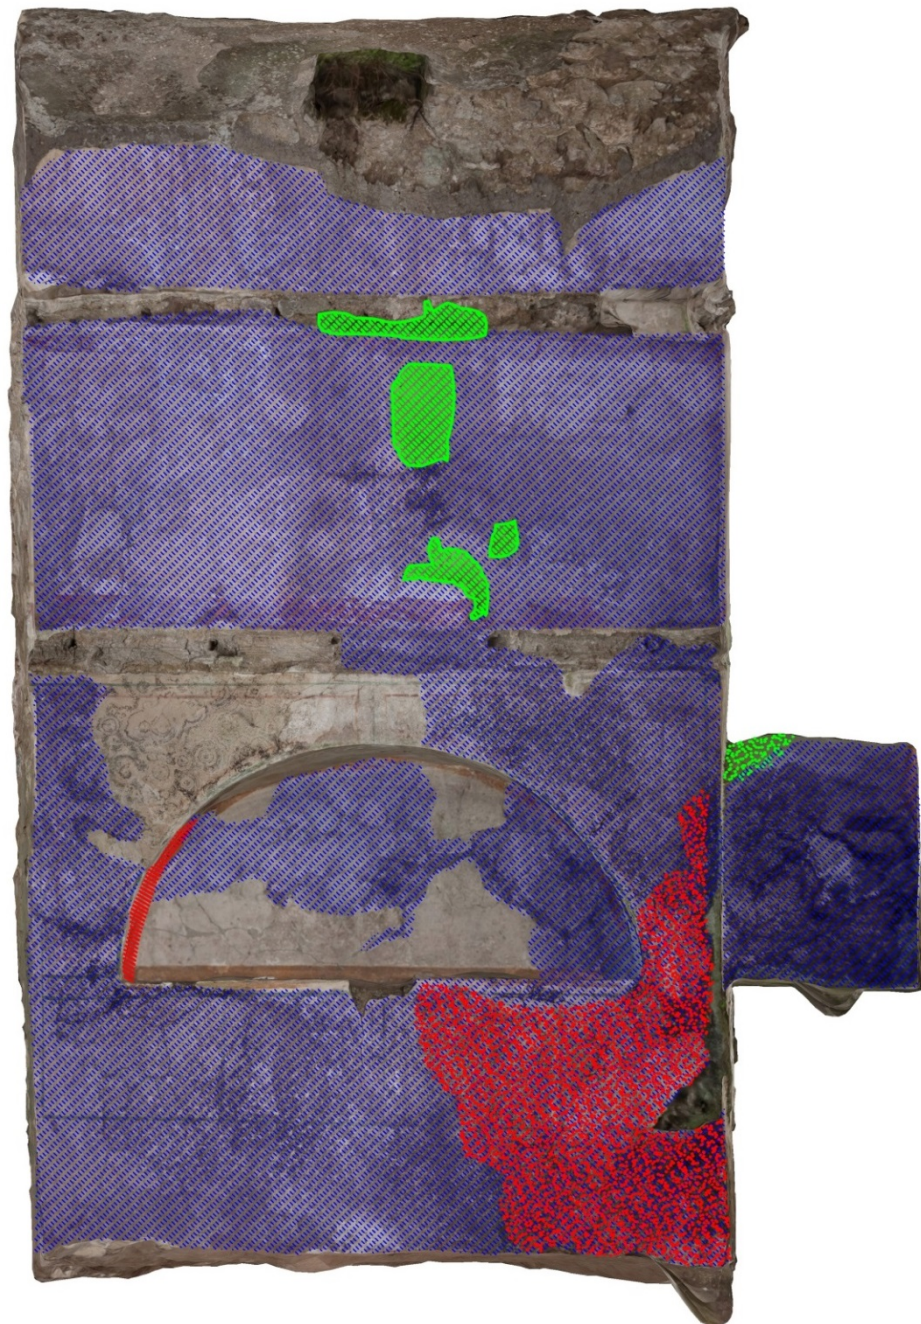
## NECROPOLIS OF PORTA NOCERA - 07\_ES\_E\_I

Figure 211: map 07\_ES\_E\_I of possible algae.

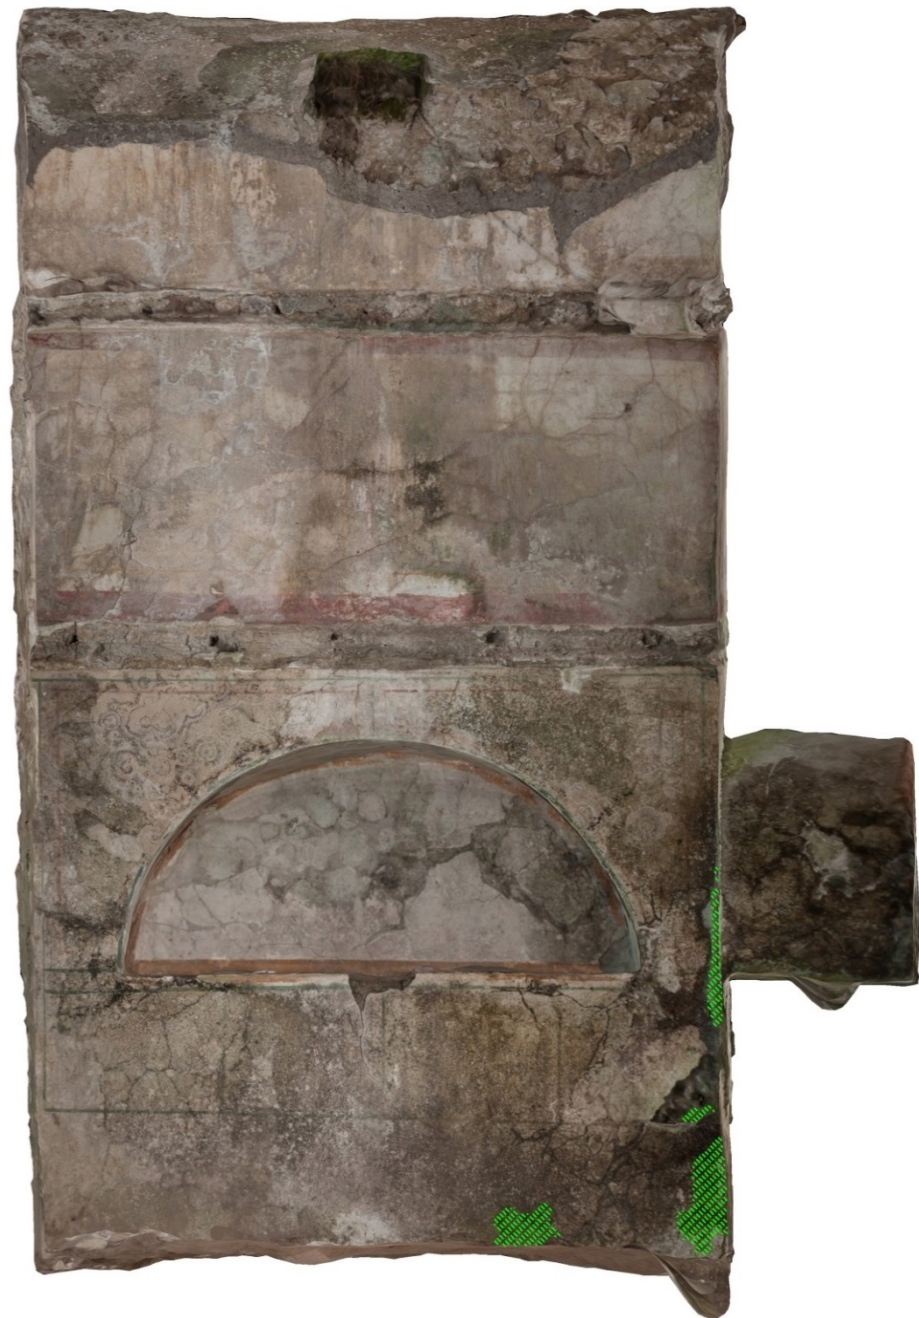
## NECROPOLIS OF PORTA NOCERA - 07\_ES\_E\_I

Figure 212: map 07\_ES\_E\_I of moss and lichens.

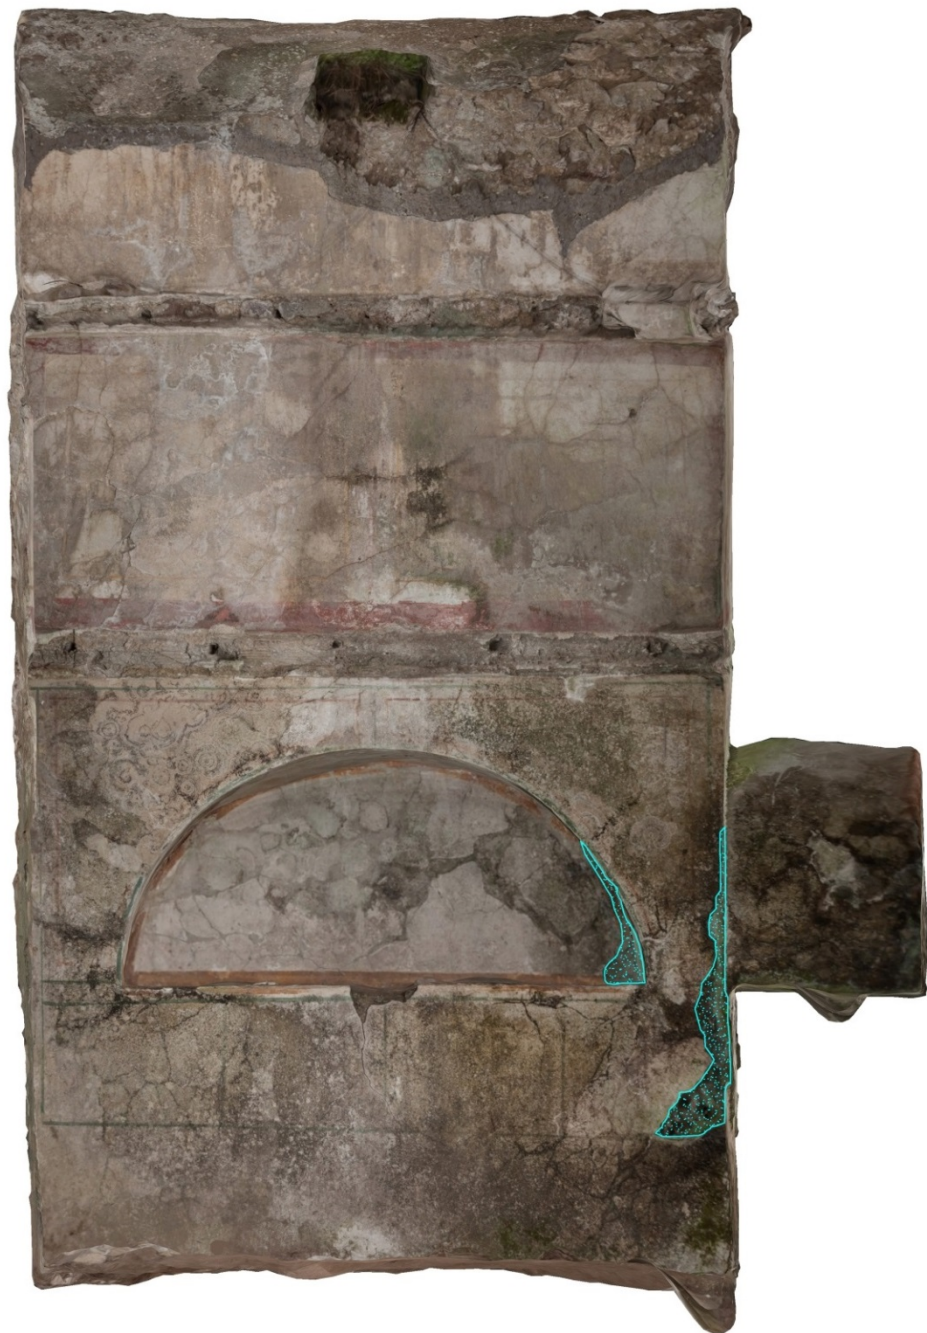
## NECROPOLIS OF PORTA NOCERA - 07\_ES\_E\_I

Figure 213: map 07\_ES\_E\_I of possible fungi.

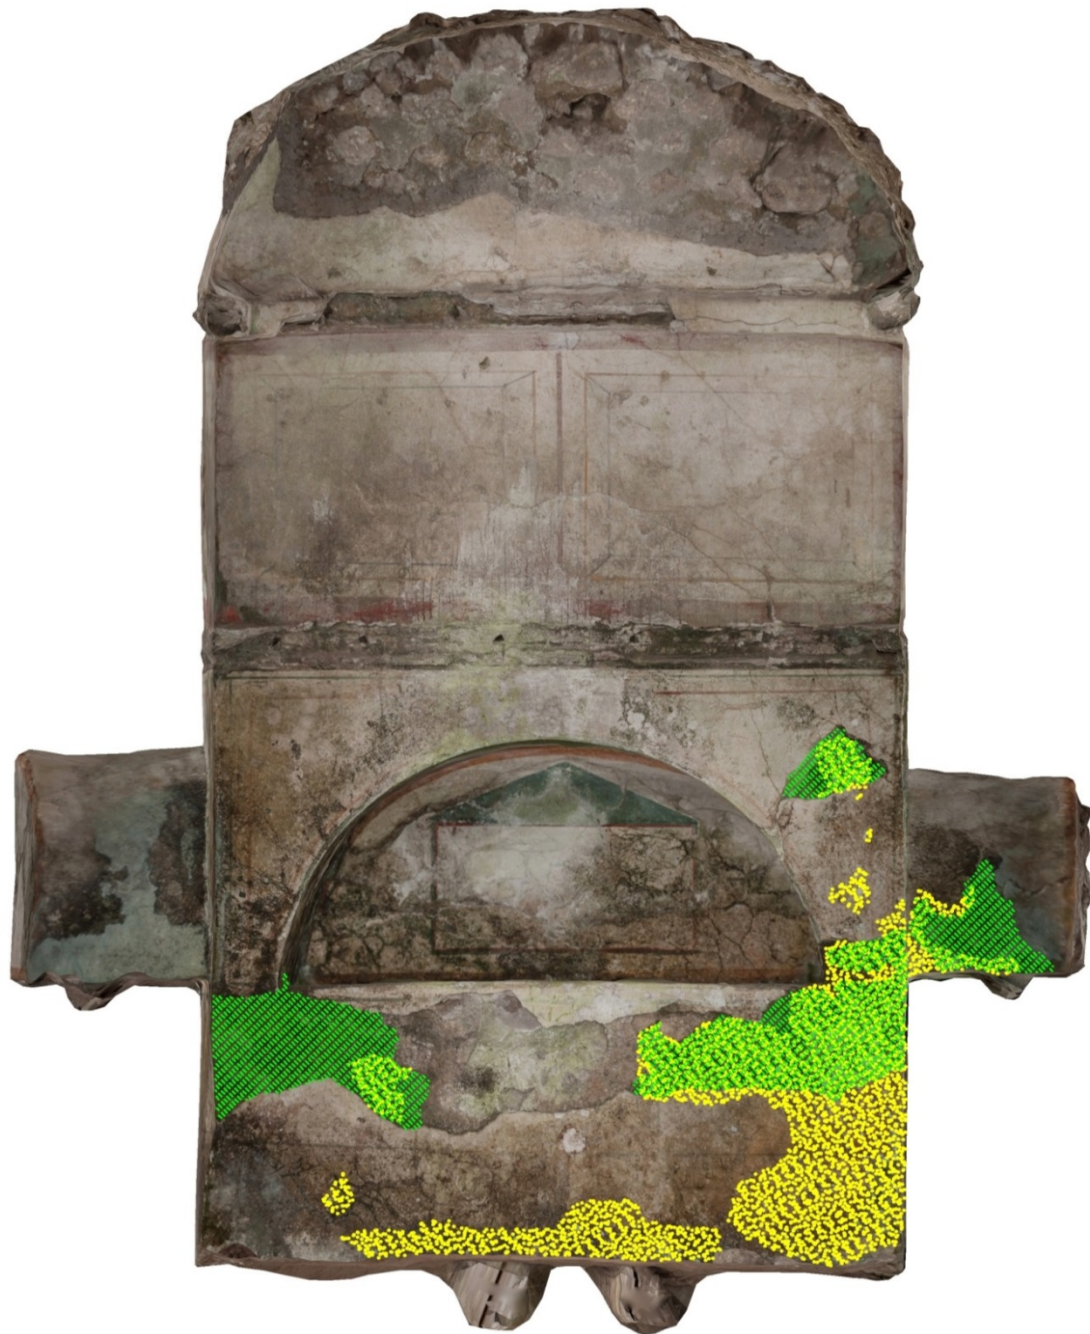
## NECROPOLIS OF PORTA NOCERA - 07\_ES\_S\_I

Figure 215: map 07\_ES\_S\_I of moss and lichens.

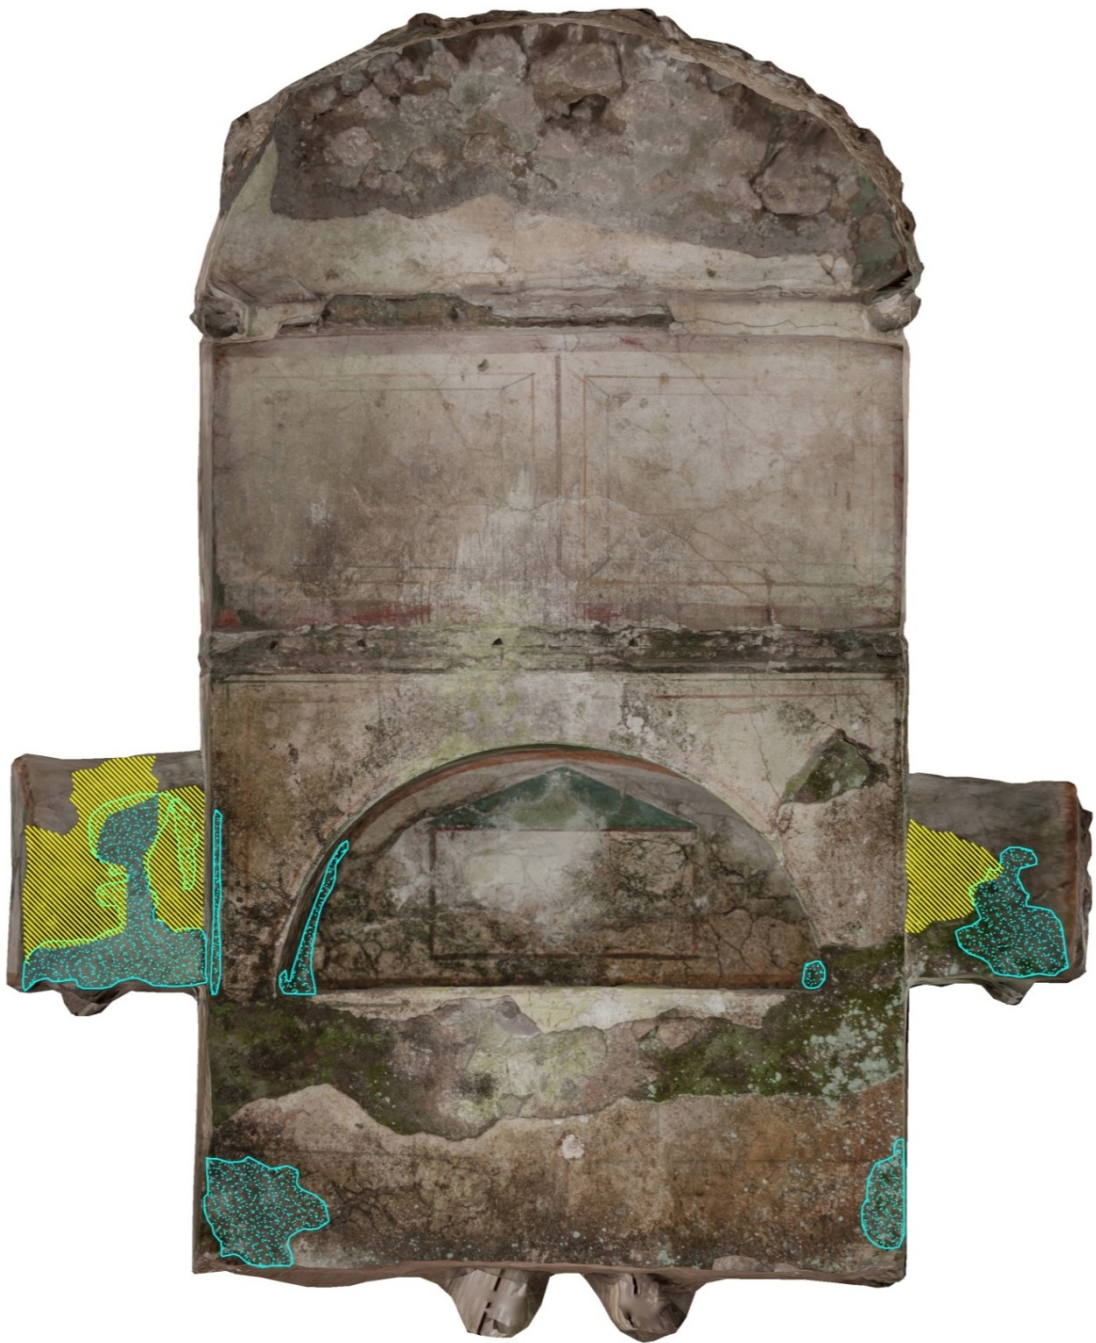
## NECROPOLIS OF PORTA NOCERA - 07\_ES\_S\_I

Figure 216: map 07\_ES\_S\_I of possible fungi.

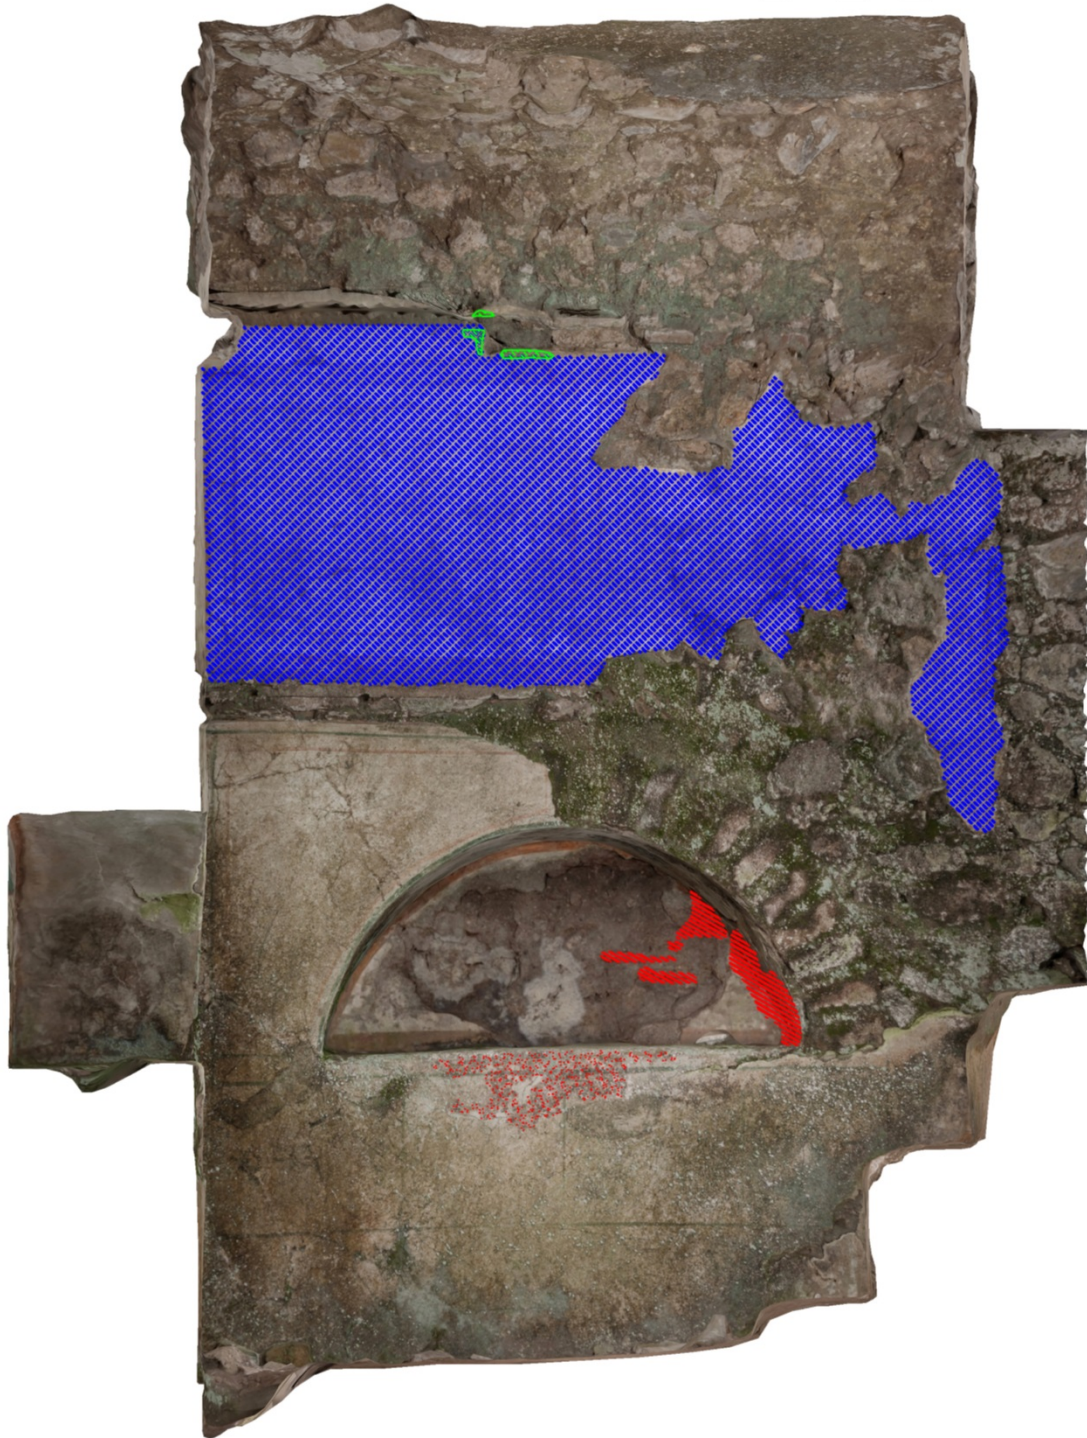
## NECROPOLIS OF PORTA NOCERA - 07\_ES\_W\_I

Figure 217: map 07\_ES\_W of possible alga.
